**EBENEZER FLATS/KIDD ROAD
EROSION PROTECTION STUDY
DRAFT**

**SUBMITTED TO
REGIONAL DISTRICT OF BULKLEY-NECHAKO**

McElhanney Consulting Services Ltd.
1633 First Avenue
Prince George BC V2L 2Y8

October 2008
Our File: 2331-00650-0

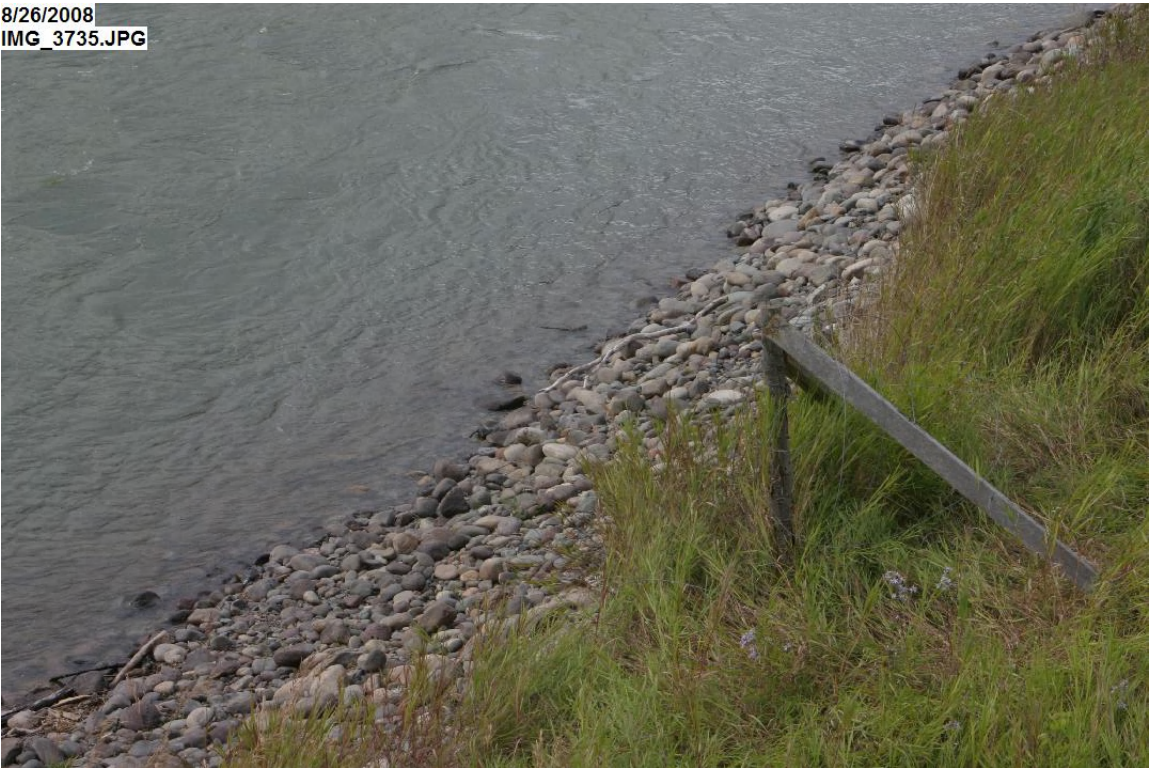
8/26/2008
IMG_3735.JPG

Typical bank material – cobbles to 200mm

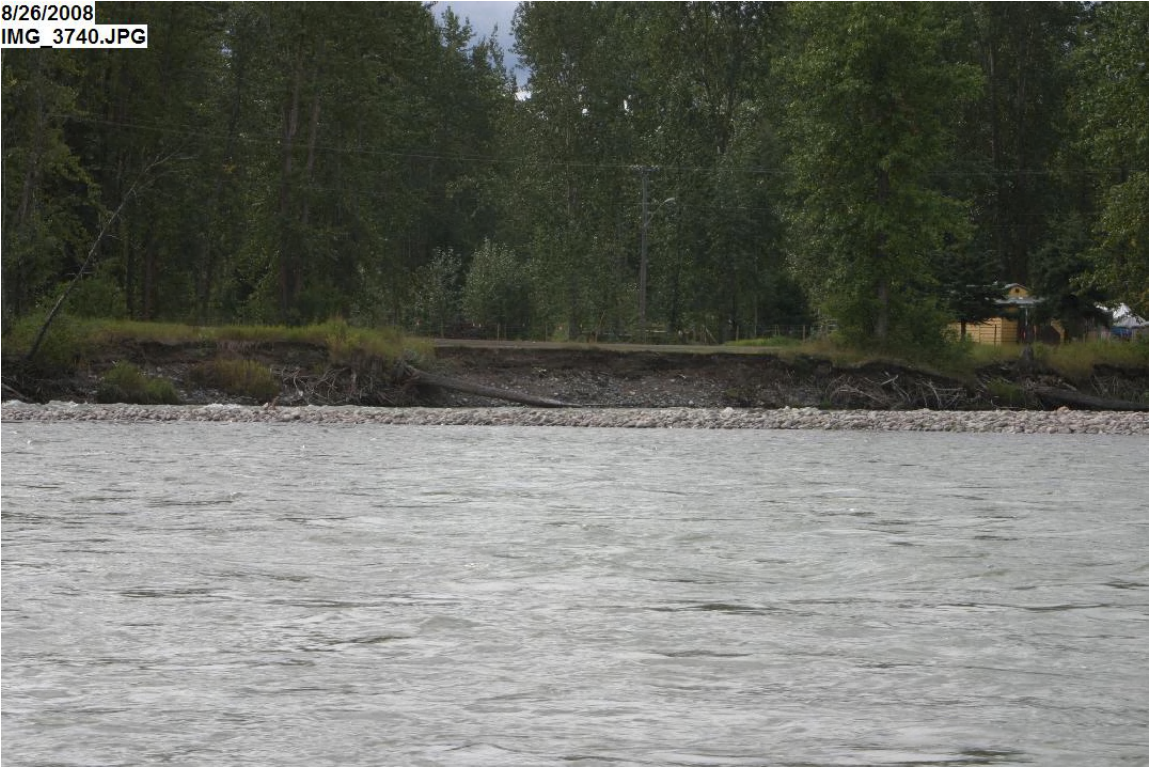
8/26/2008
IMG_3740.JPG

View of left bank showing bank erosion

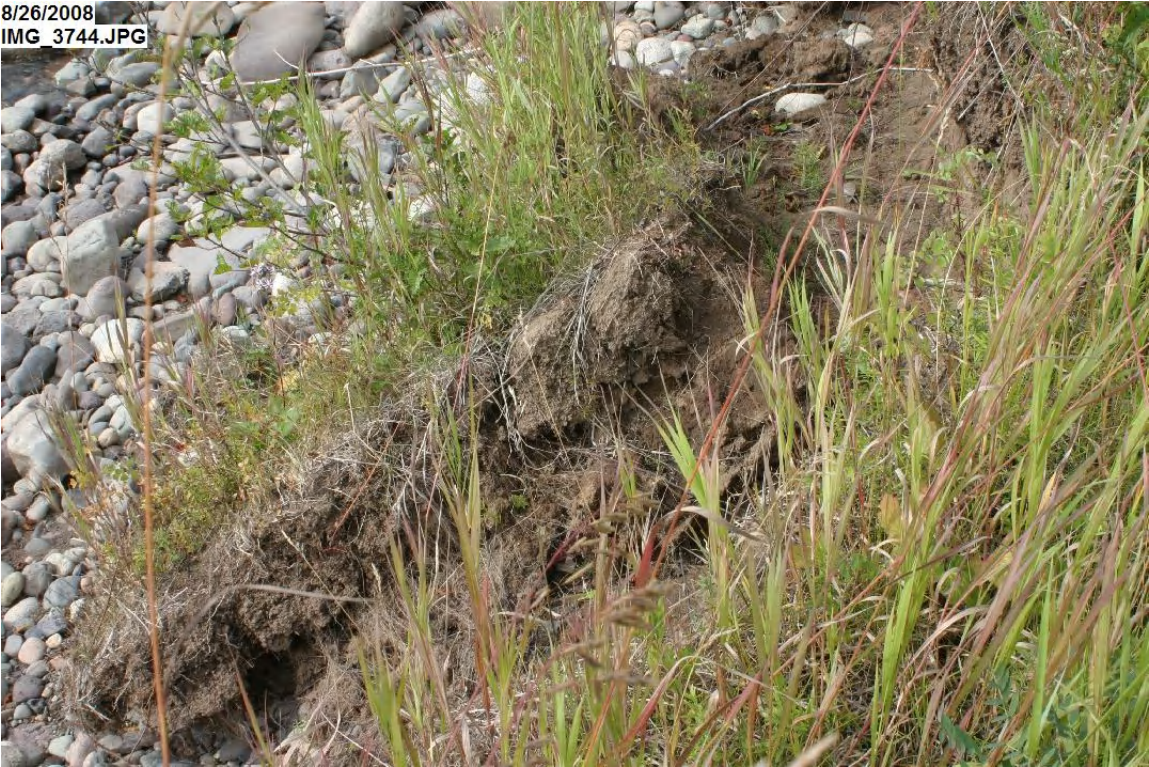
8/26/2008
IMG_3744.JPG

Typical overburden on field showing erosion and sloughing

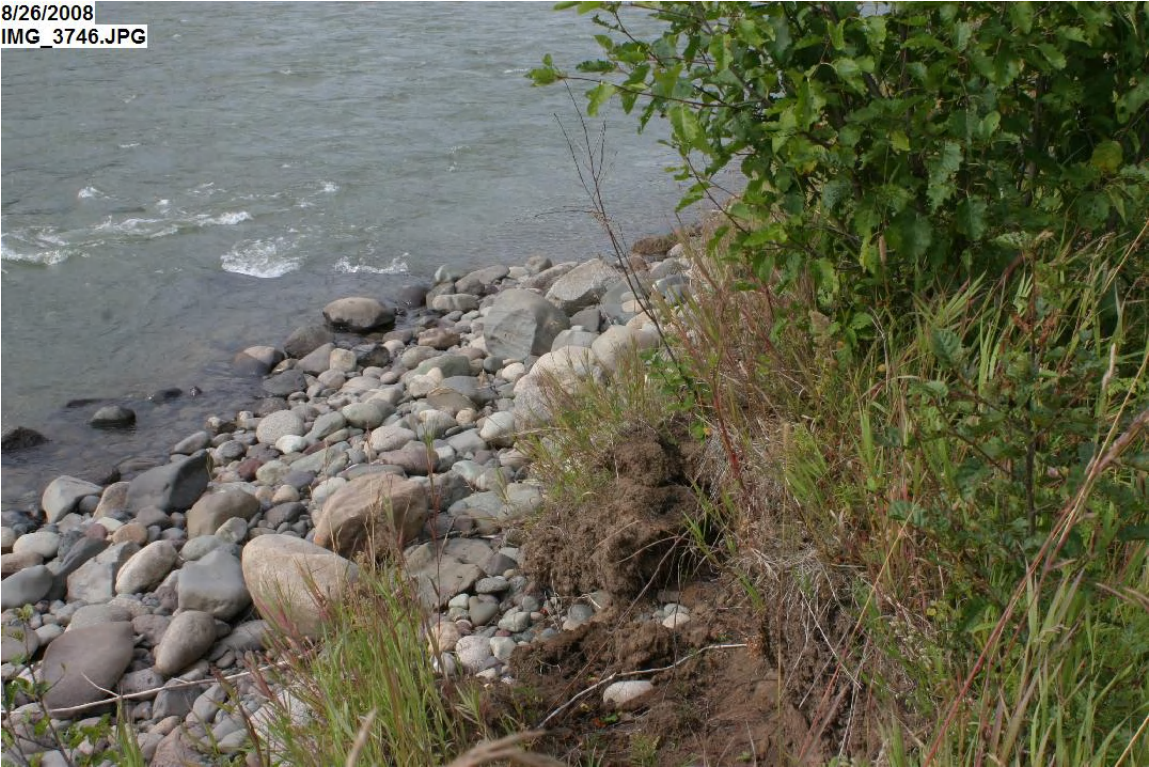
8/26/2008
IMG_3746.JPG

Substantial increase in bank rock size in this location

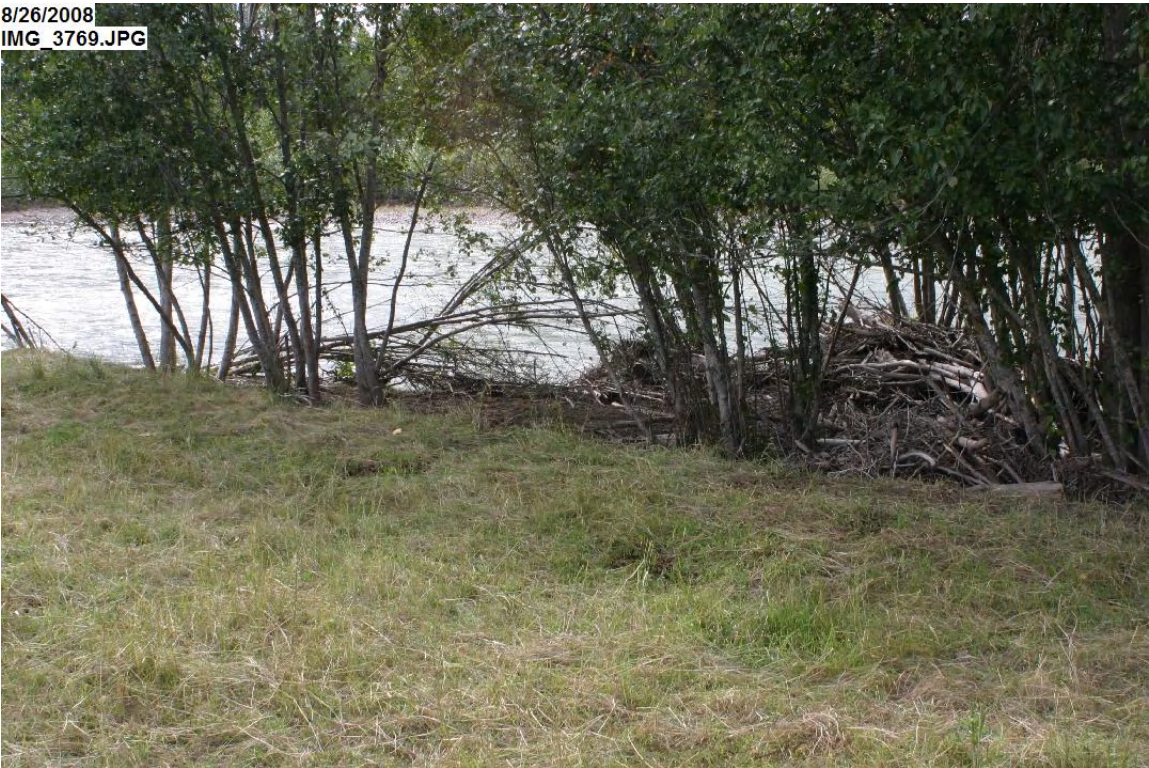
8/26/2008
IMG_3769.JPG

Flood debris caught in trees

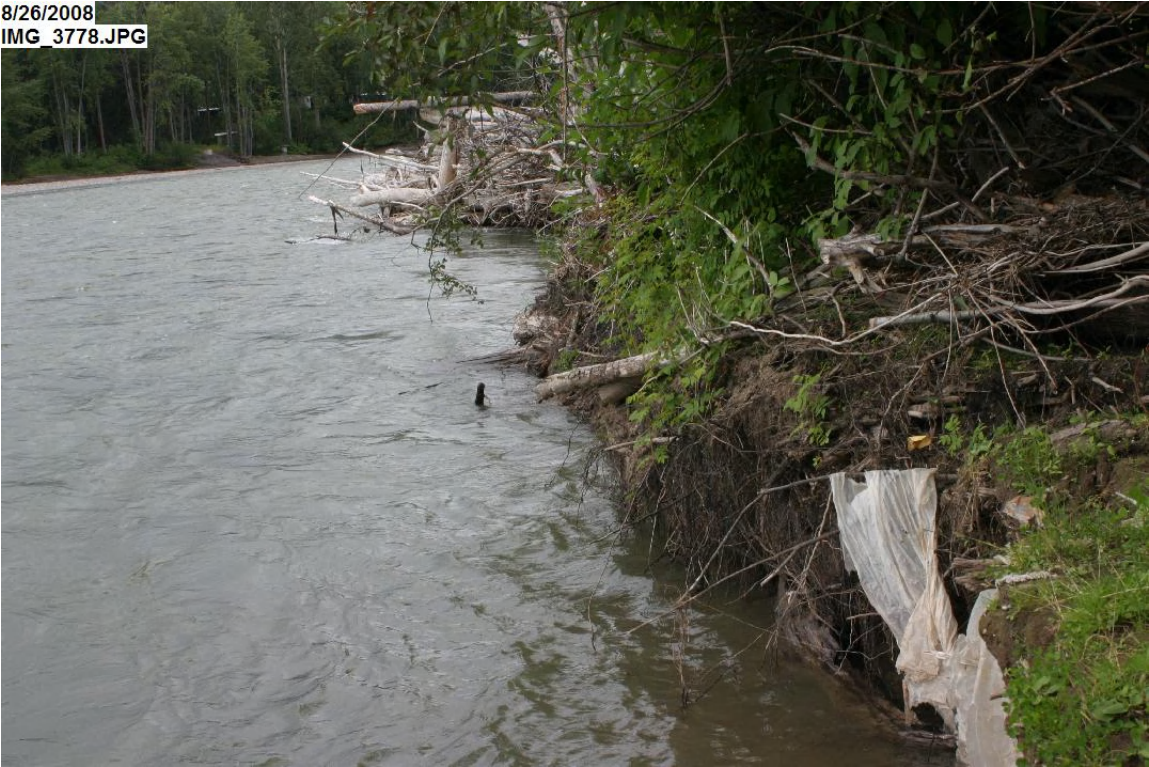
8/26/2008
IMG_3778.JPG

The fine bank material can also be found in the treed area seen in photos 3769 to 3782. This area is vegetated and looks like it is the end of the major erosion. It is likely that the roots of the vegetation and trees are preventing some of the erosion from taking place, although evidence of the onset of erosion can be seen from the leaning trees.

Note bank sloughing and soils with weak resistance to erosion

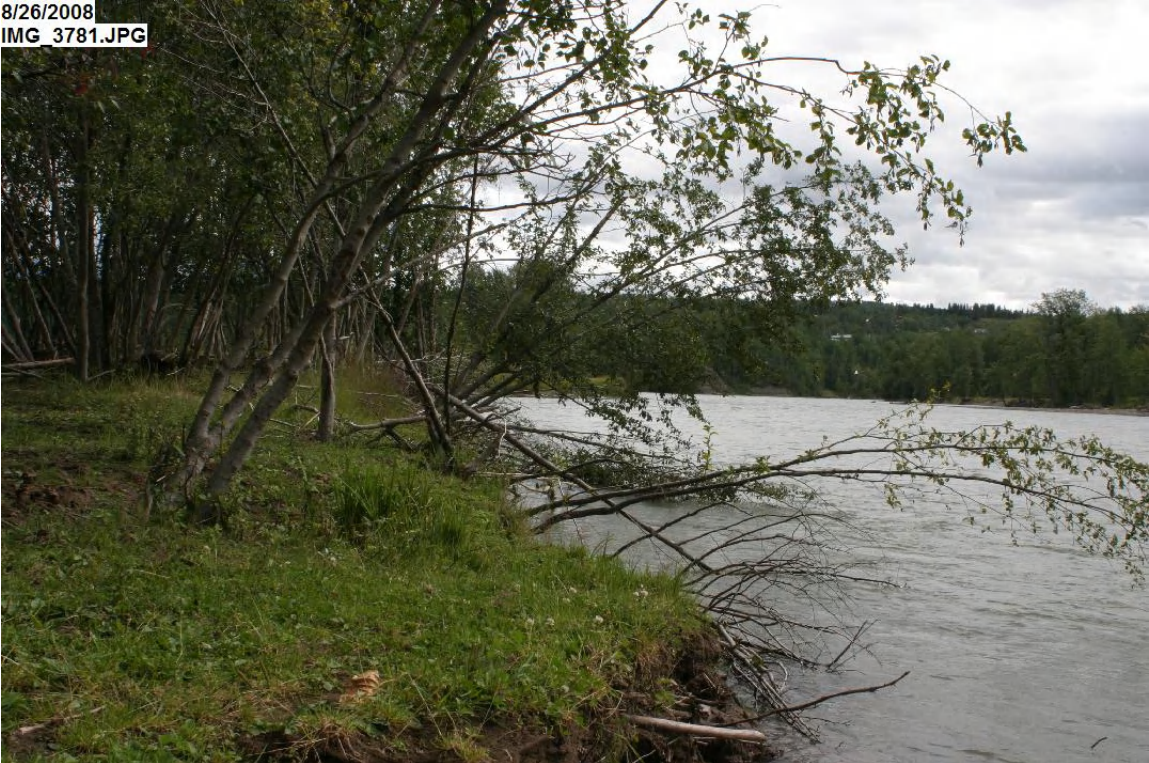
8/26/2008
IMG_3781.JPG

Leaning trees indicate continued erosion and bank failure

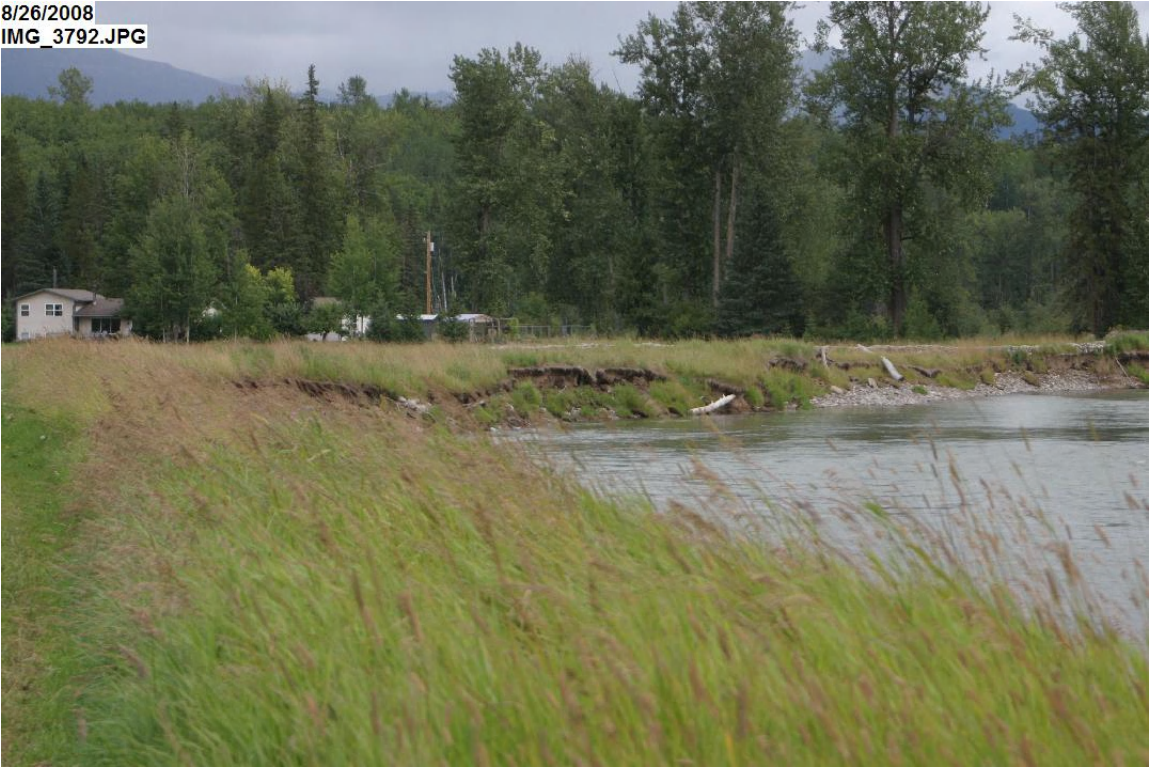
8/26/2008
IMG_3792.JPG

Photos and measurements were also taken at the end of Kidd Road on the bank of the Bulkley River (see GPS waypoint 41 in Appendix B). At this location the Bulkley River has eroded the banks such that there is a vertical or undercut face at depths ranging from 1.2 to 1.6 metres. The overburden on top of the cobbles and gravel is similar to the material found at the end of Lower Viewmount Road. At this location the river jumped its banks and flowed north through the field, eventually making its way back into the main channel. A sandbag dike setback from the river was built during the flood.

Bank erosion at end of Kidd Road

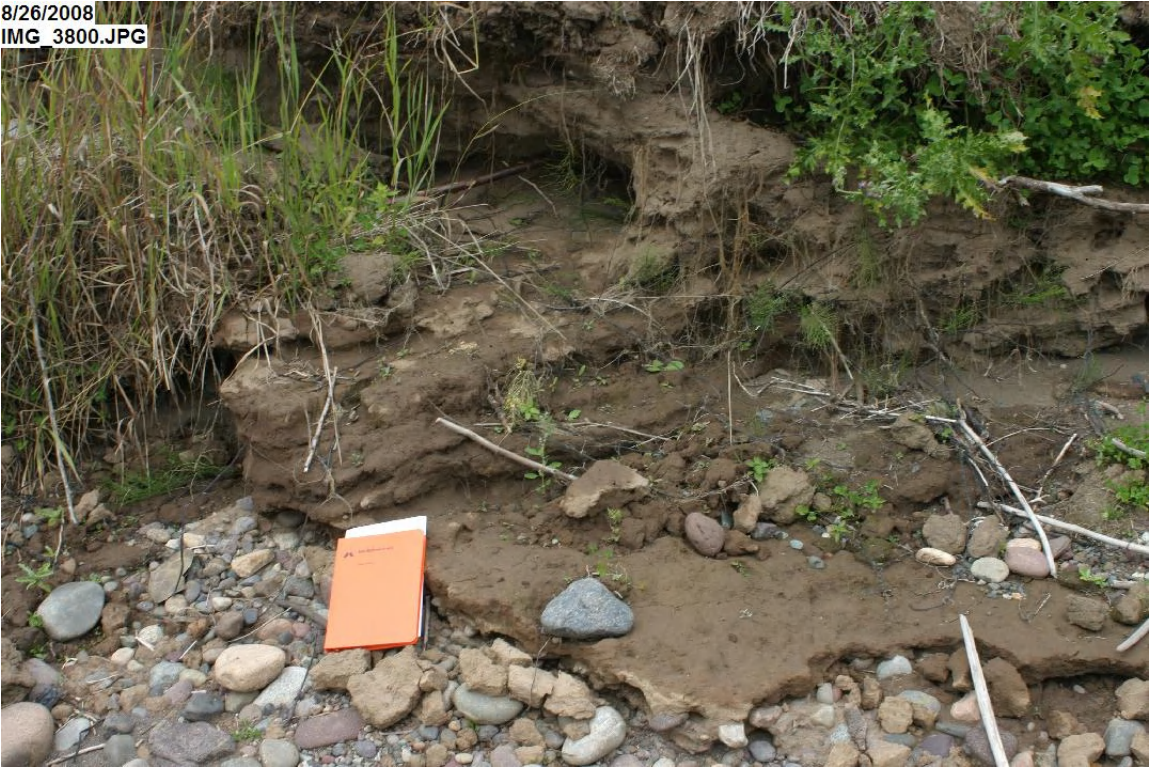
8/26/2008
IMG_3800.JPG

Silty sand overlying cobbles at end of Kidd Road

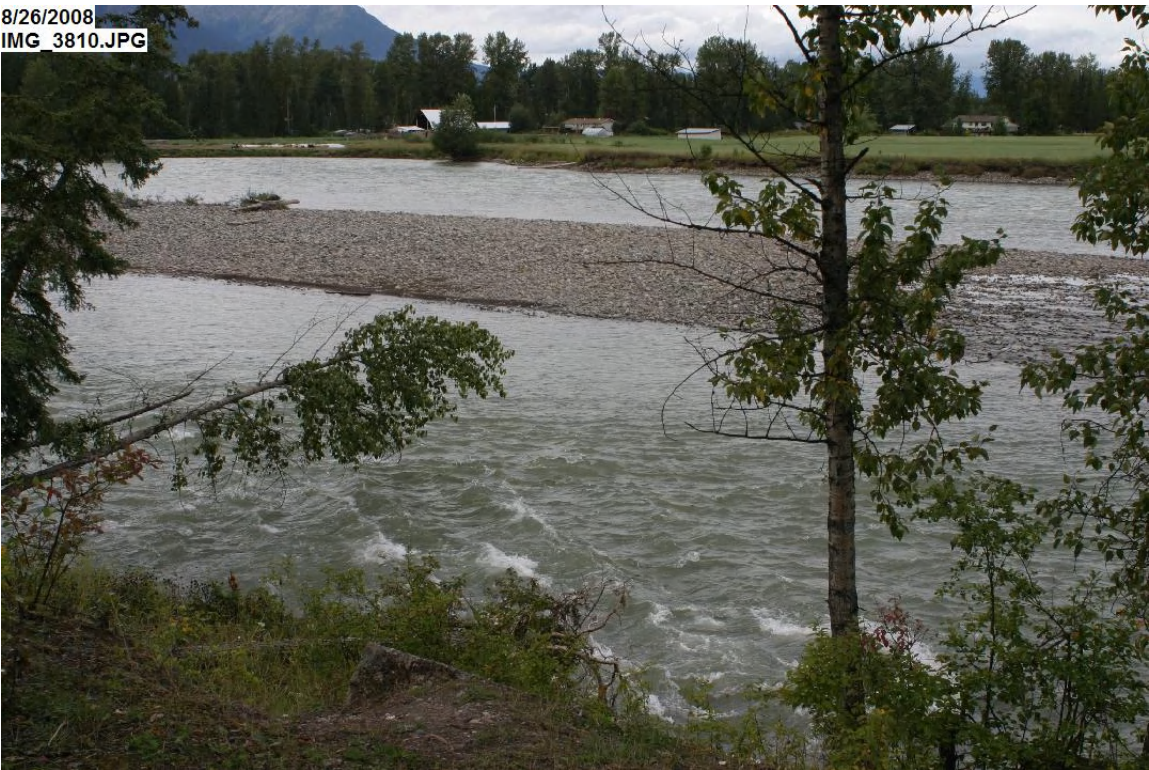
8/26/2008
IMG_3810.JPG

A review of the south end of the old Bulkley River crossing gave some interesting insight into the current behaviour of the river channel and allowed an overview of the right bank which is our area of interest in this project. There is a large gravel bar in the channel (photo 3824) and there is lateral flow from the right side of the channel toward the left side over top of the beginning of the gravel bar. Photo 3821 shows this lateral flow. Velocities in the left channel are approximately 2.5 to 3 m/s while the right channel is seeing velocities of around 1 m/s. The left bank is also experiencing bank erosion. The left bank is higher than the right bank and so the extent of erosion damage is greater.

mid stream gravel bar – flow was higher velocity on this side

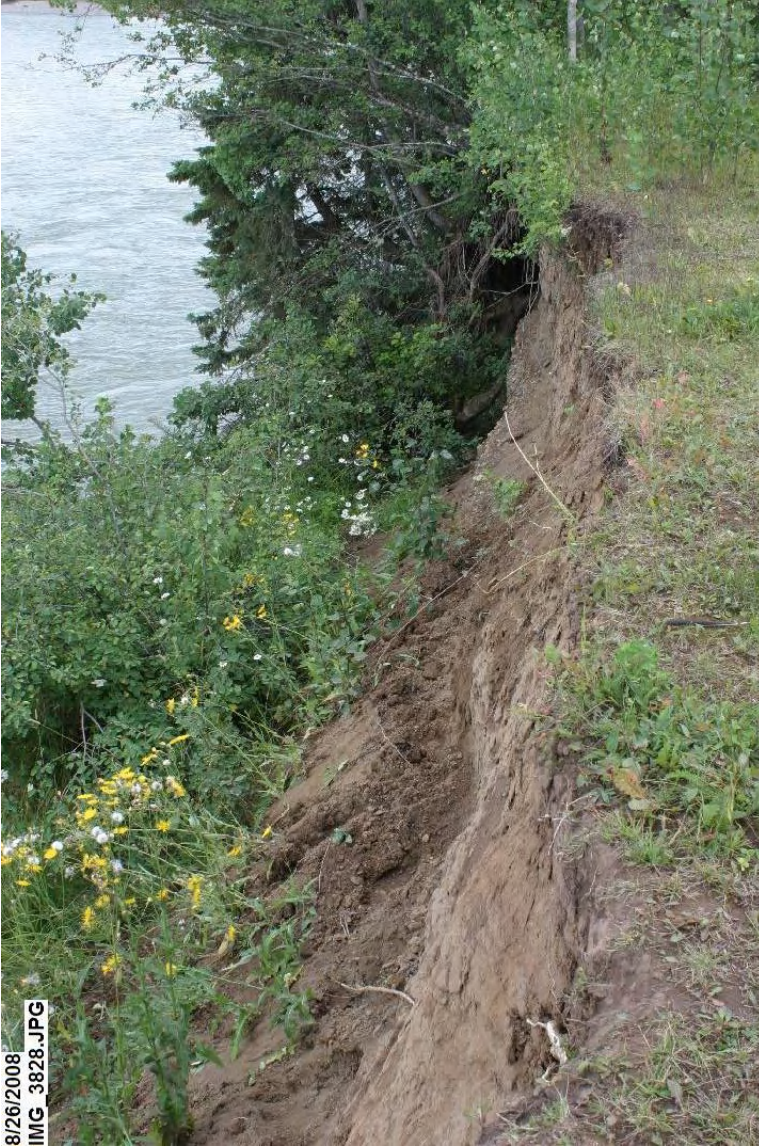
Just before the entrance into Riverside Park there is a bank failure that has been flagged off for safety reasons (photo 3828). This side of the river is being reviewed since there is a possibility that erosion protection works on the right bank may impact the left bank.

Slope failure east of Riverside Park
