APPENDIX B

Photos

GEOTECHNICAL ASSESSMENT
LOWER VIEWMOUNT ROAD
SMITHERS, BC

PROJECT No: KX04813

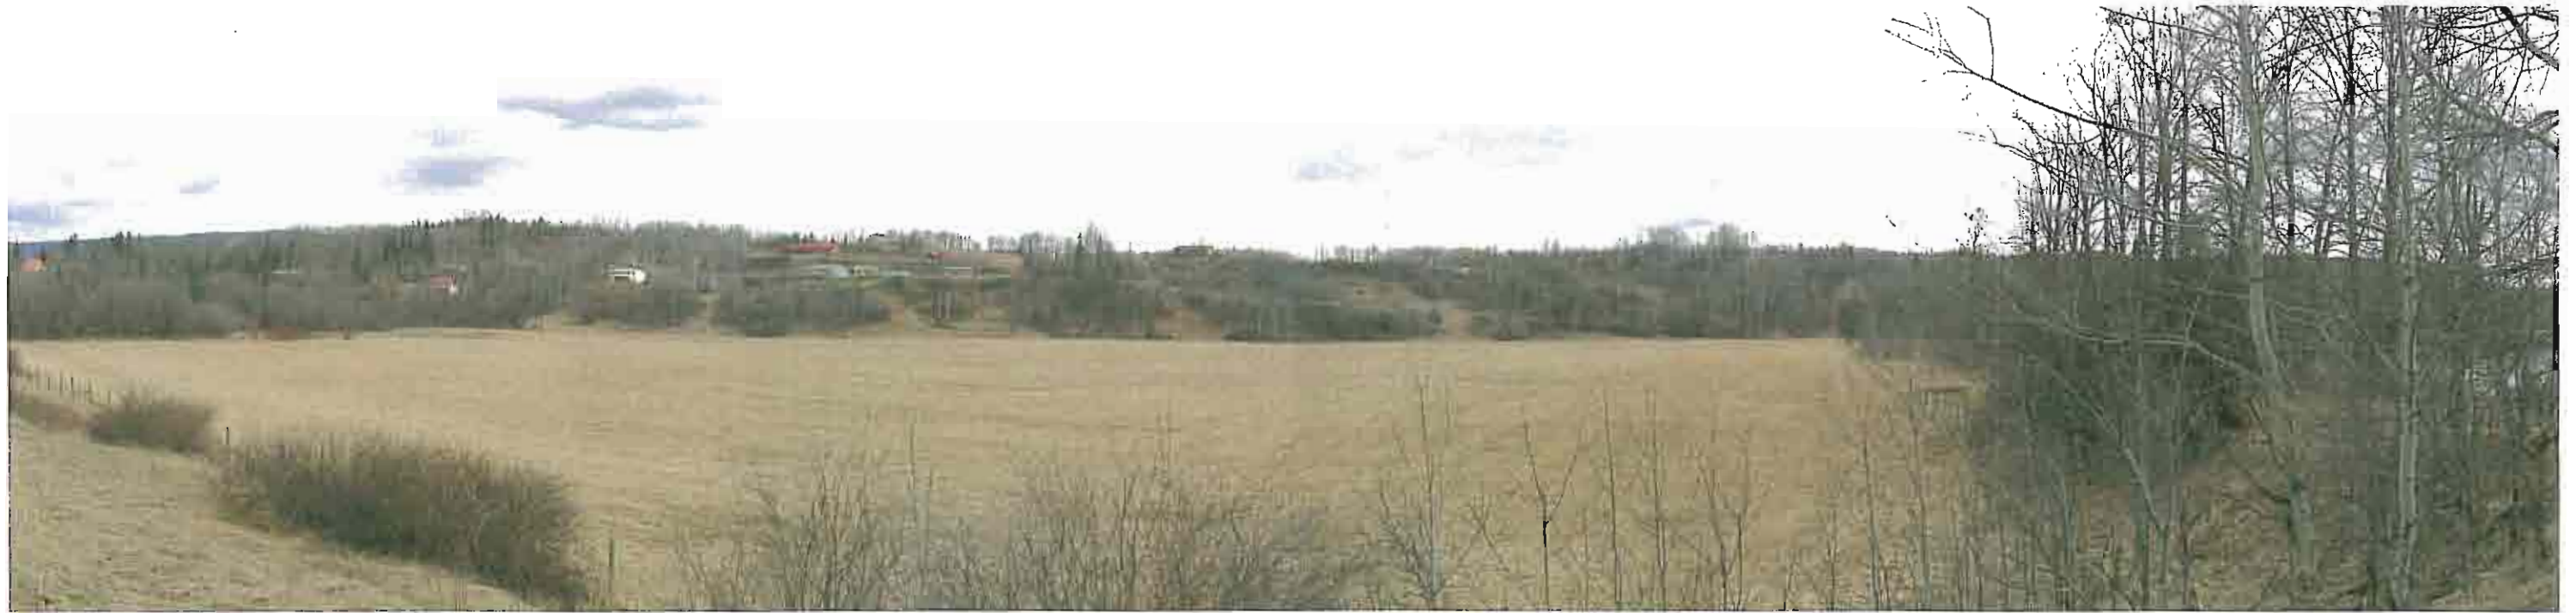
Photo 1: Panorama view east at existing development on old river valley slope along Lower Viewmount Road (Study Area A). Modern river valley slope above the Bulkley River at extreme right. Floodplain / terrace in foreground.

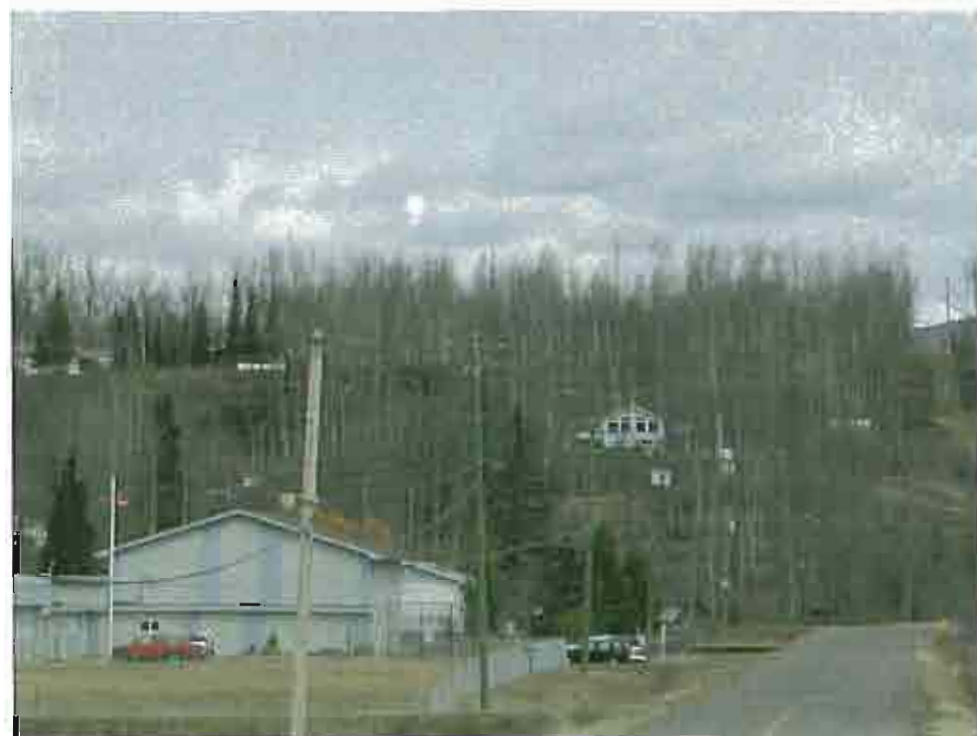
Photo 2: View north at existing development on old river valley slope north of Lower Viewmount Road (Study Area B).

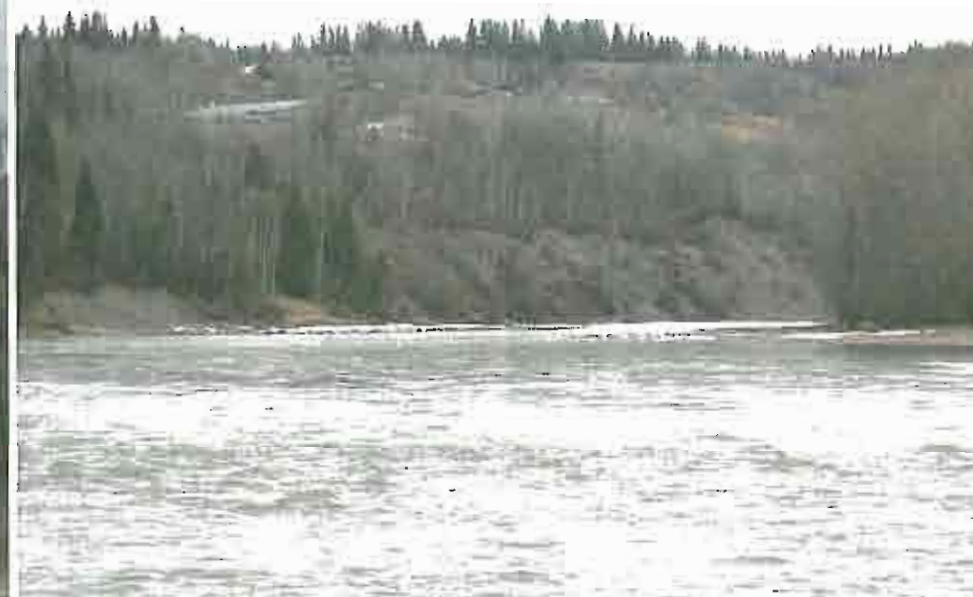
Photo 3: View upstream along Bulkley River at modern river valley slope in vicinity of Harris Auto Wrecking (Study Area A).

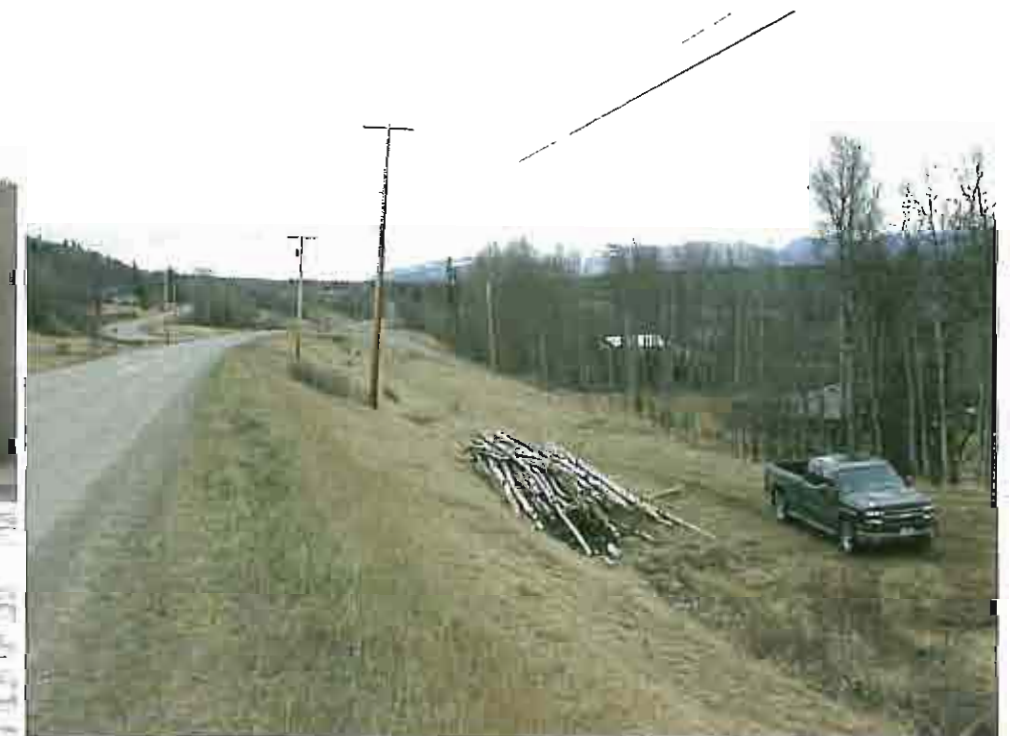
Photo 4: View south along Old Babine Lake Road at old river valley slope south of Harris Auto Wrecking (Study Area B).

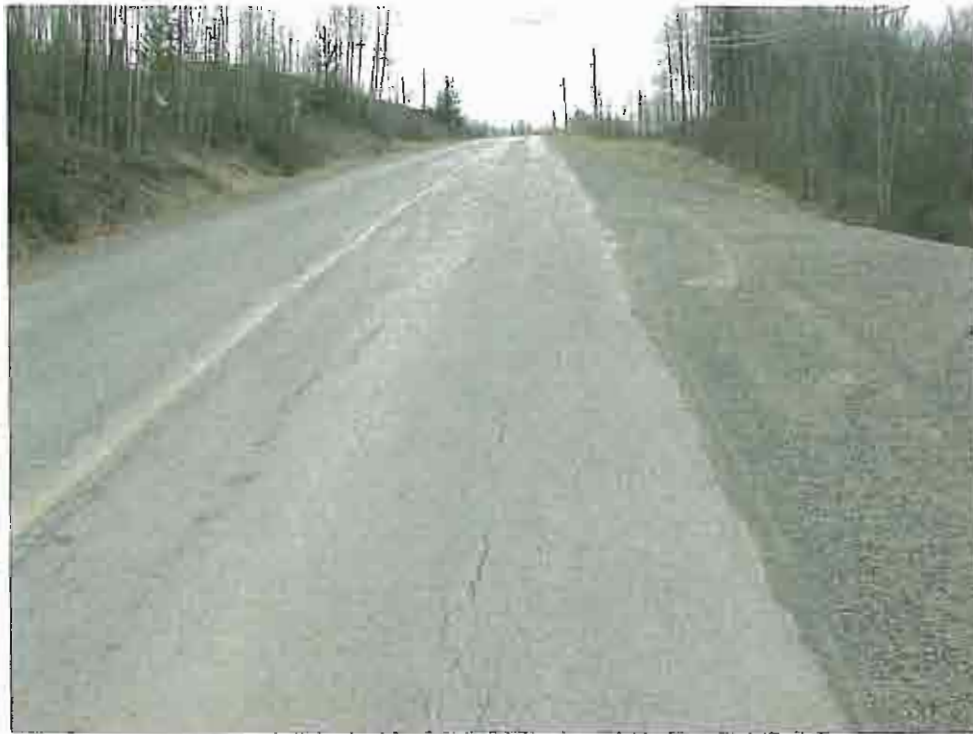
Photo 5: View south at pavement deformation on Lower Viewmount Road due to a fill failure in the vicinity of the driveway for 1037.

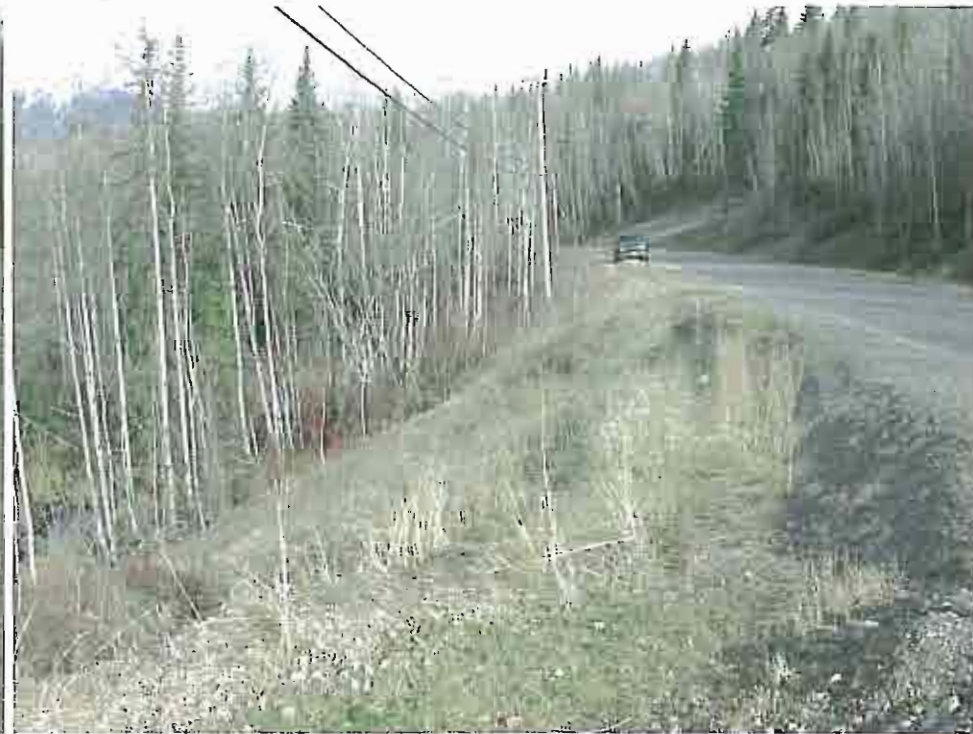
Photo 6: View north at fill failure on Lower Viewmount Road, just north of driveway entrance for 1037.

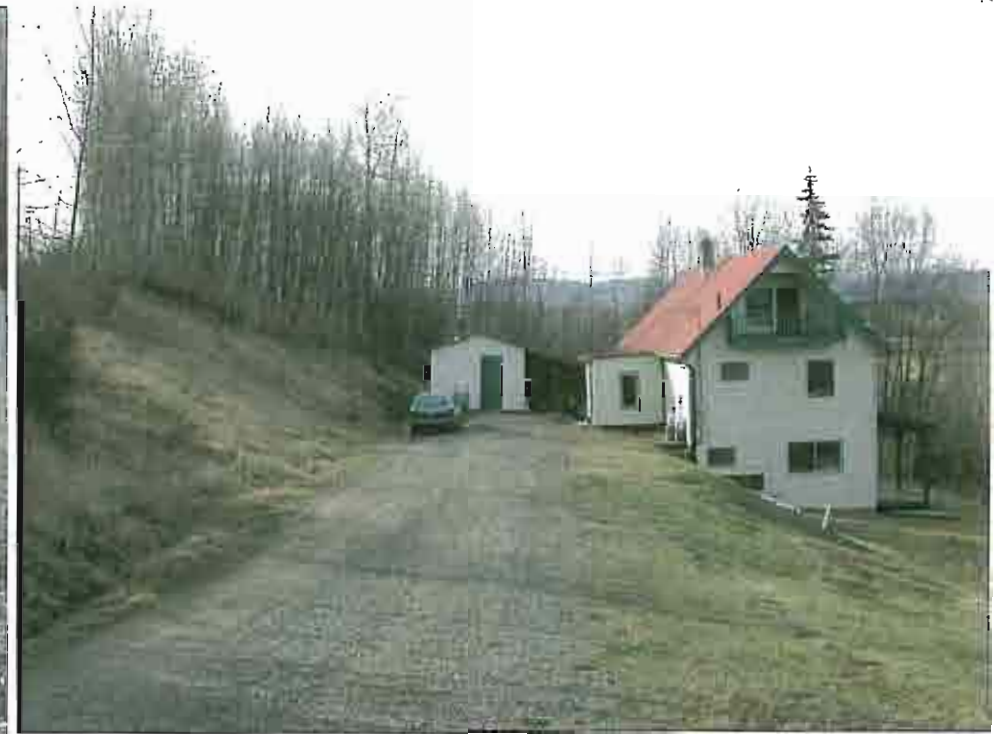
Photo 7: View southwest at driveway and house at 1037. Development created by cutting and filling on old river valley slope.

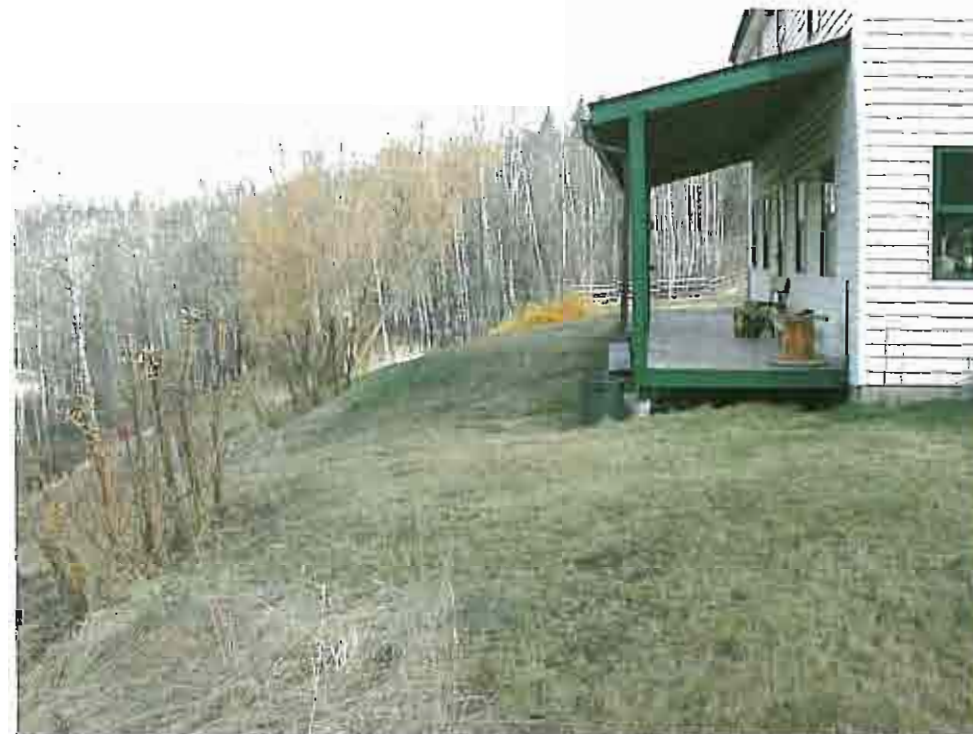
Photo 8: View north at fill on west side of 1037. Possible slow fill settlement and/or sliding downslope of house.

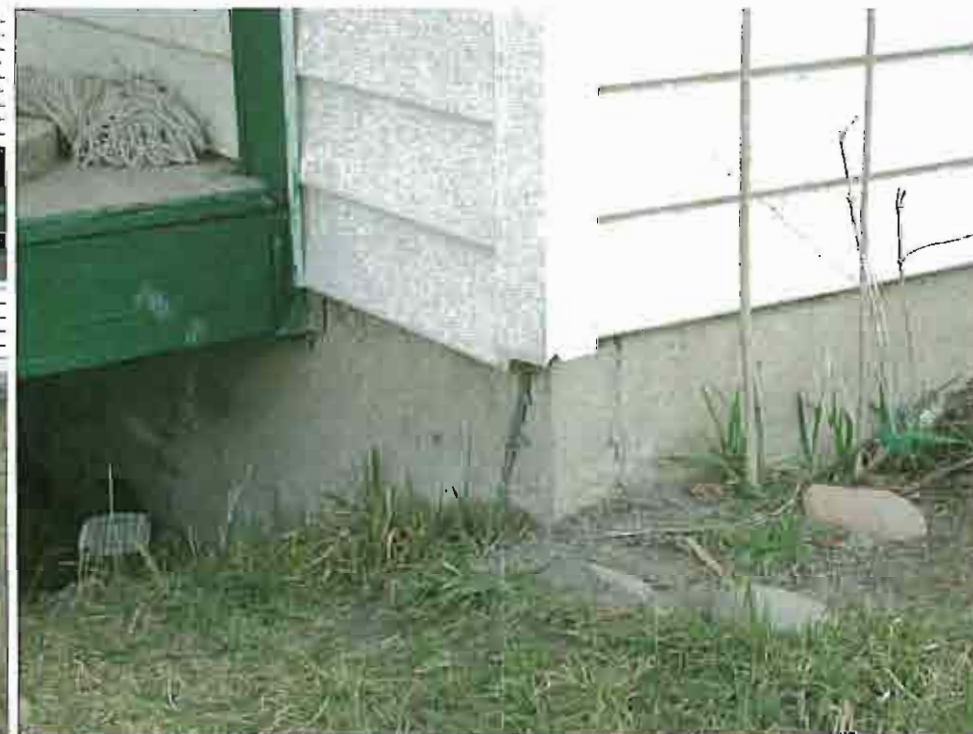
Photo 9: Small crack in south west corner of concrete foundation of 1037.

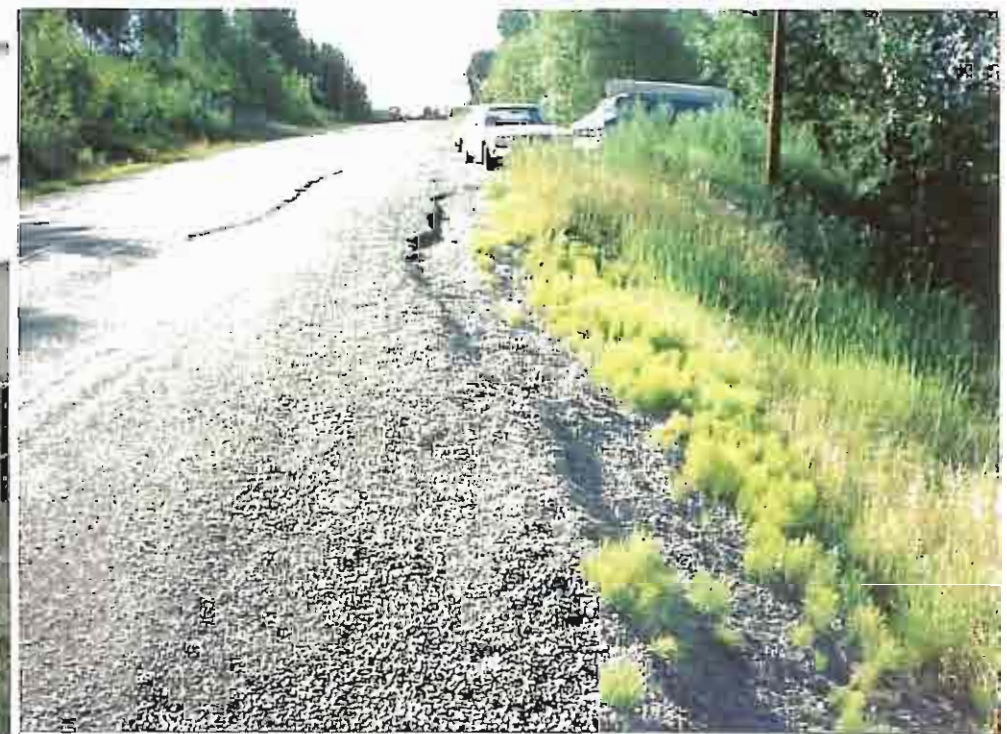
Photo 10: MoT file photo (ca. 1989), looking south at fill failure on Lower Viewmount Road near driveway access for 1037.

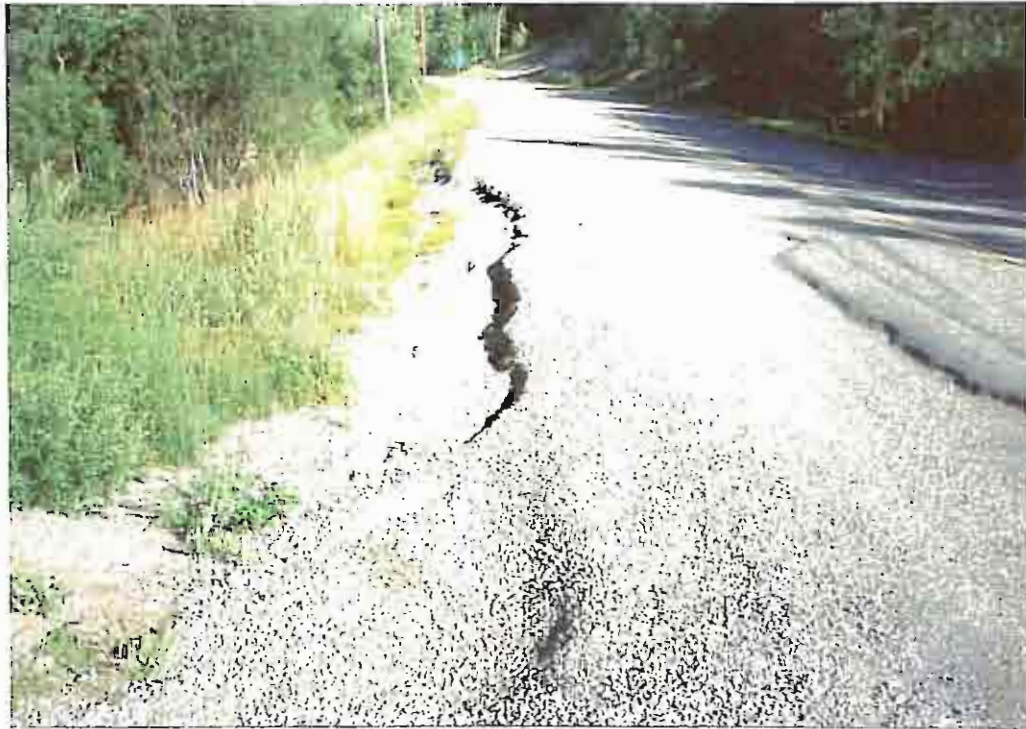
Photo 11: MoT photo (ca. 1989), looking north at fill failure on Lower Viewmount Road just north of driveway access for 1037.

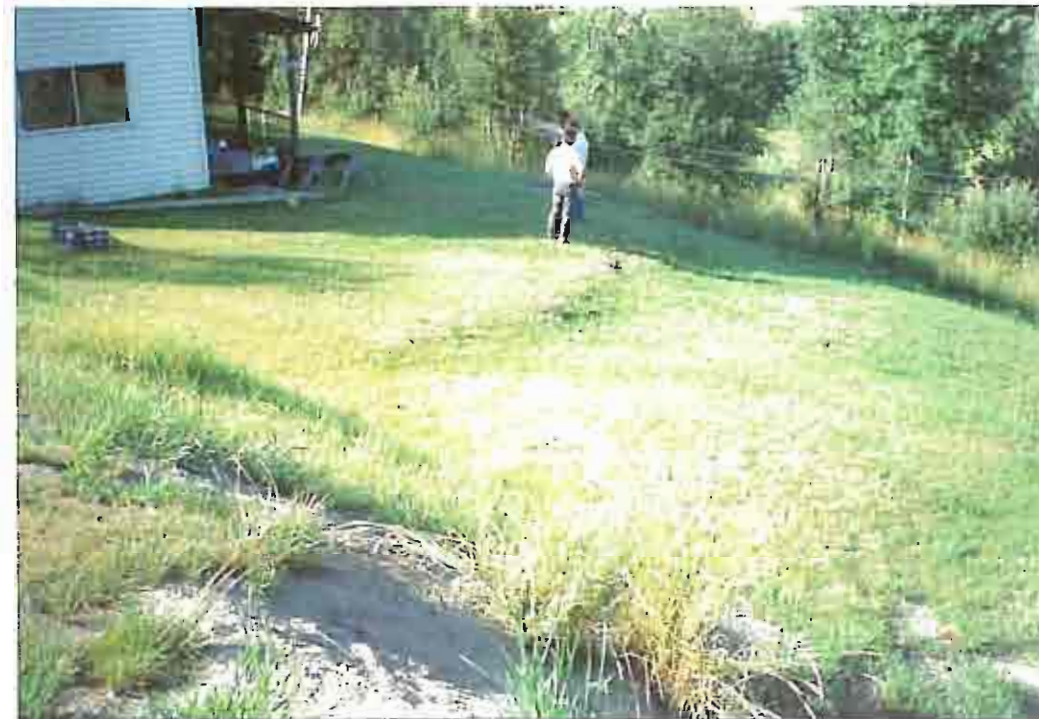
Photo 13: MoT photo (ca. 1989), looking south west at ground movements in fill north and west of 1037. Note, present day septic disposal and possibly water service lines may cross this area.

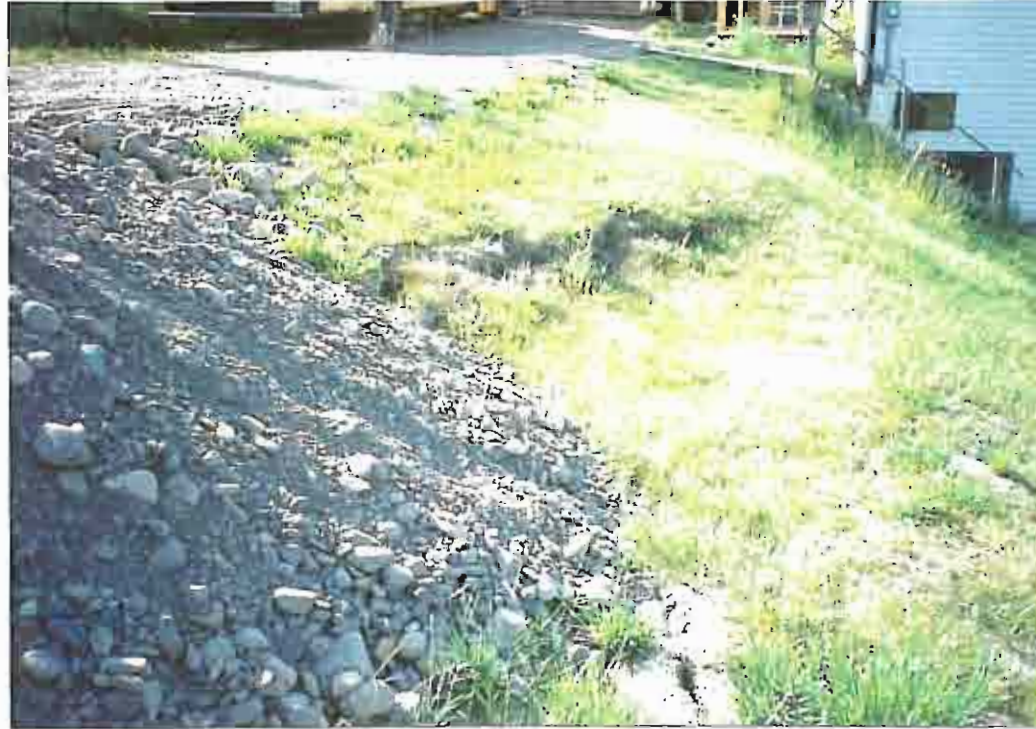
Photo 12: MoT photo (ca. 1989), looking south west at ground cracking in fill below driveway of 1037.

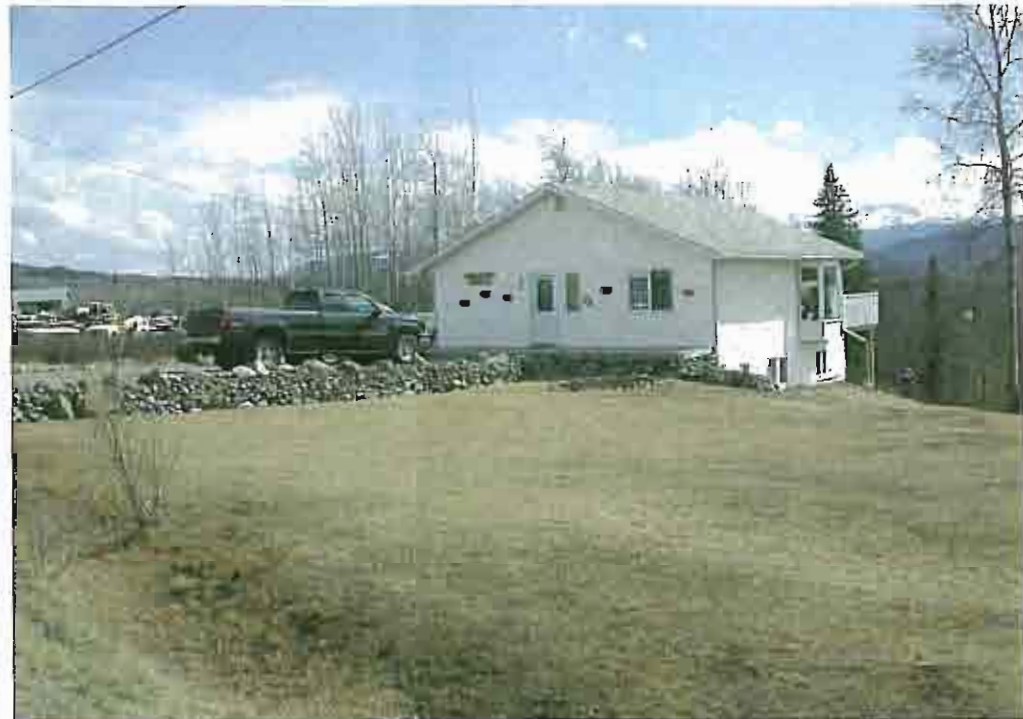
Photo 14: View southwest at 195 Lower Viewmount Road, house located at crest of river valley slope.

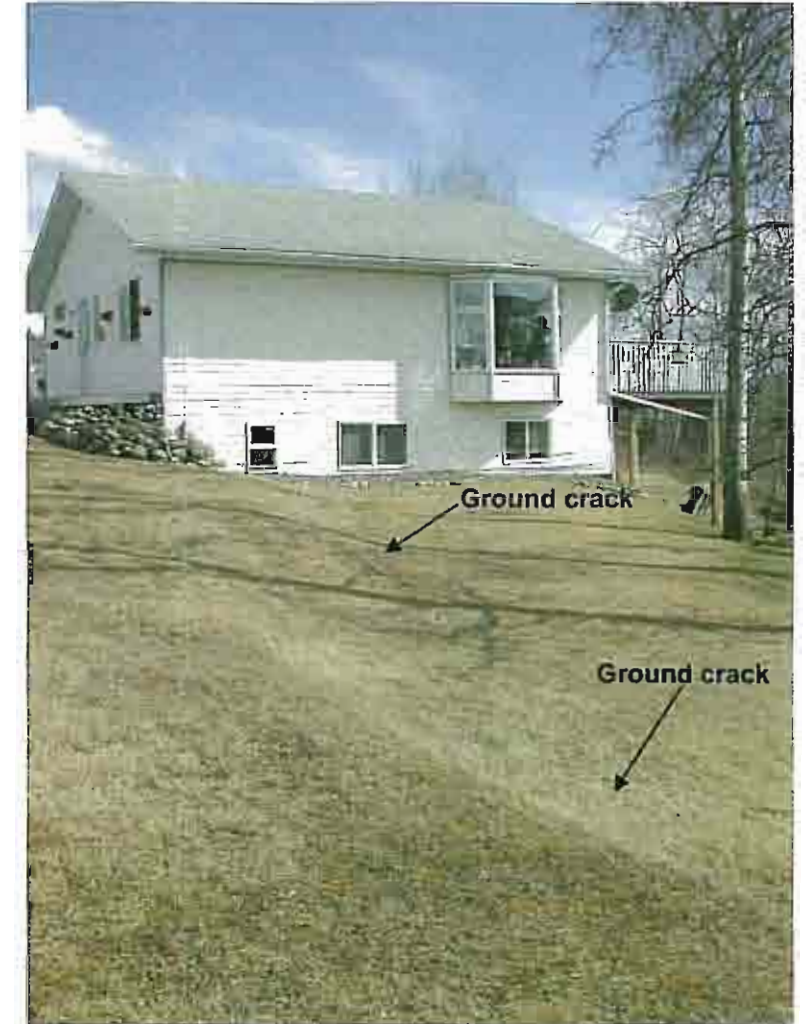
Photo 15: View south east at 195. Note ground depression/fresh cracking that can be traced to north west side of house and crack in north west foundation wall. This represents the likely new main scarp of a deep-seated landslide into Bulkley River.

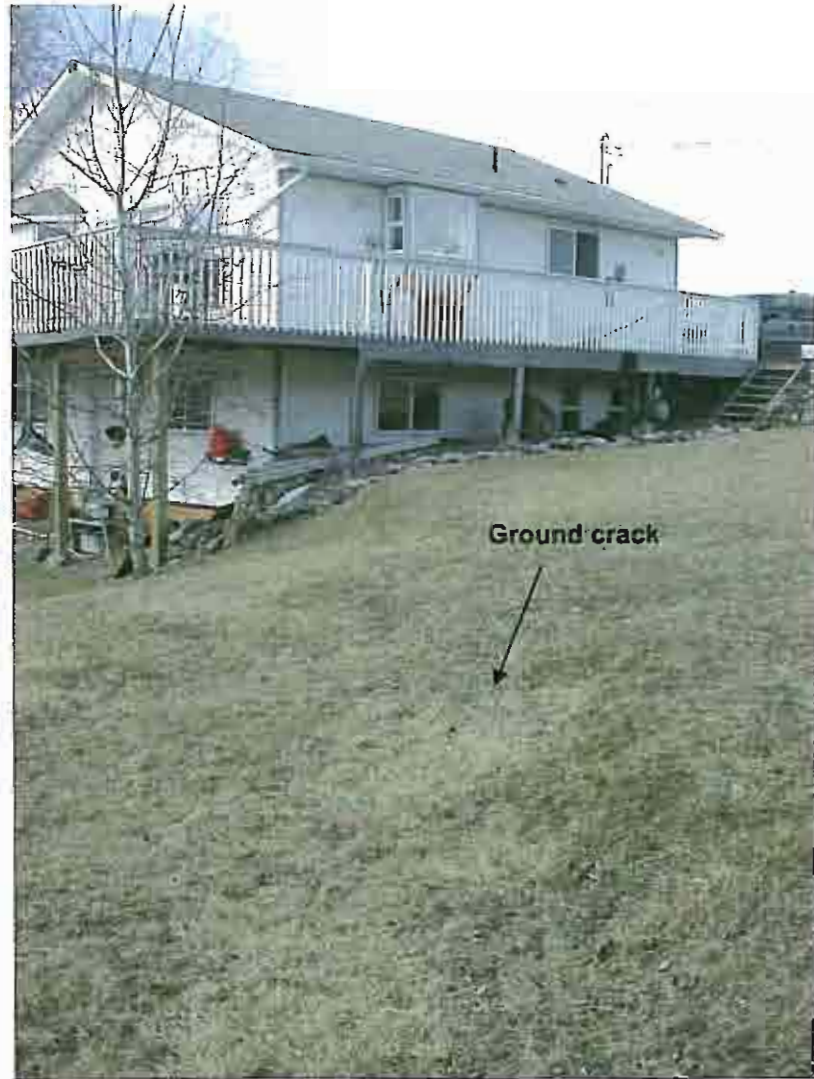
Photo 16: View north at 195 along ground depression/fresh cracking that can be traced to south east foundation wall of house.

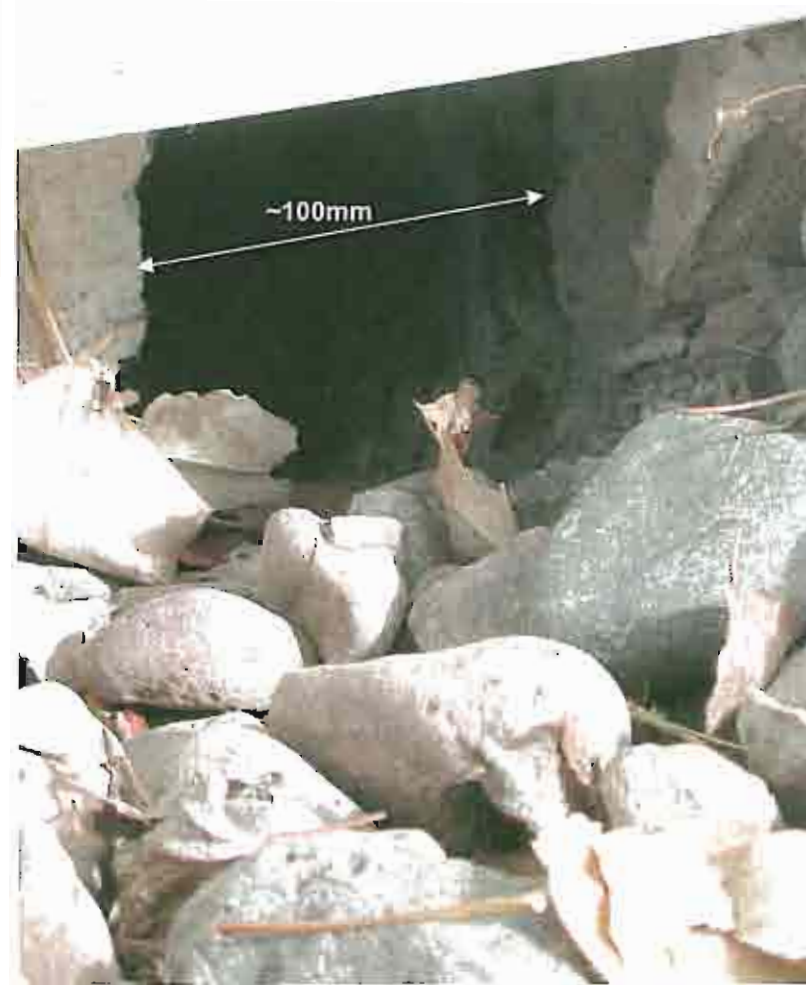
Photo 17: An approximately 100 mm wide crack in basement concrete wall on north west side of 195.

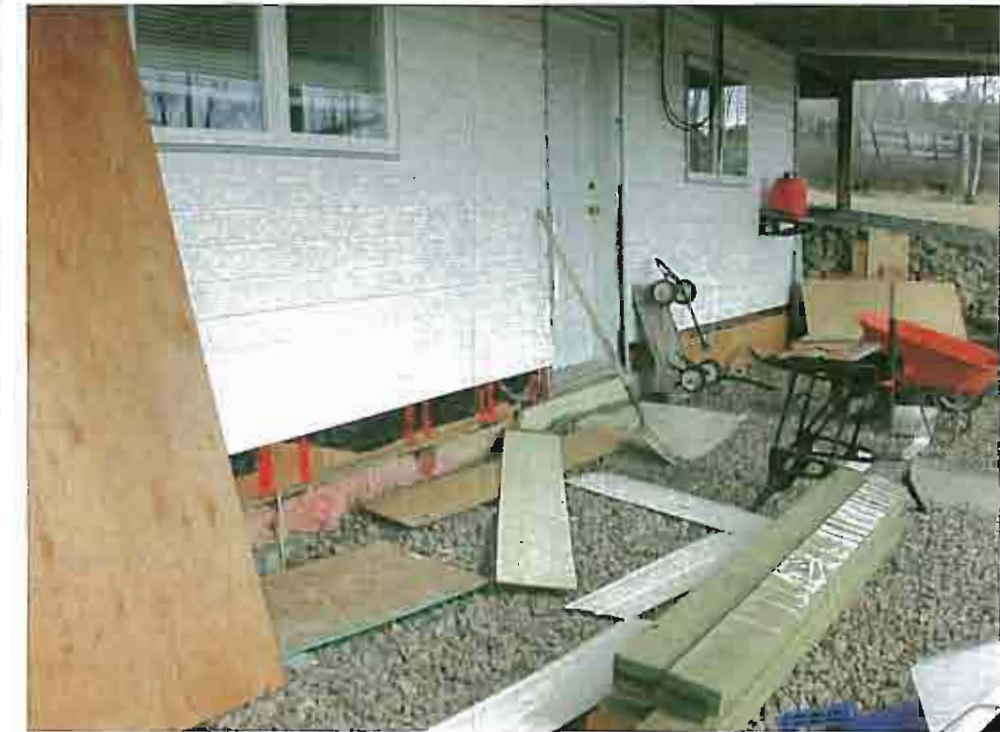
Photo 18: Exposed jacking system on down slope (south west) side of 195.

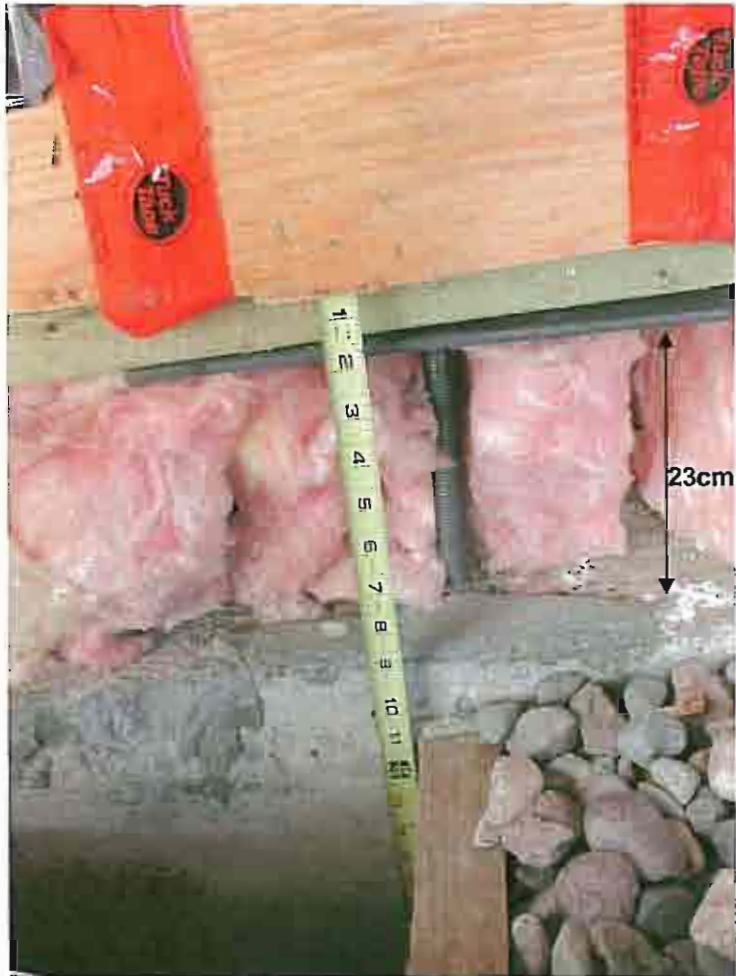
Photo 19: Close up view of a foundation jack on south west side of 195. Note total vertical displacement of approximately 23 cm (9inches).

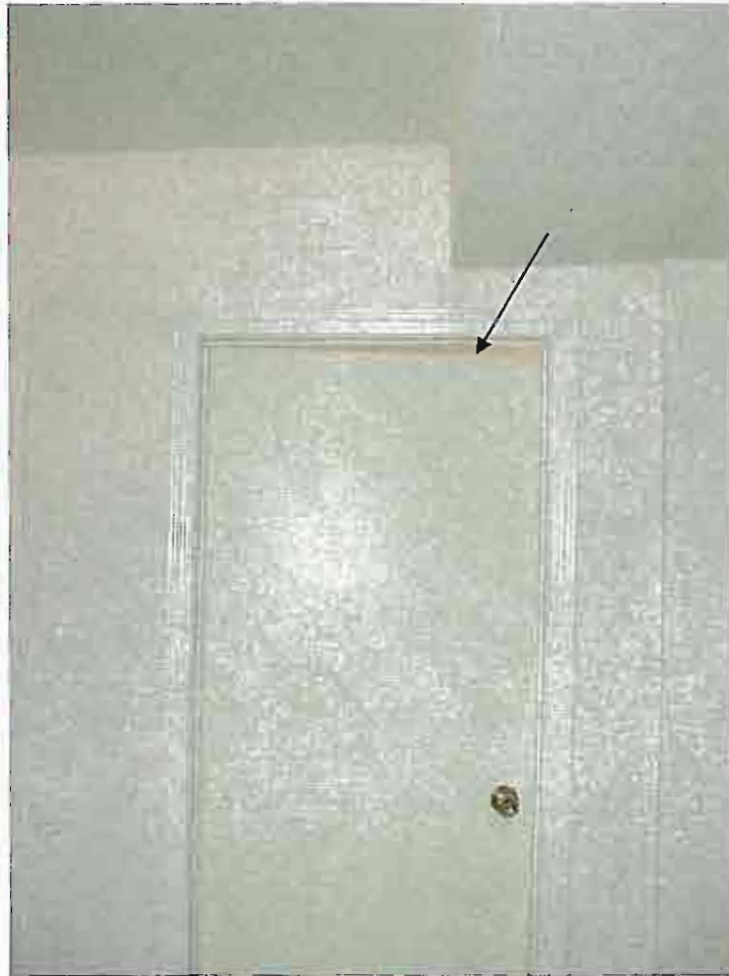
Photo 20 Typical distorted interior door frame on the basement level of 195.

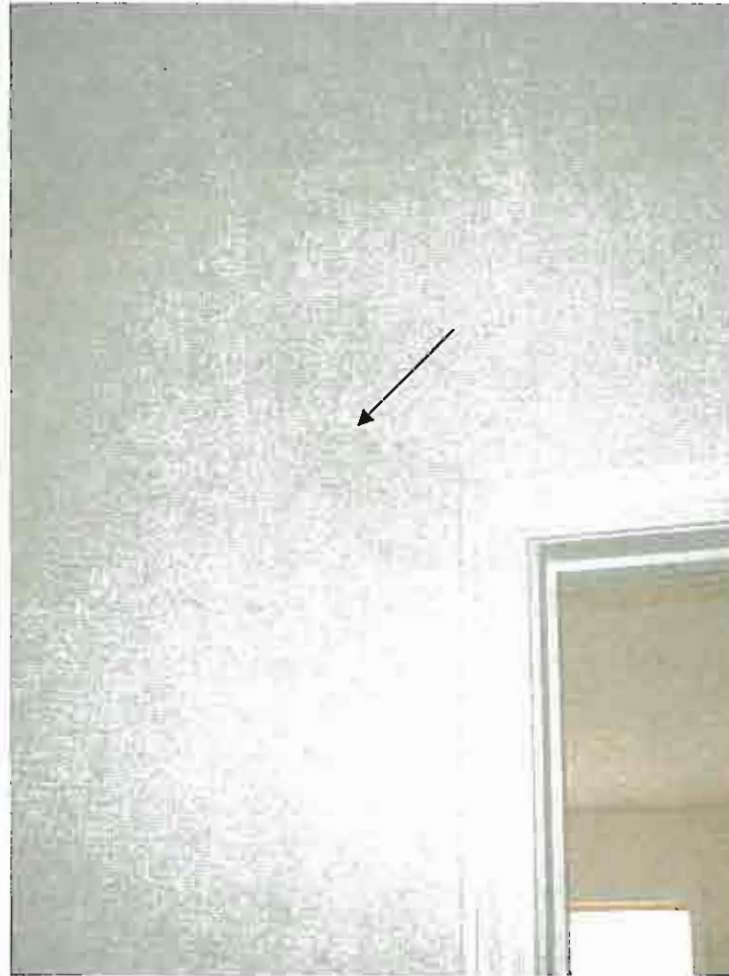
Photo 21: Typical cracking in gyproc on the basement level of 195.

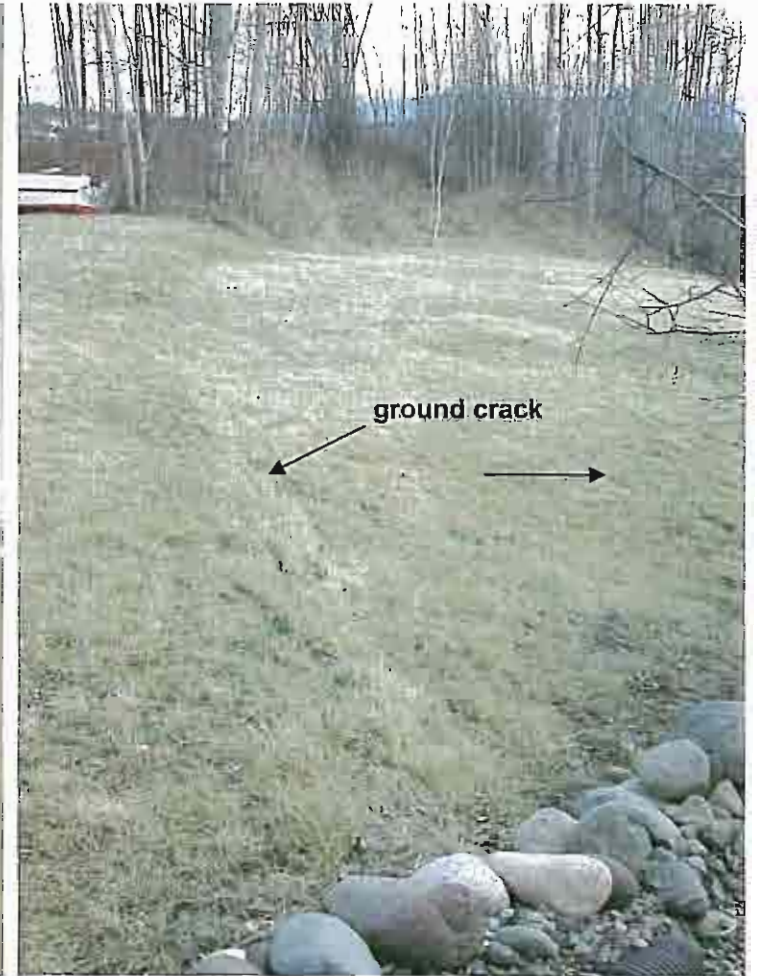
Photo 22: View south along fresh ground cracking (likely new main scarp of landslide) from south east side of 195. Note, the house septic disposal line crosses this area.

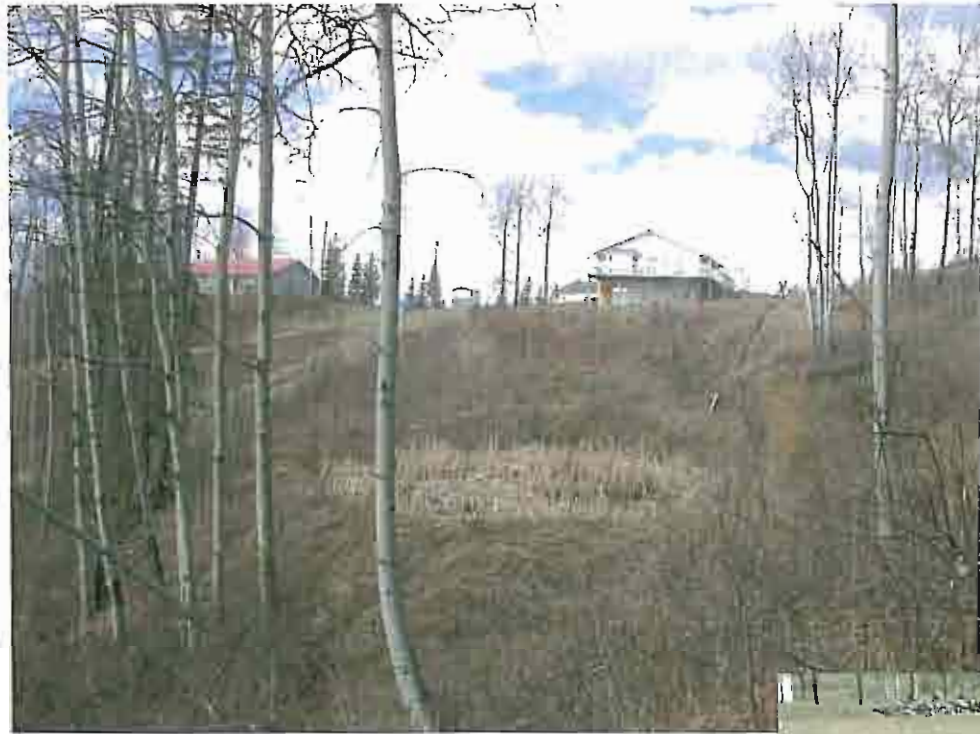
Photo 23: View north east across body and main scarp of landslide area below 195. Note septic lagoon on slide area.

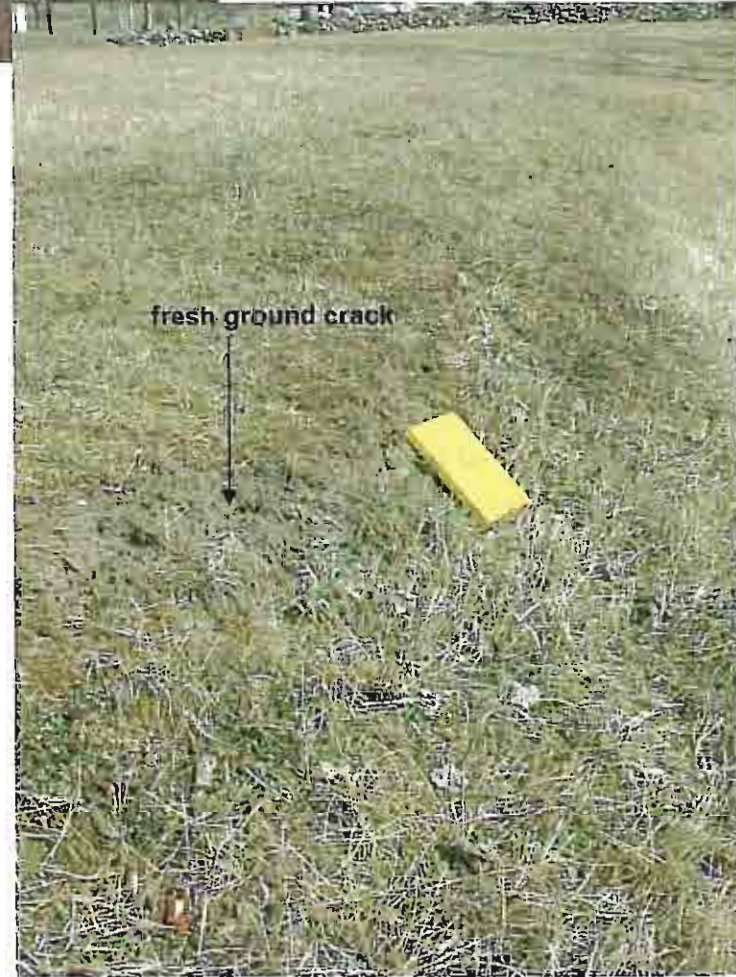
Photo 24: Trace of fresh ground cracking, looking south between 195 and 265 Lower Viewmount Road.

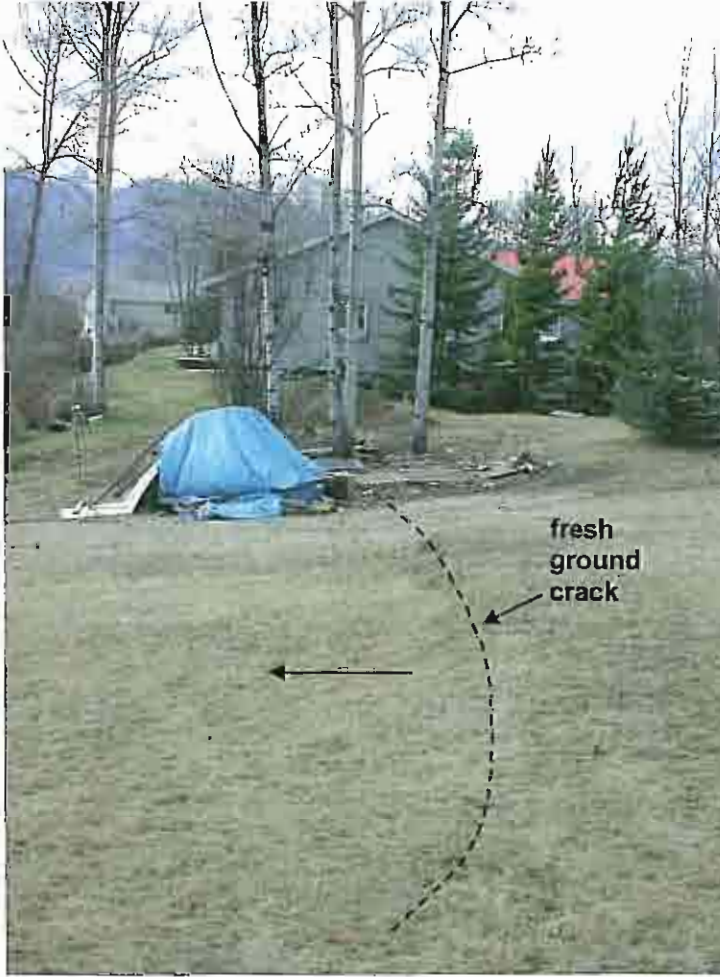
Photo 25: Looking north west along fresh ground cracking between 195 and 265.

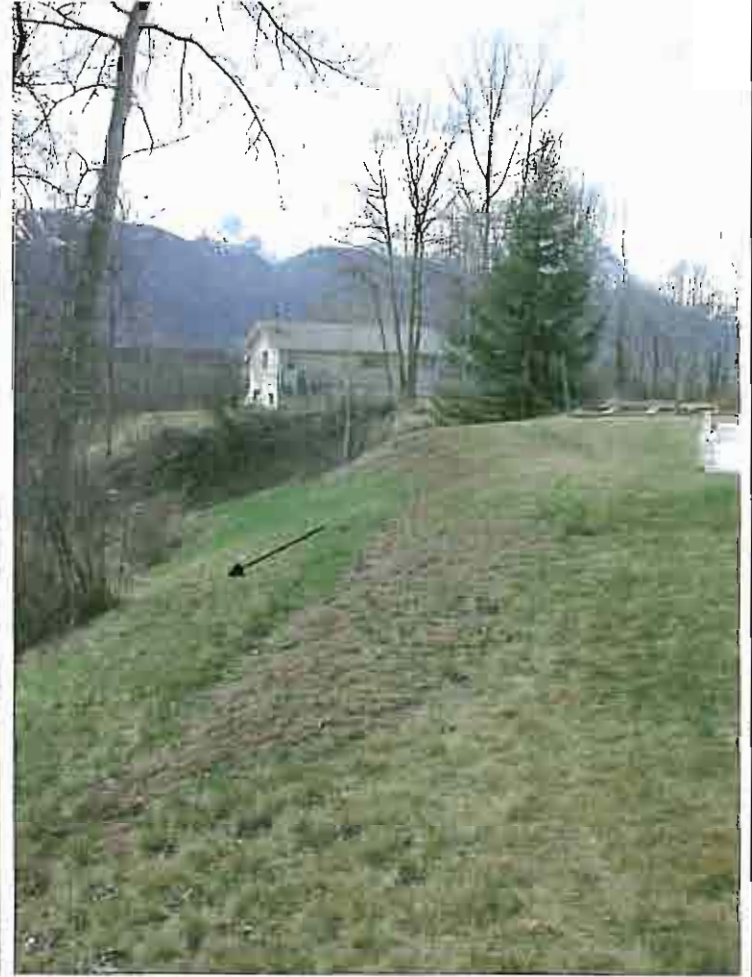
Photo 26: Looking north west at main scarp of landslide, just behind (downslope) of 265. Evidence of recent ground disturbance or movement.

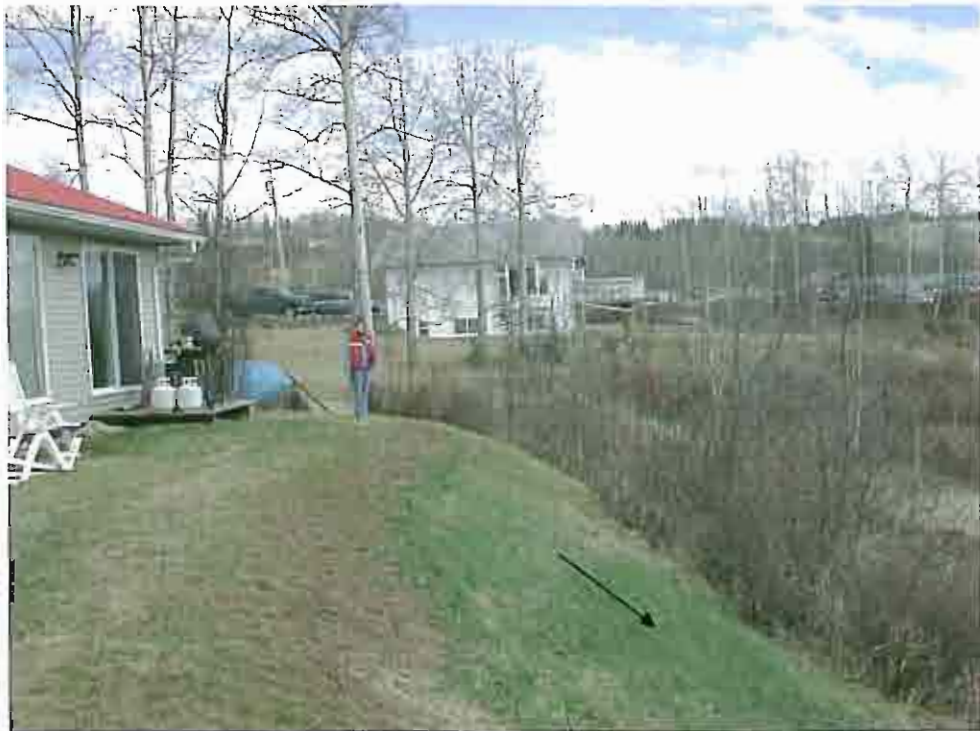
Photo 27: Looking south east along main scarp of landslide behind 265 towards 195. Note that community water line and septic line crosses this scarp area.

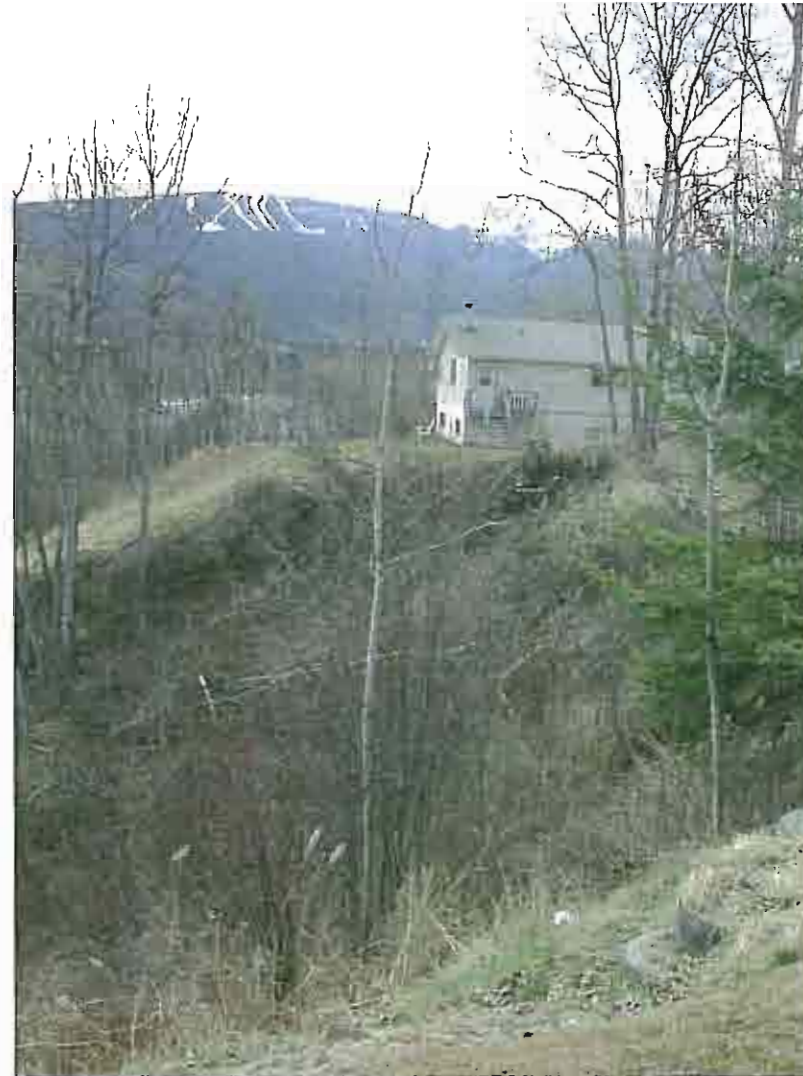
Photo 28: Looking west along main scarp of landslide between 265 and 355.

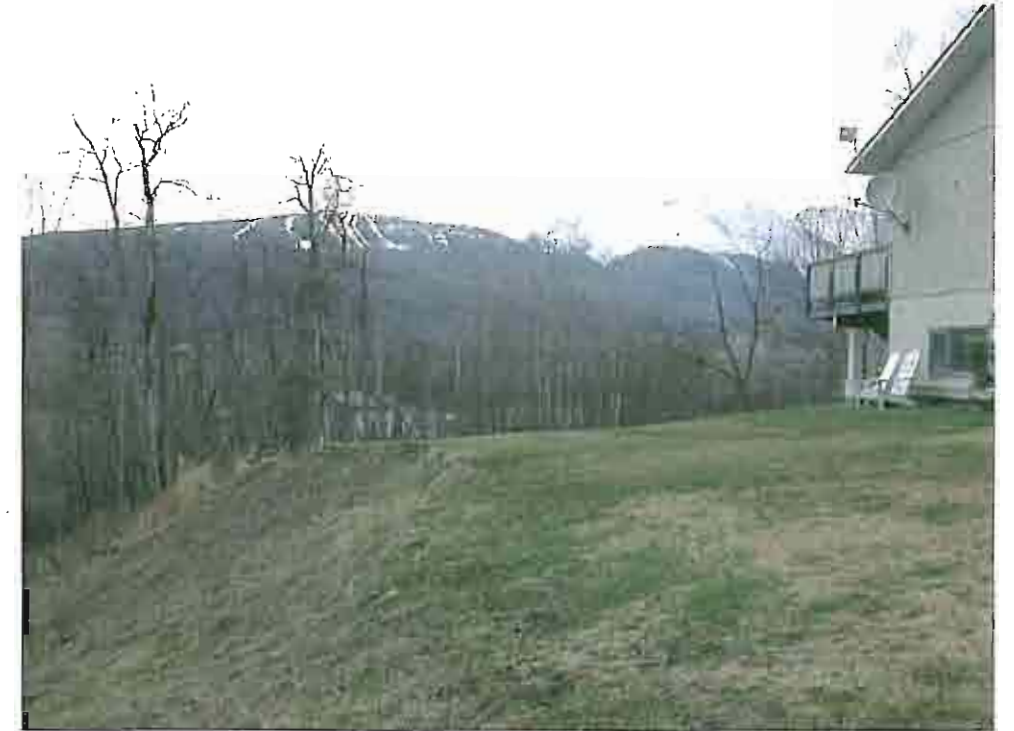
Photo 29: Looking west at main scarp of landslide adjacent to 355. Scarp area has been regraded by landowner. Septic line crosses this slope.
