APPENDIX B

Photos

GEOTECHNICAL ASSESSMENT
LOWER VIEWMOUNT ROAD
SMITHERS, BC

PROJECT No: KX04813

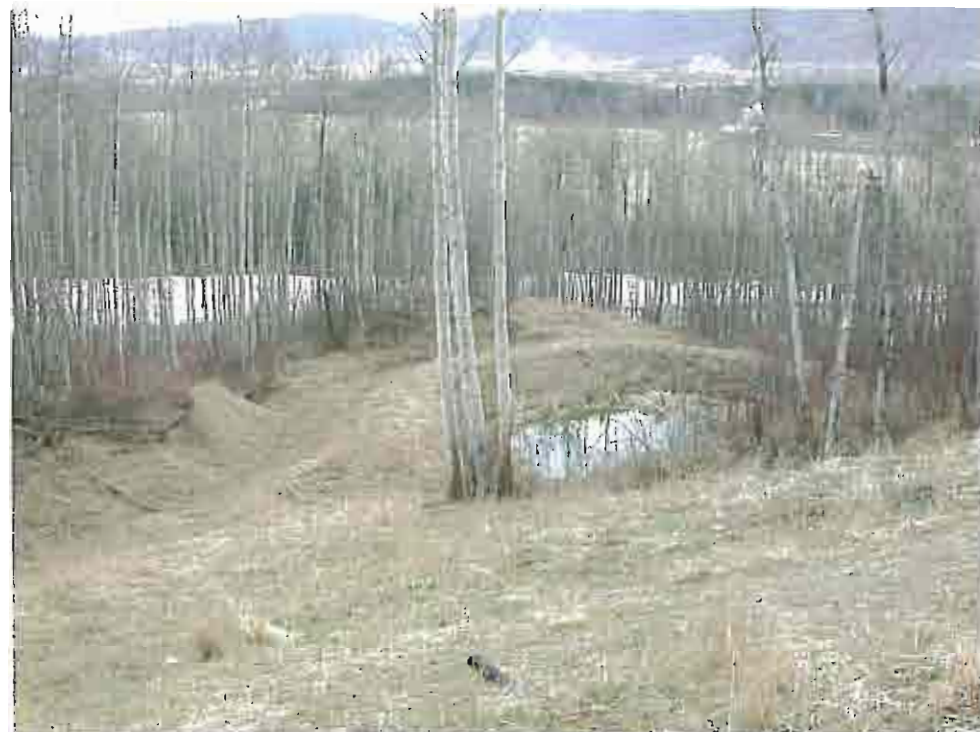
Photo 30: Looking south at lagoon constructed below main scarp on 355.

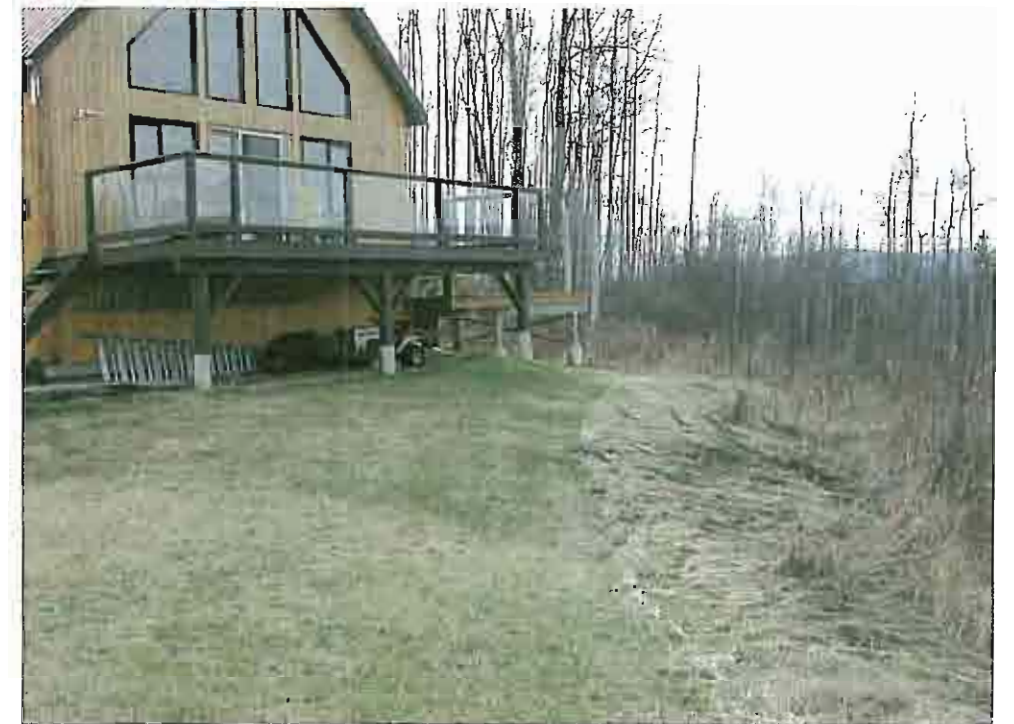
Photo 31: View east at house 485 located at the crest of the valley slope, possible main scarp location but less distinct. Septic and water lines cross this slope, septic lagoon located on slope to right of photo.
