# RIDLER TRAIL STRUCTURES REPAIR PROJECT

Inspection date: October 22, 2025

Compiled by: Jason Berlin, Senior Building Inspector & Maria Sandberg, Planning and Parks Coordinator

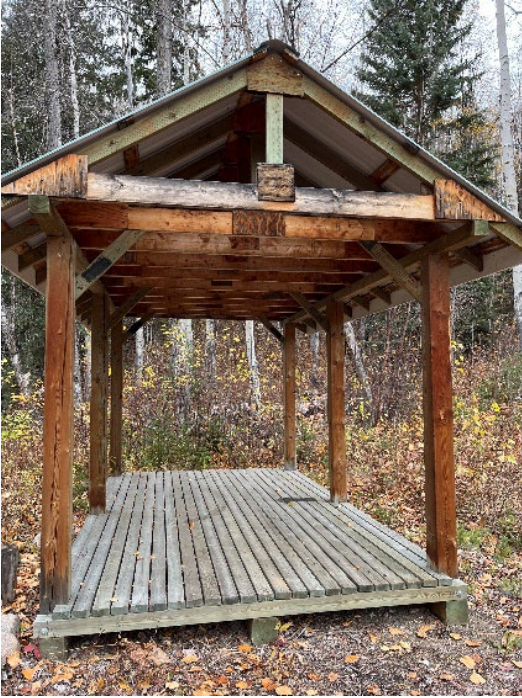
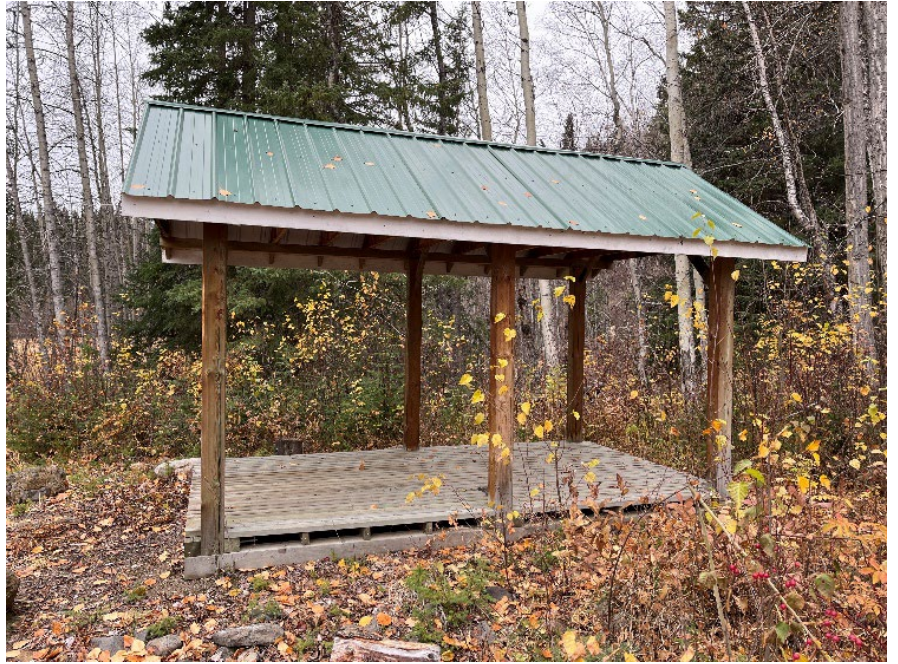
### Structure 2 - Shelter, 8'x 14'

In very good condition, constructed of pressure treated materials

Additional lateral bracing required at top of posts

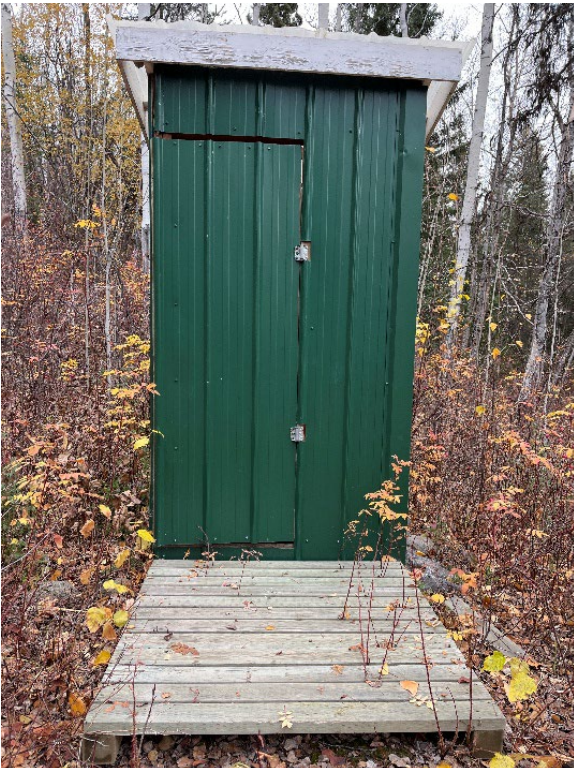
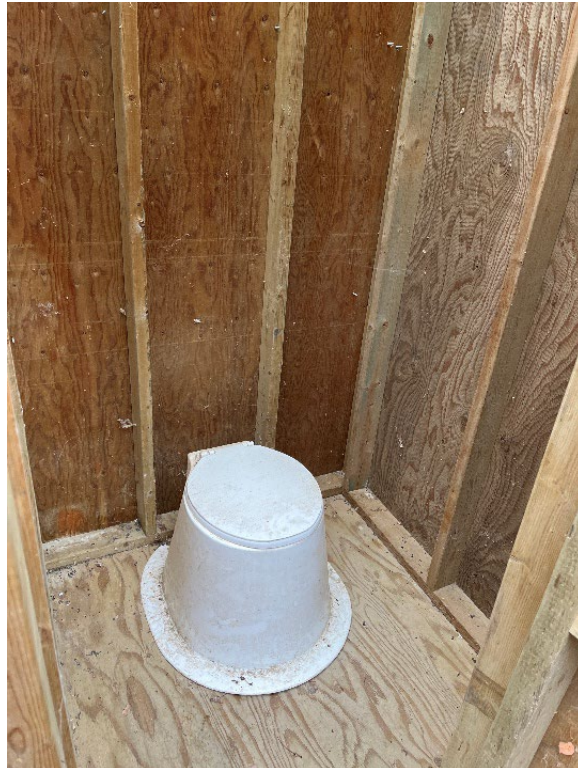
### Structure 4 - Outhouse, 4'x4' with 4'x4' entry landing

In very good condition, constructed of pressure treated materials. Ample volume left in pit privy

Door handle and lock required, door needs adjustment.

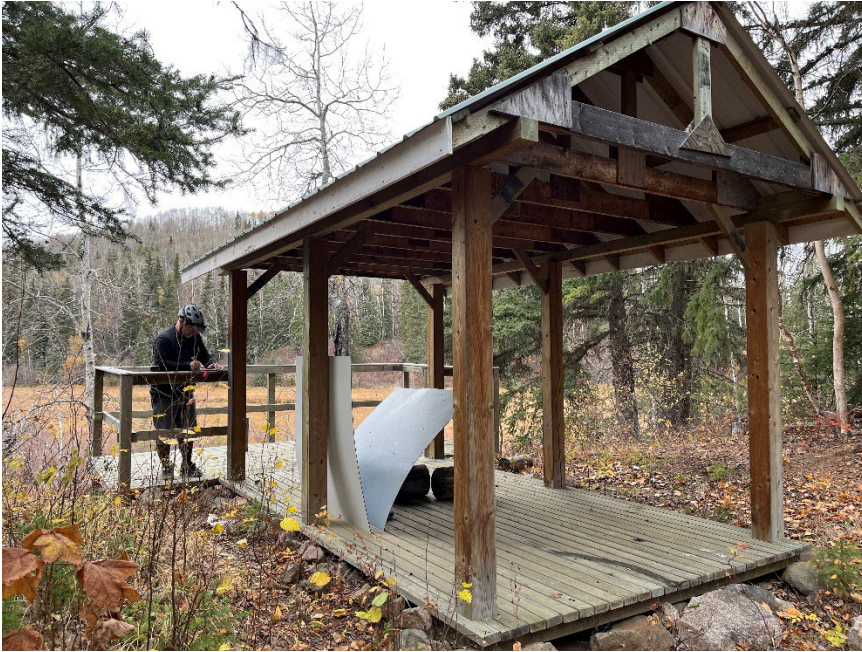
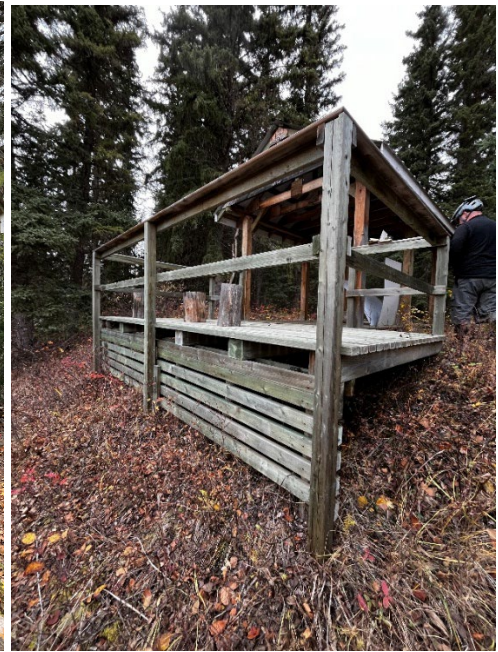
## Structure 12 - Shelter 8'x14' with deck 7'x14'

In very good condition, constructed of pressure treated materials

Additional lateral bracing required at top of posts, brushing around structure required

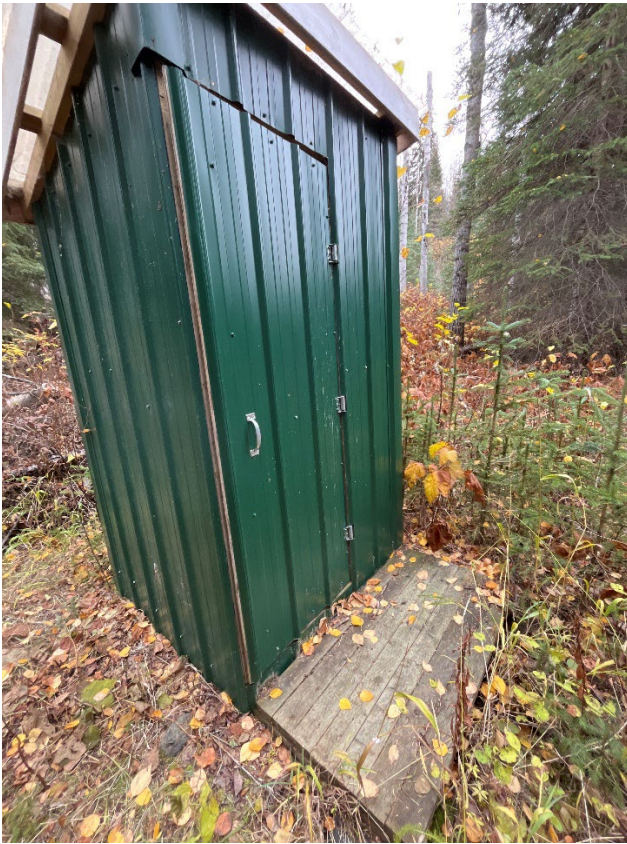
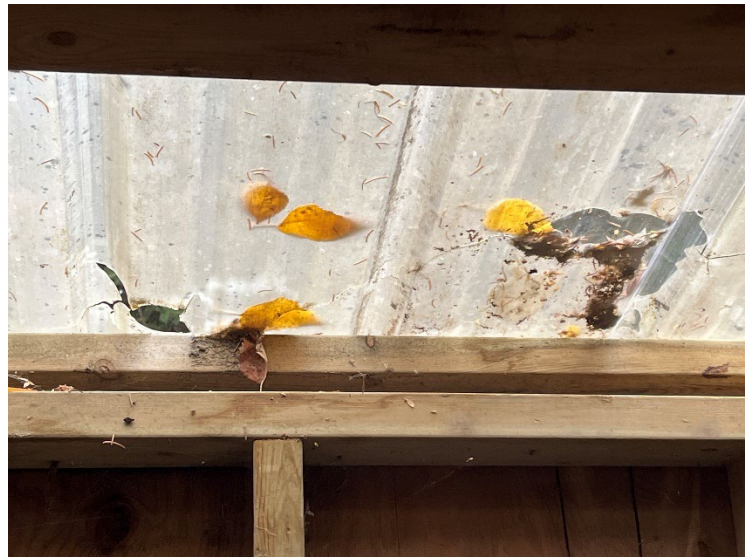
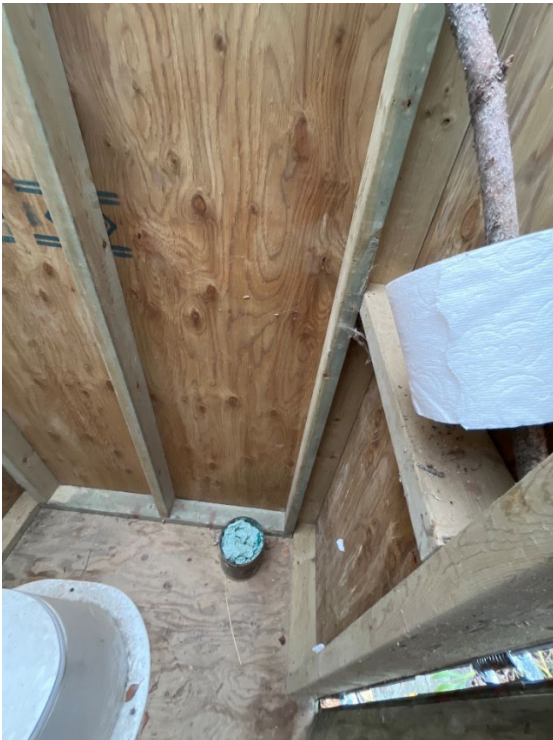
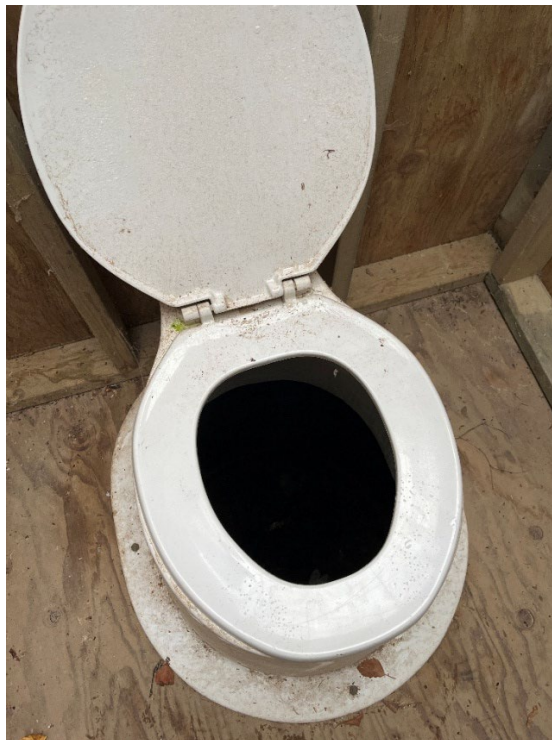
### Structure 13 - Outhouse, 4'x4' with 2'x4' entry landing

In very good condition, constructed of pressure treated materials. Ample volume left in pit privy  
Roofing cracked needs replacement, door lock needs adjustment.

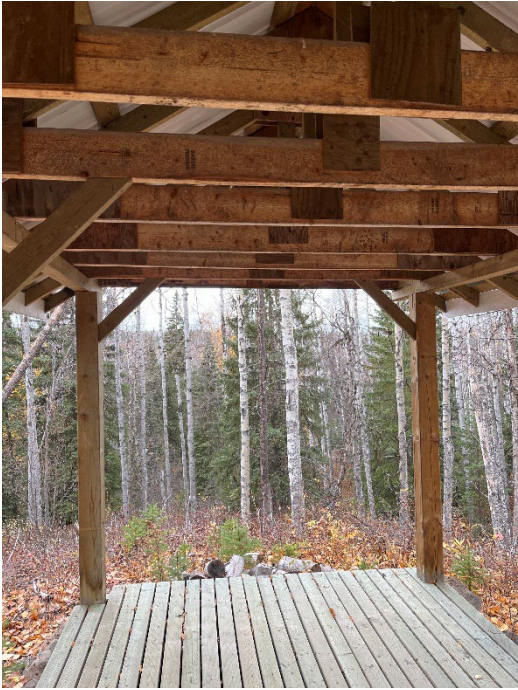
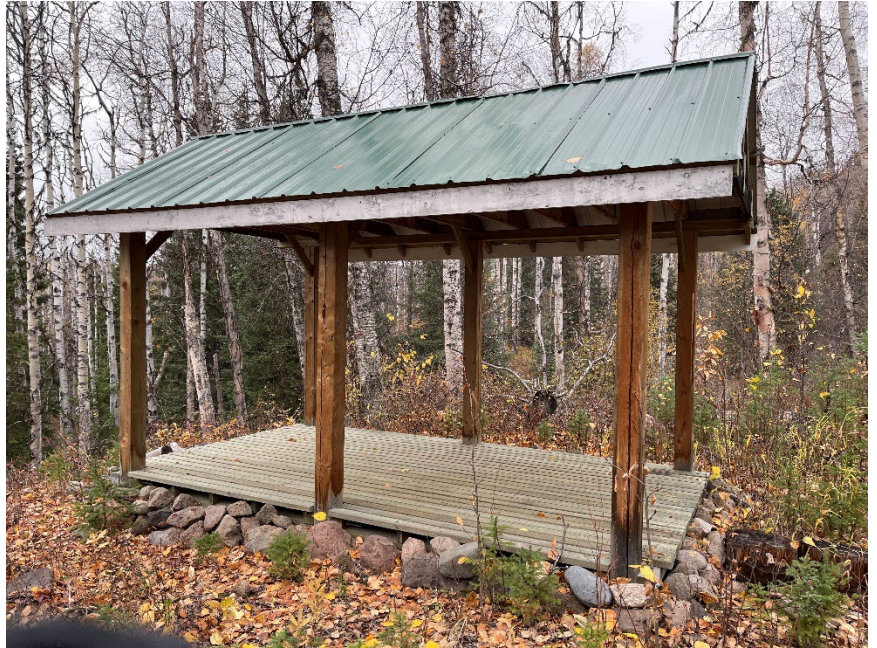
### Structure 14 - Shelter, 8'x 14'

In very good condition, constructed of pressure treated materials

Additional lateral bracing required at top of posts

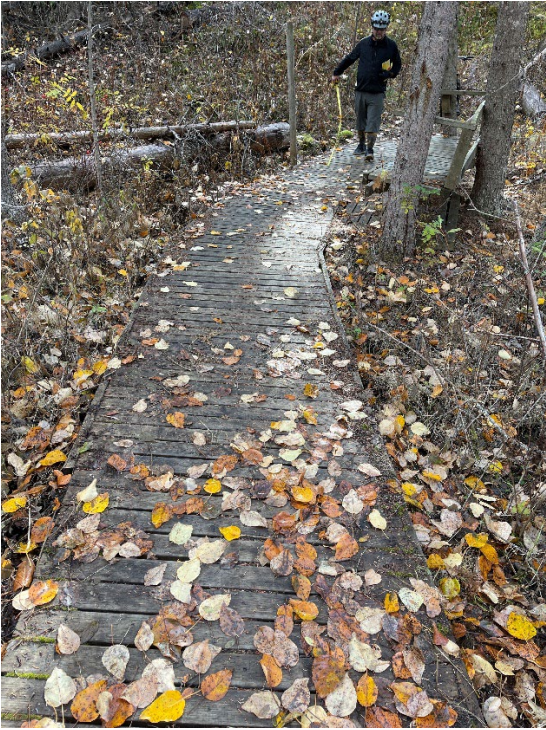
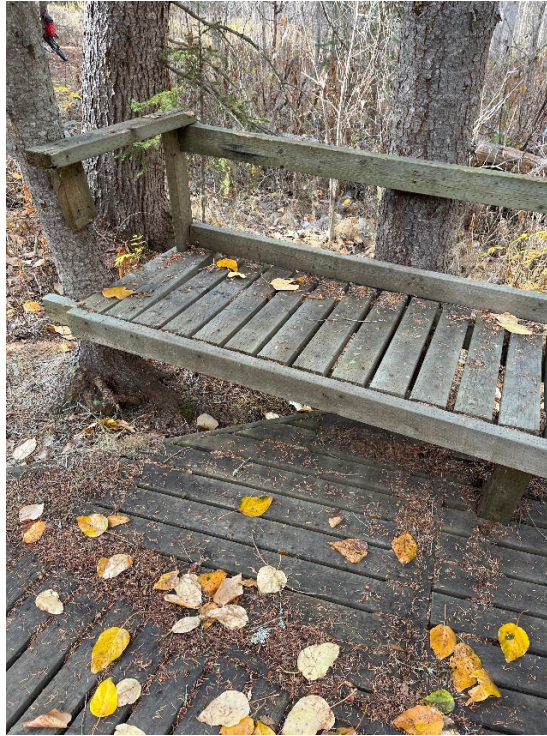
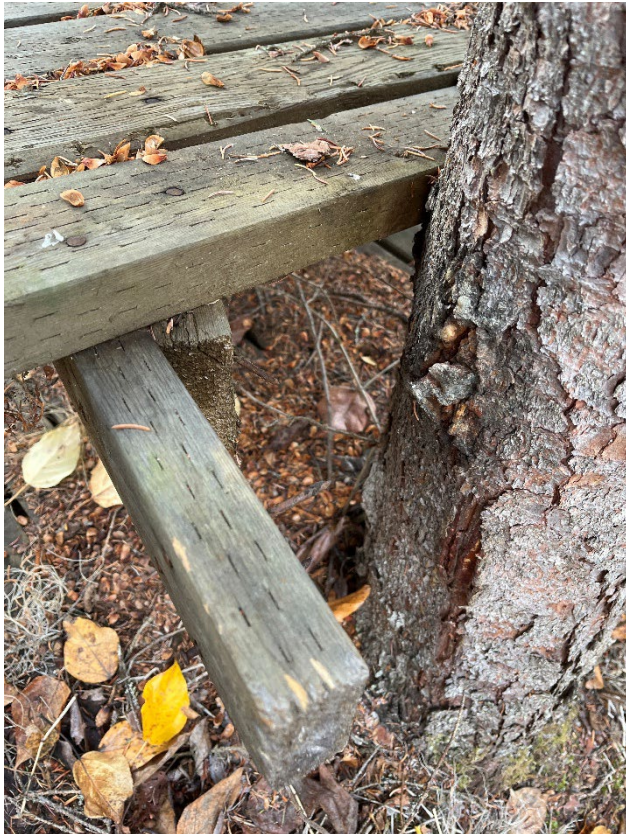
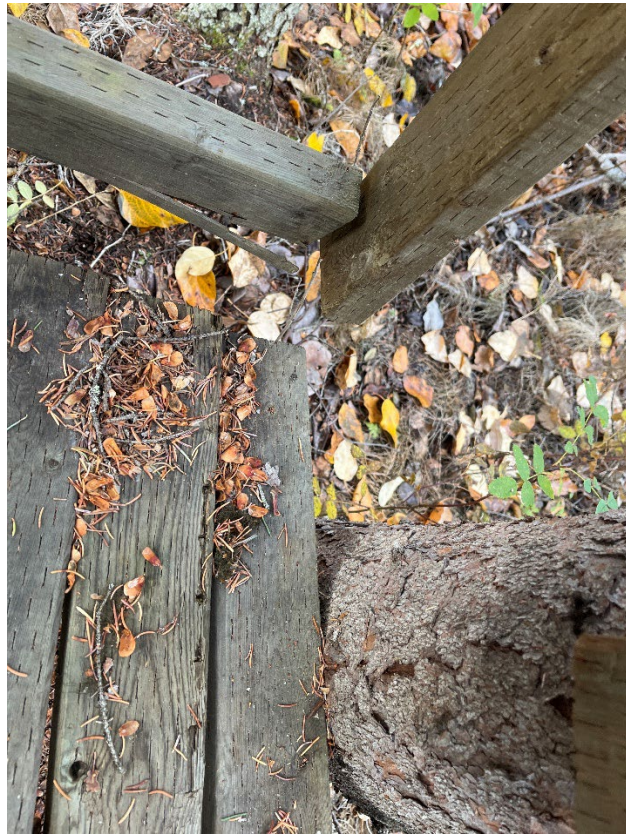
### Structure 17 - Boardwalk 4'x59' with bench 2'x8'

Boardwalk in overall good condition some general maintenance required to one deck board and skirting boards. Bench attached to trees, removal required as detaching from tree trunk.

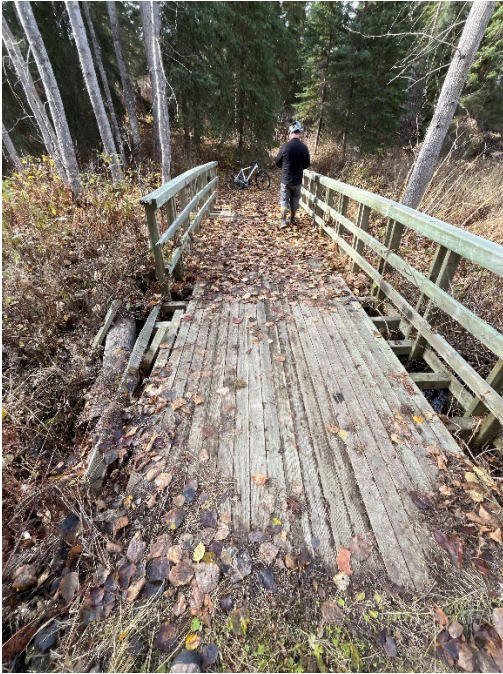
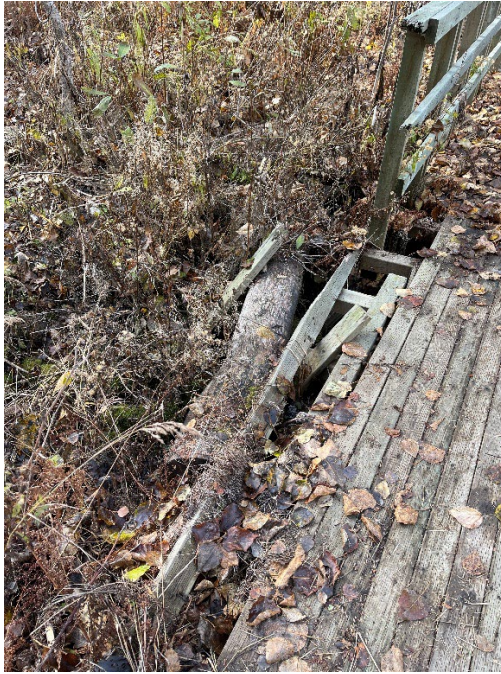
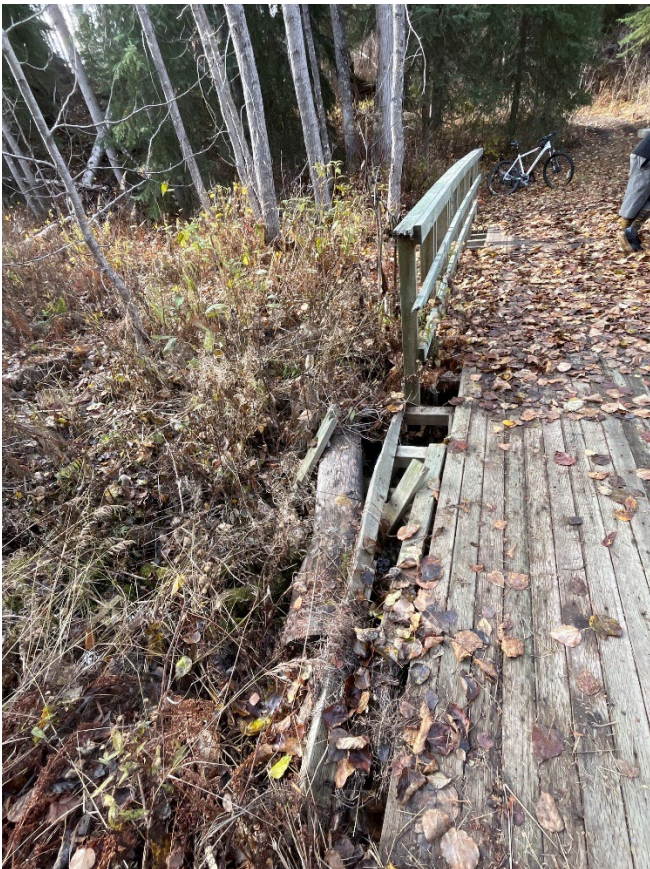
### Structure 18 - Bridge, 8'x30'

Very good condition, constructed of pressure treated materials

Guard rail broken from tree damage to be removed and replaced. Gaps at edge bridge deck to be filled in to avoid possible spots for injury.
