August 26, 2014

Reference No. 051413495-2014-064-L-Rev0-2114

## **DENAK EAST PIT: DENAK FAULT STABILITY ASSESSMENT**

PROJECT  
DENAK EAST PIT  
DENAK FAULT STABILITY ASSESSMENT

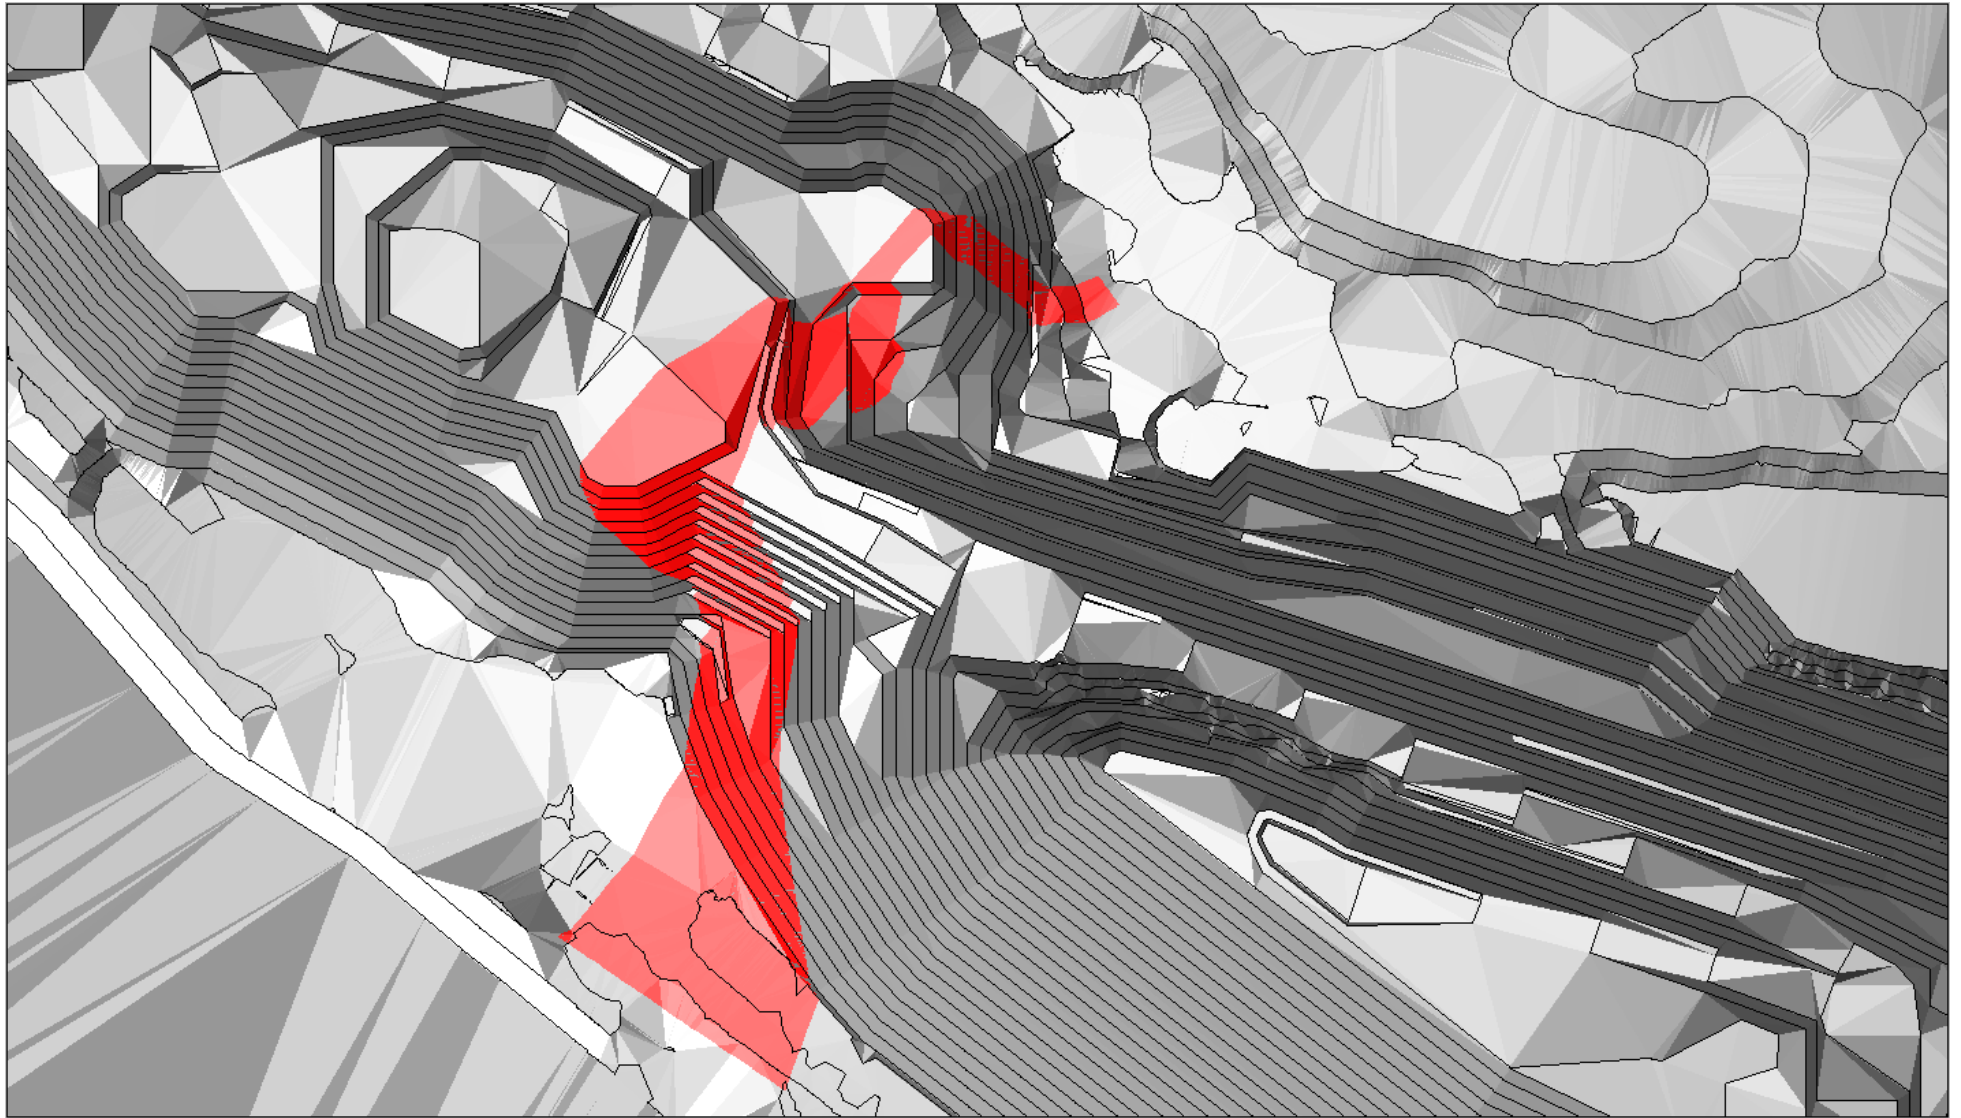
Figures 2 and 3 indicate that the nose that was originally planned on the portion of the south wall between the Denak East and the Endako Pits will be partially mined out as part of the Denak East interim pit excavation. Figure 4 shows the projection of the Denak Fault on the ultimate south wall. Figure 4 indicates that the fault complex will be exposed in the northwest facing slopes that will be excavated along the southeast side of the Denak East Pit. The benches in these slopes will undercut the shallow northwesterly dipping fault complex. Bench to multi-bench planar instability can be expected to develop along the undercut faults. Consequently, the walls along the southeast and east sides of the pit should be laid back to an angle of approximately 35 degrees to minimize undercutting and planar failure within the fault complex. The two walls segments that should be laid back to 35 degrees are shown on Figure 5.

On the north side of the rock cut, the fault complex will be exposed in the northwest-facing slopes that will be excavated along the northwest side of the nose that will be excavated above the saddle rock cut. Figure 4 indicates that these northwest-facing slopes will be excavated at a shallow slope inclination with wide benches. The shallow slope inclination will follow the northwesterly-dipping fault complex, and the shallow slope is expected to provide sufficient catchment to accommodate any raveling that may occur within the fault zone. Consequently, slope design modifications are not required on this portion of the slope.

Figure 4 indicates that fault will be exposed in the westerly-facing slope that will be excavated along the east side of the cove that will be excavated along the northeast side of the Denak East Pit. The northwesterly-dipping fault complex will be undercut in the westerly-facing benches, and bench to multi-bench scale planar failure can be expected to occur along the undercut faults.
