# Agriculture Report

Fractional SW  $\frac{1}{4}$ , Section 4, Township 4, Range 5, Coast District

Submitted by: Wendy Siemens PAg  
Date: June 26, 2009

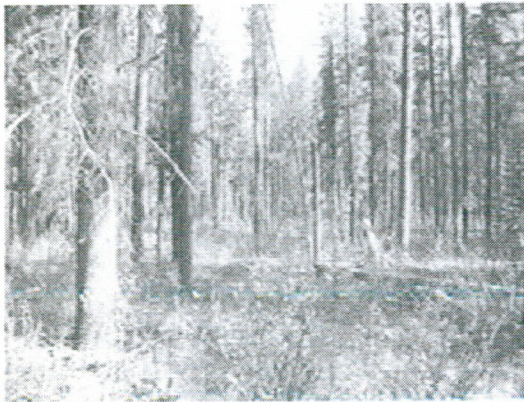
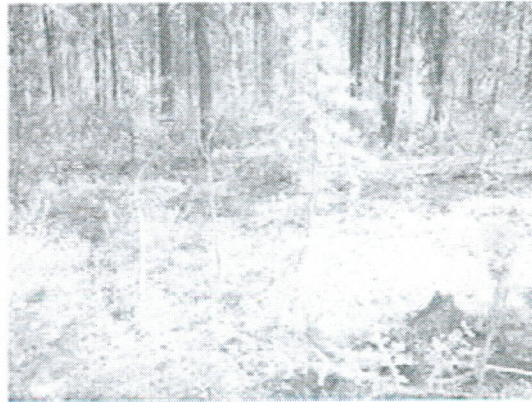
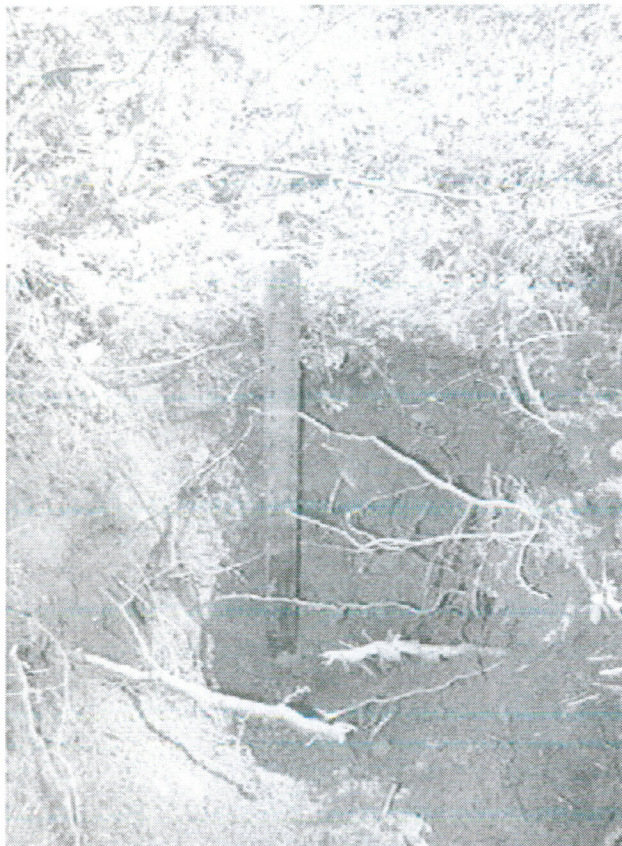
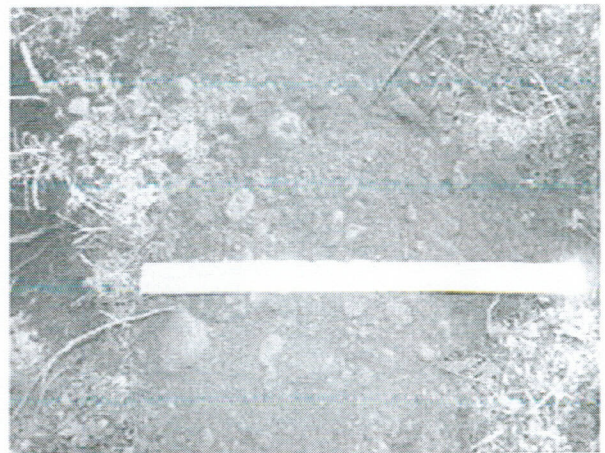
Soil Pit #1:

Within a standing pine block, with visible effects of Mountain Pine Beetle, a soil pit was dug 16" deep that shows the typical soil matter found in the area. Aggregate was also present in the sample plot as shown in bottom right photo.

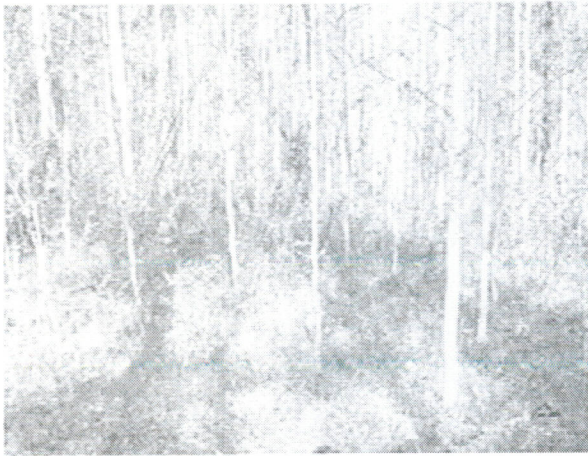
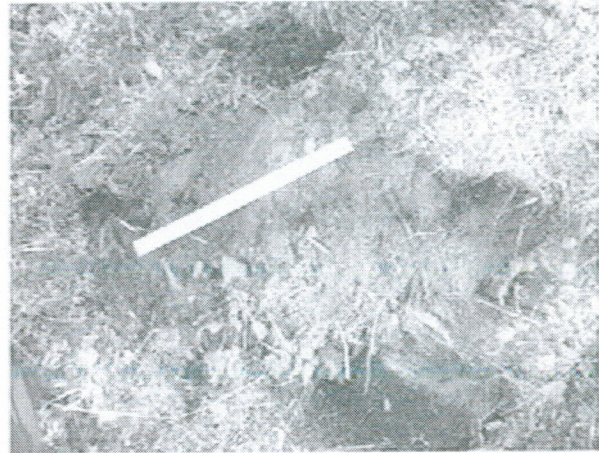
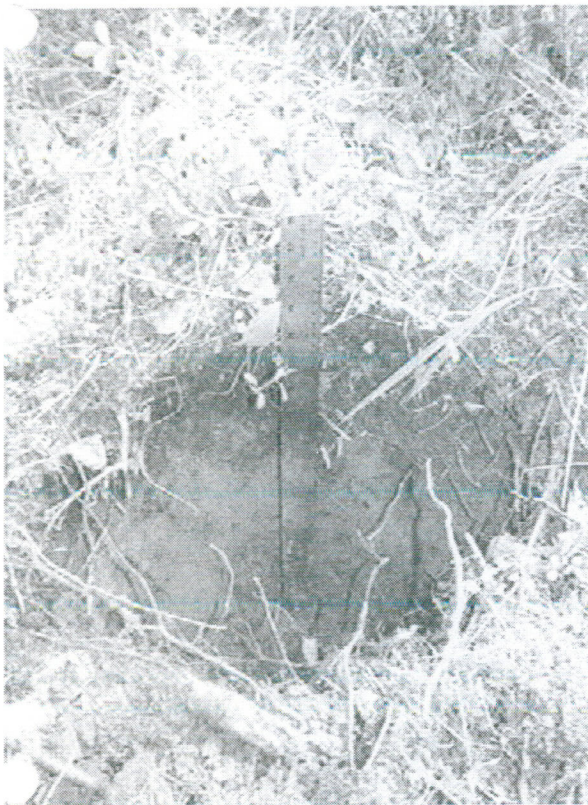
Soil Pit #2: In a deciduous area soil pit 2 was dug finding very little coarse material. This deciduous area runs along an edge that drops off with slope limiting the arable portion. The top areas of the ridge and the bottom have production capabilities as seen in soil pit #3 photos.

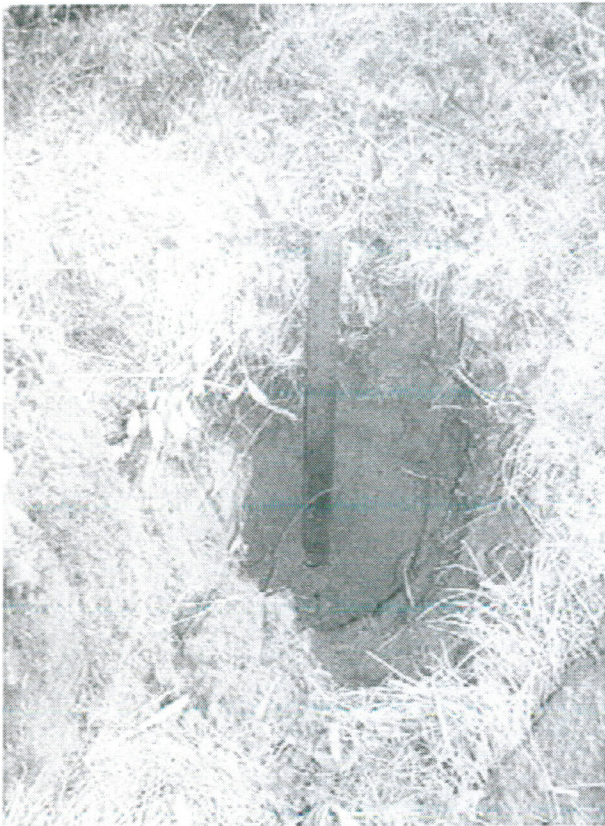
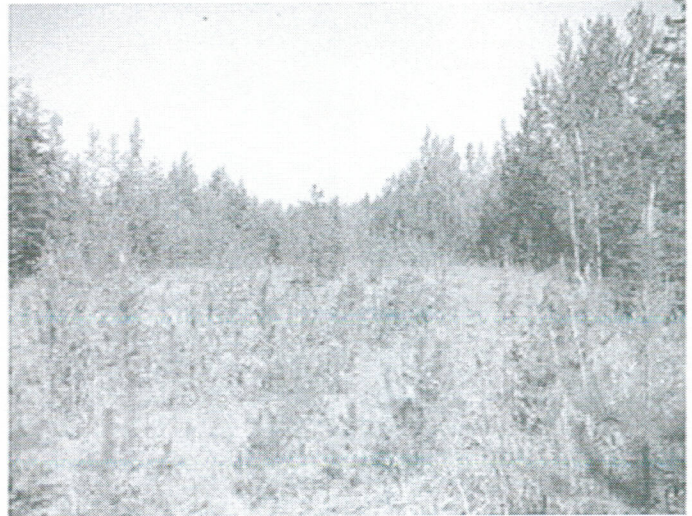
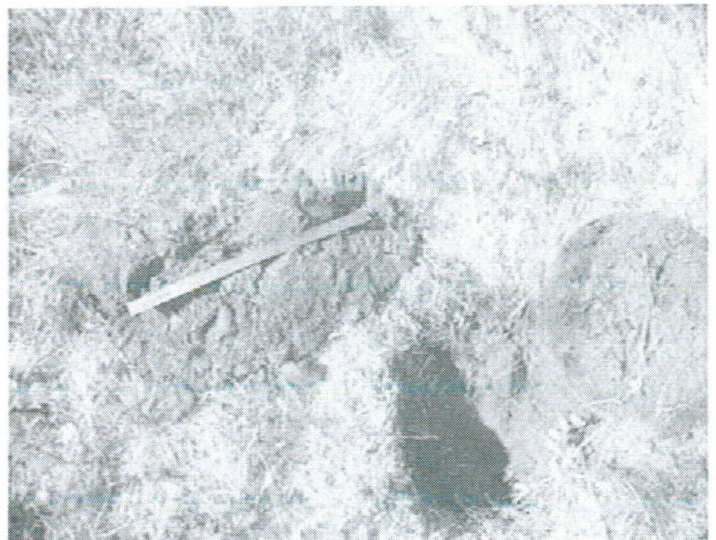
Soil pit #3: Dug in an area west of a sloped area. High soil producing capabilities in this narrow band of land. Currently small pine trees, a grass mix and a hawkweed infestation are found in the area.

Soil depth >18 found negligible aggregate in the area.

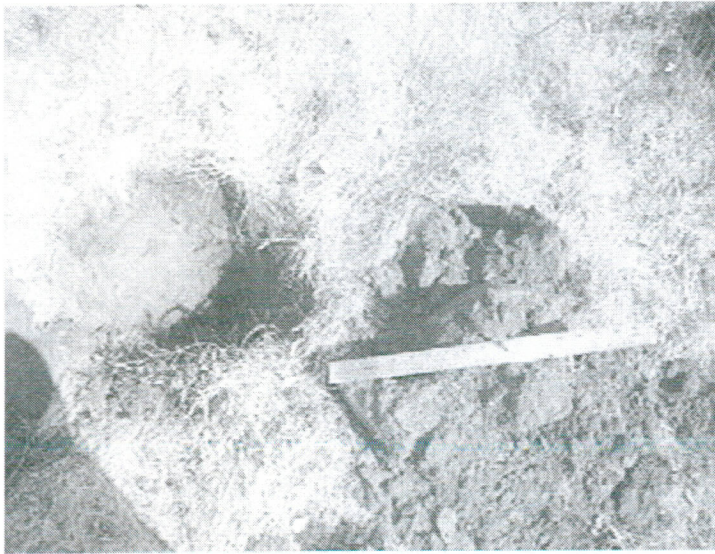
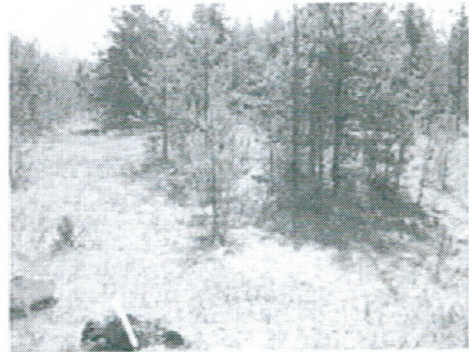
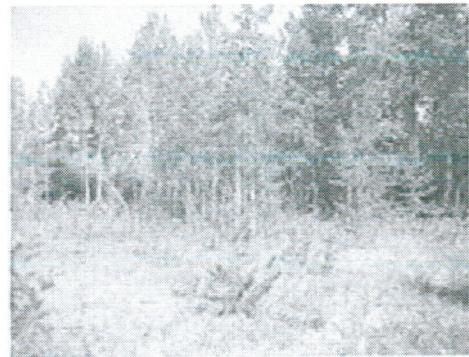
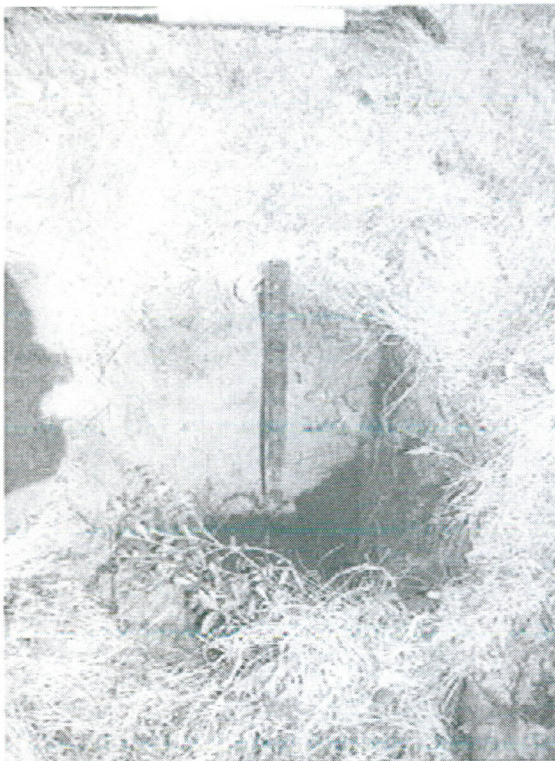
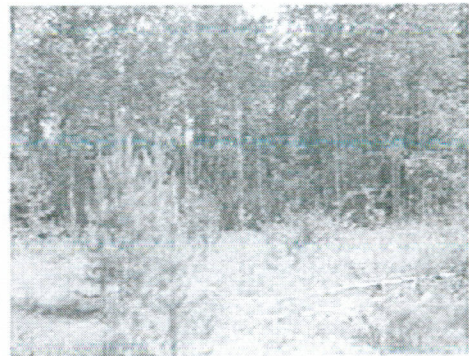
Soil Pit #4: Dug in the NW corner of lot. Similar soil attributes were noted in the area as pit 2 and pit 3. Very little aggregate in area with steep terrain to the north.

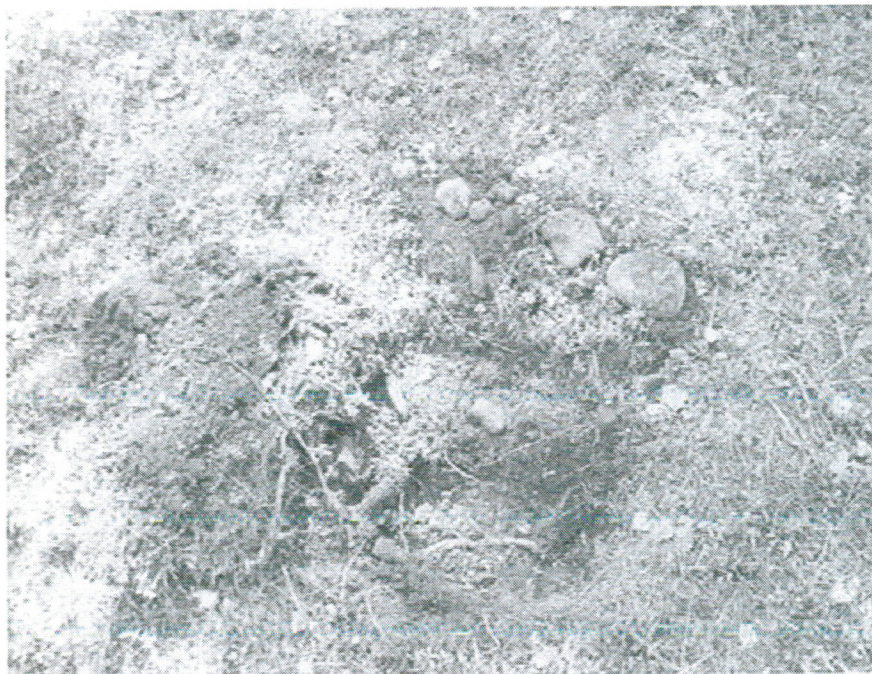
Soil pit #5: Along the north edge of the lot on a higher bench than pit 3 and 4, pit 5 was attempted. Digging equipment in this area was not adequate to get through the surface material. Stoniness is definitely a factor in this area.

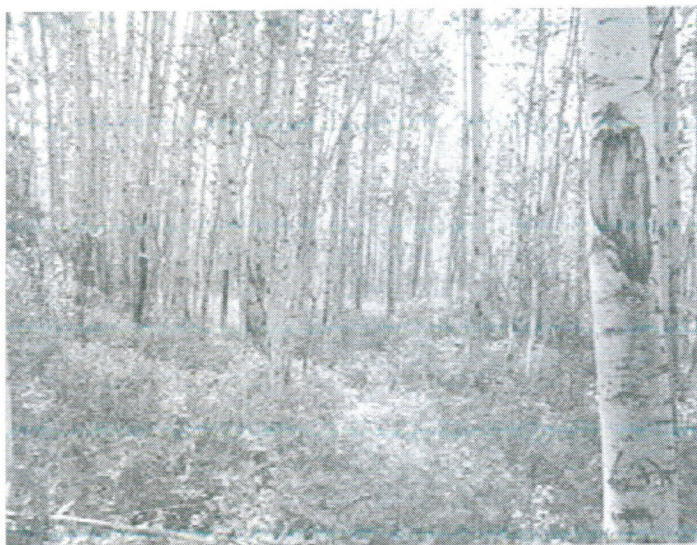
Area to the south with appreciable slope.

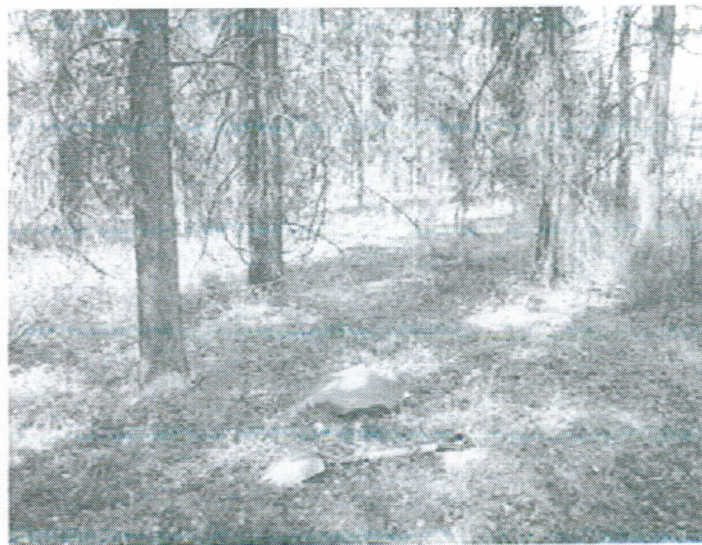
Area to the northwest with no slope.

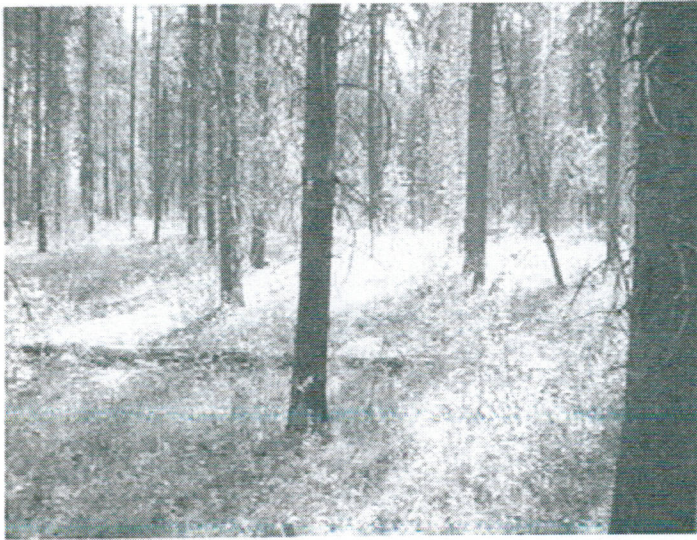
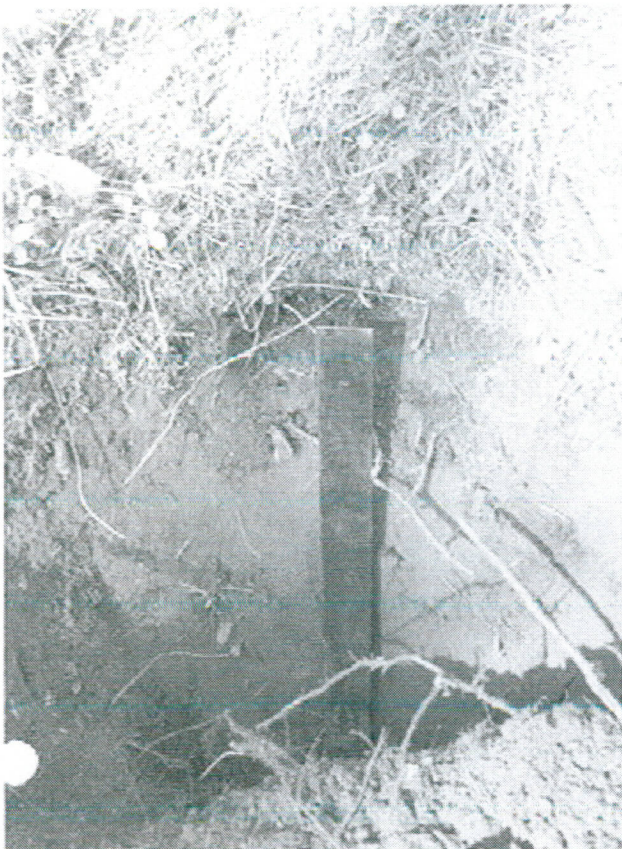
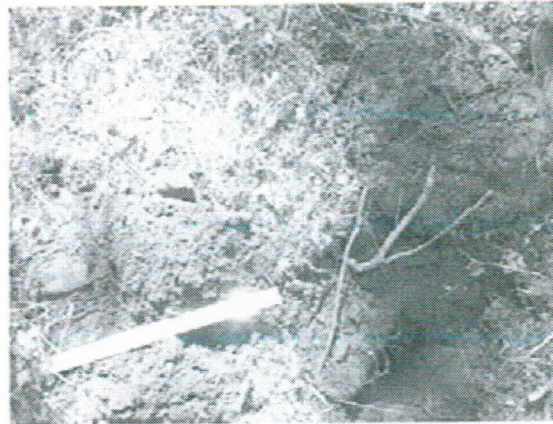
Soil pit #6: The area around soil pit #6 was relatively flat and open. No undergrowth which supports the findings of a lower producing soil material that has moisture holding deficiencies.

The soil pit in these photos has visible layers. There is a strong sand layer present.
