**EBENEZER FLATS/KIDD ROAD
EROSION PROTECTION STUDY
DRAFT**

**SUBMITTED TO
REGIONAL DISTRICT OF BULKLEY-NECHAKO**

McElhanney Consulting Services Ltd.
1633 First Avenue
Prince George BC V2L 2Y8

October 2008
Our File: 2331-00650-0

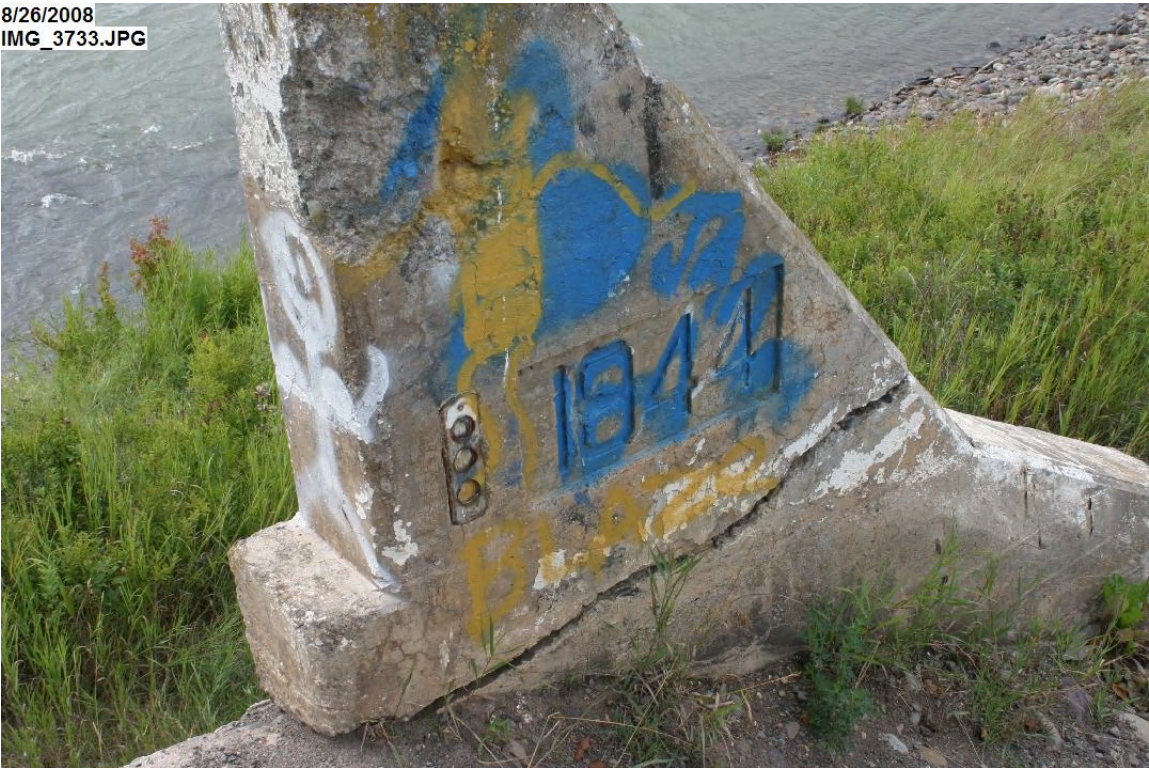
8/26/2008
IMG_3733.JPG

Old bridge wingwall

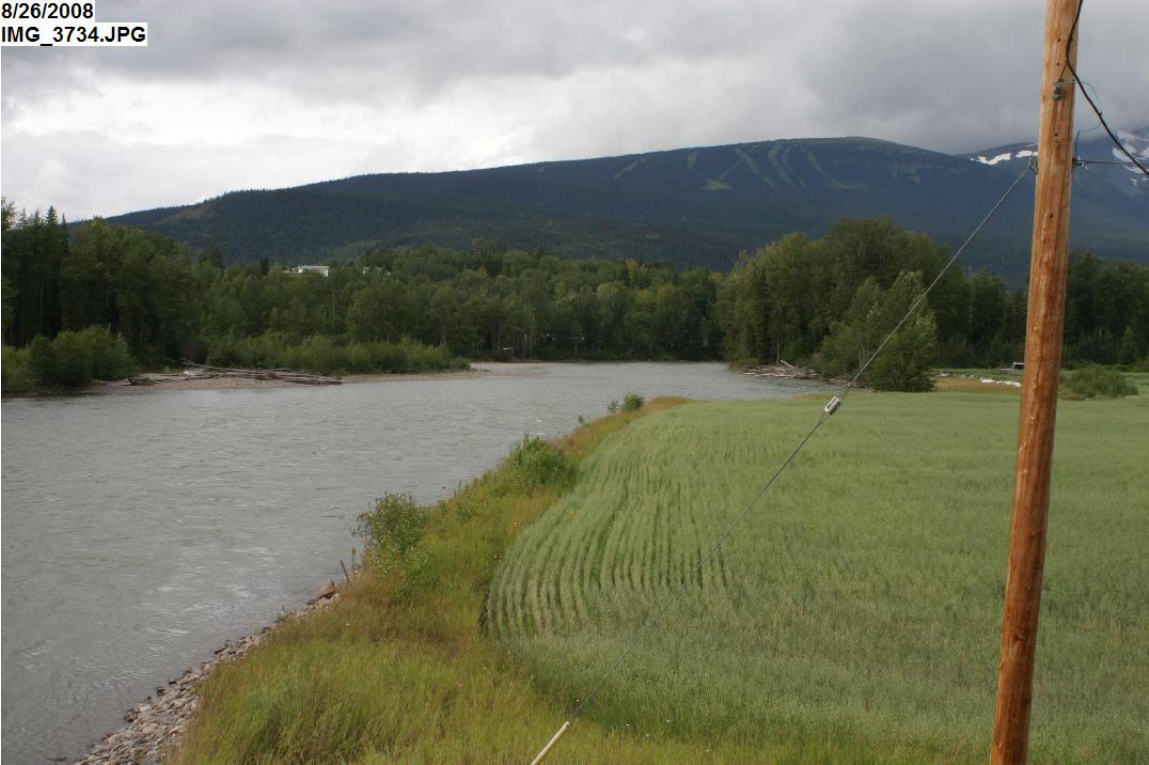
8/26/2008
IMG_3734.JPG

Looking west at right bank of Bulkley River

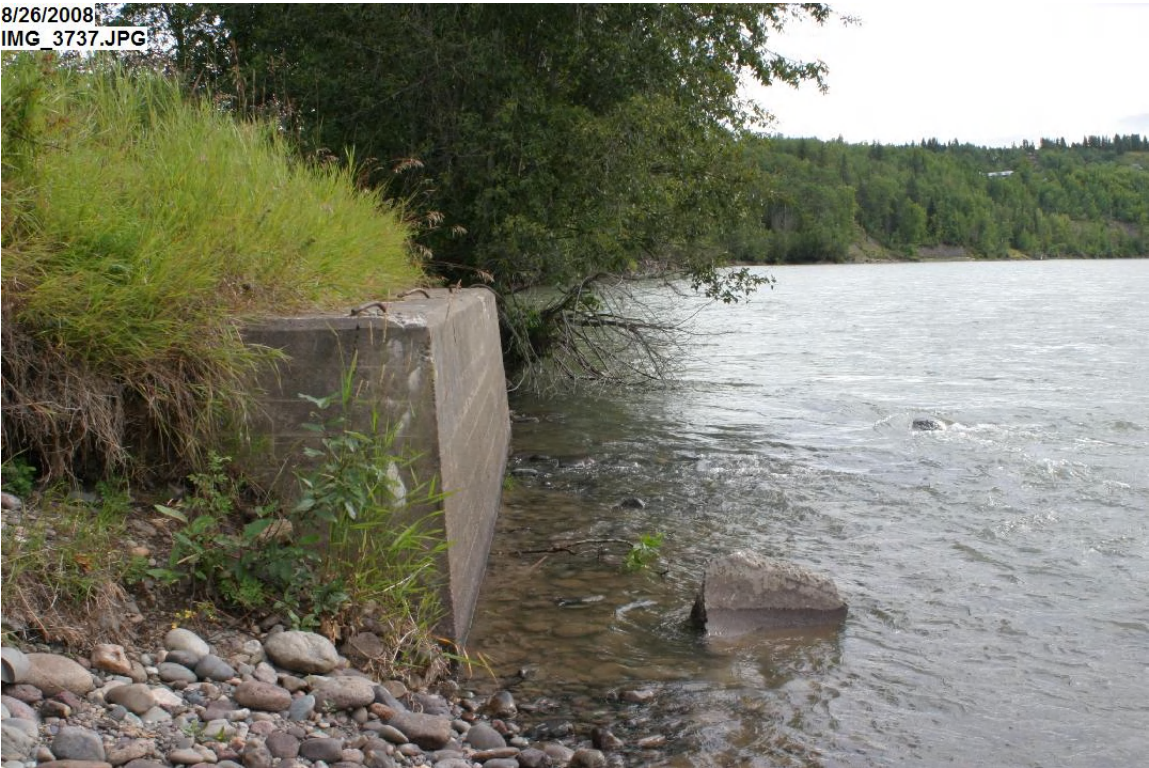
8/26/2008
IMG_3737.JPG

Bridge abutment at old crossing

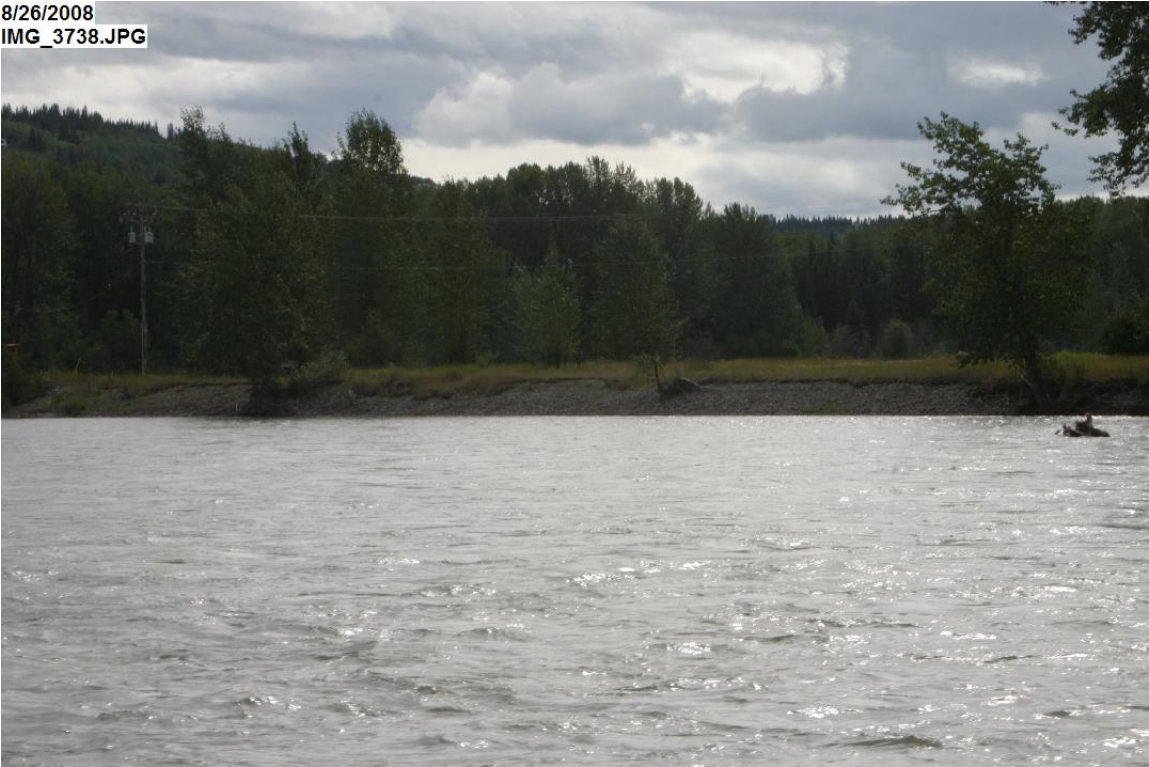
8/26/2008
IMG_3738.JPG

View of left (south) bank

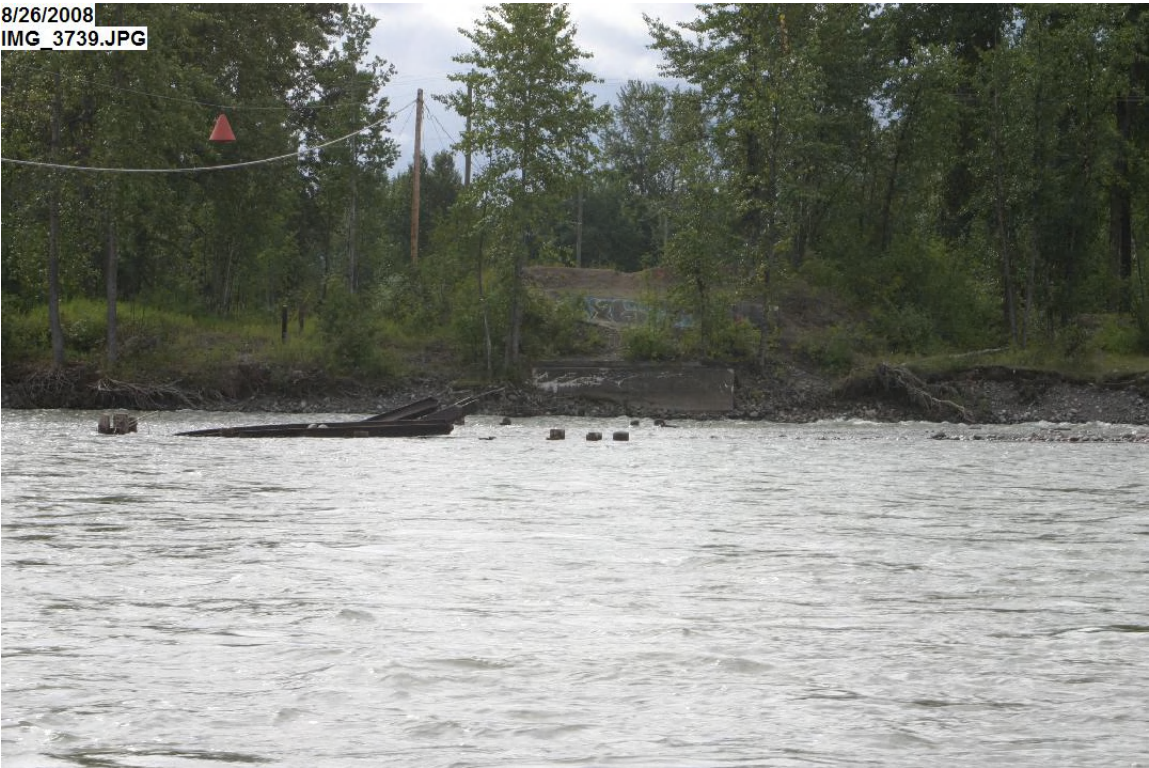
8/26/2008
IMG_3739.JPG

View of left (south) bank showing old abandoned bridge piers

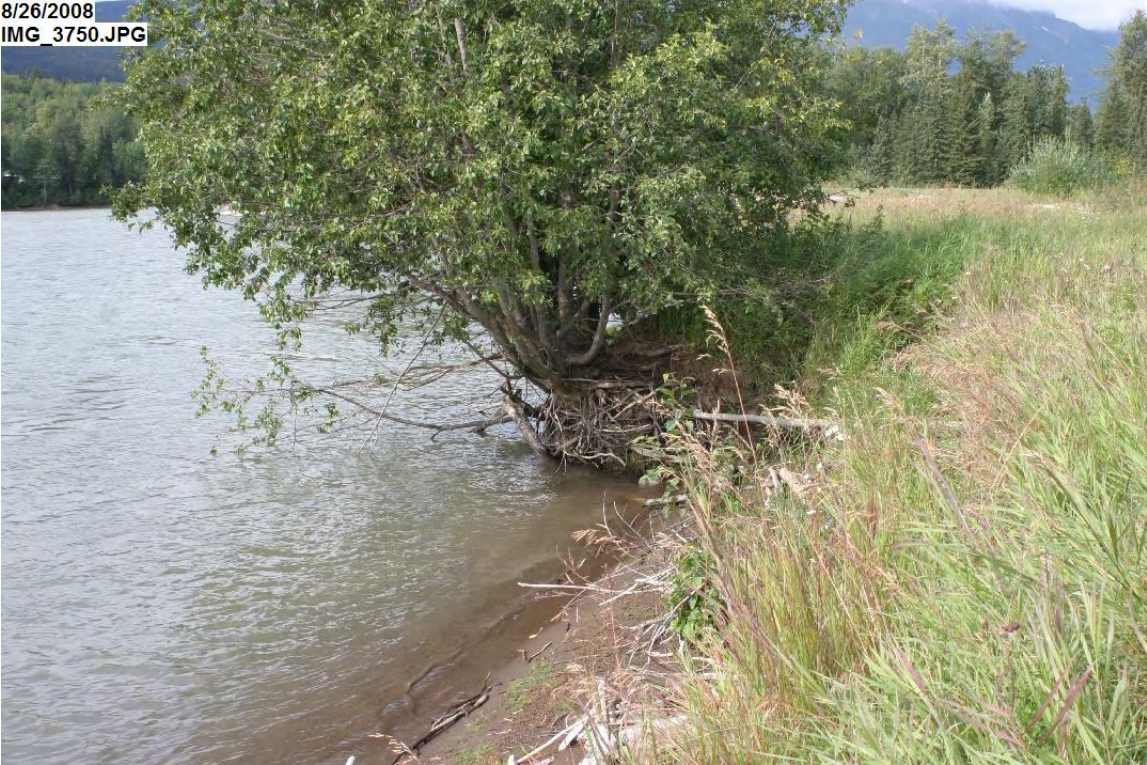
8/26/2008
IMG_3750.JPG

Beginning of undercutting of bank – bank material is silty sand

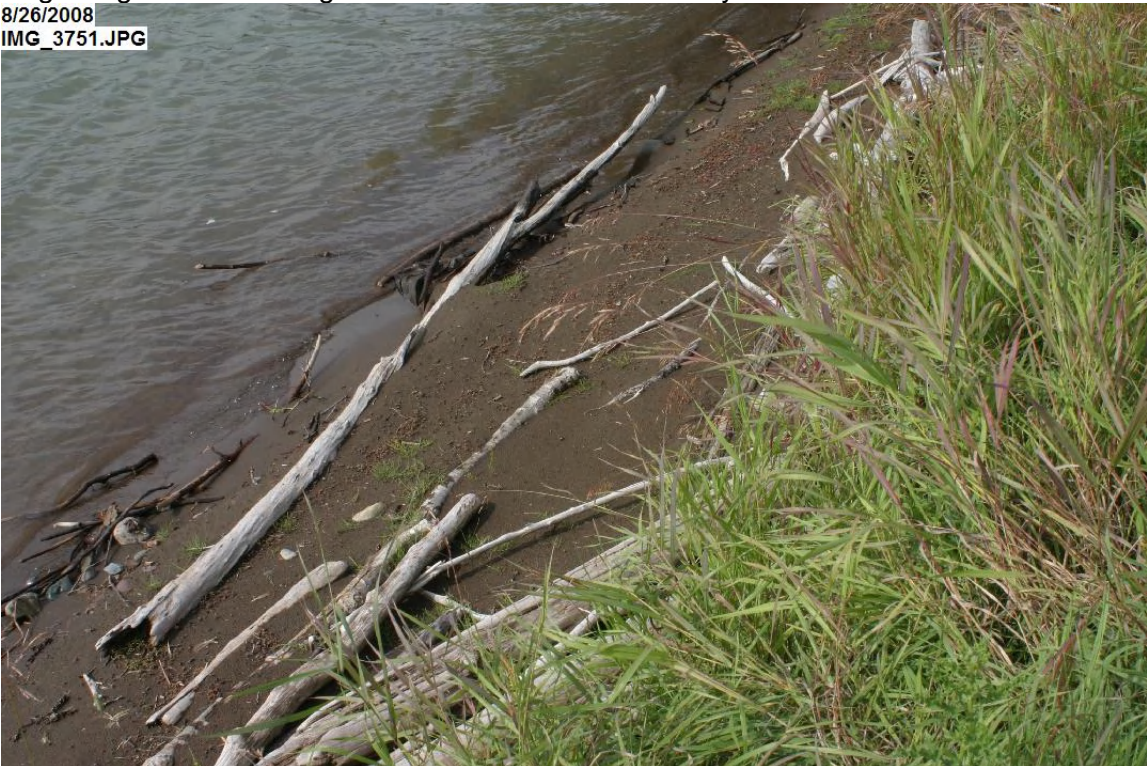
8/26/2008
IMG_3751.JPG

Sandy bank and bed material – note difference from bank material further east

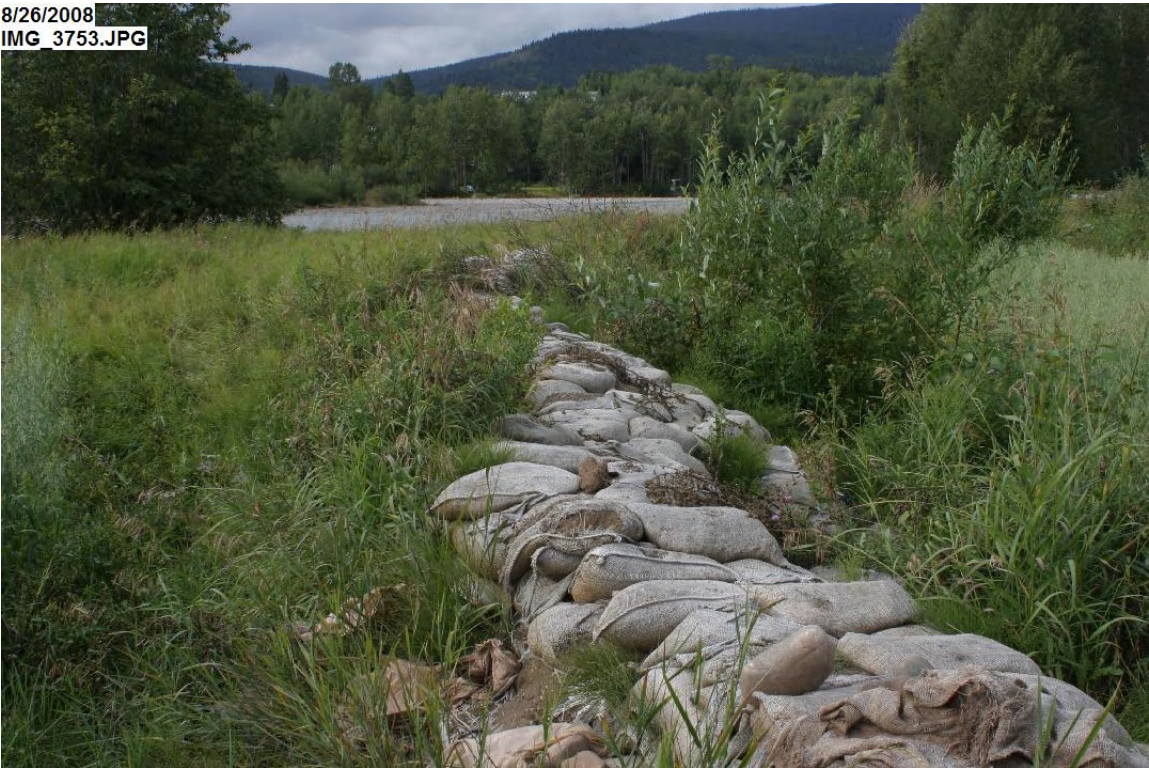
8/26/2008
IMG_3753.JPG

Start of sandbag dike

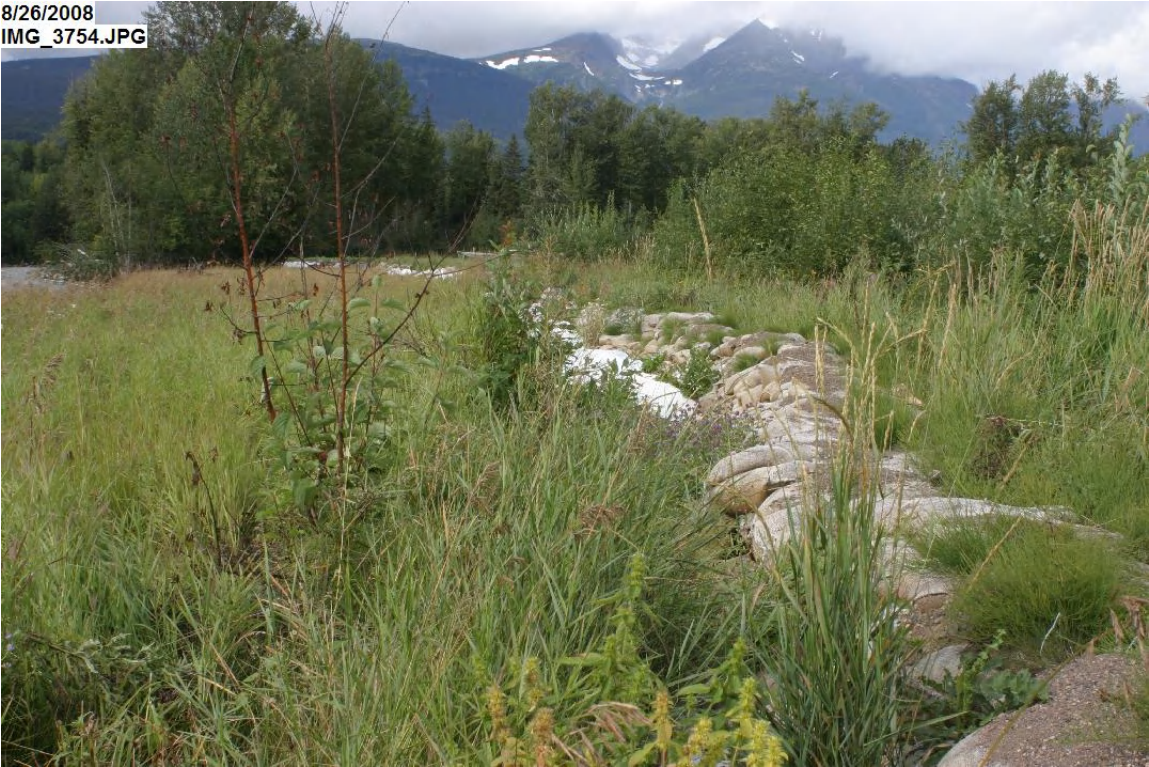
8/26/2008
IMG_3754.JPG

Sandbag dike looking west

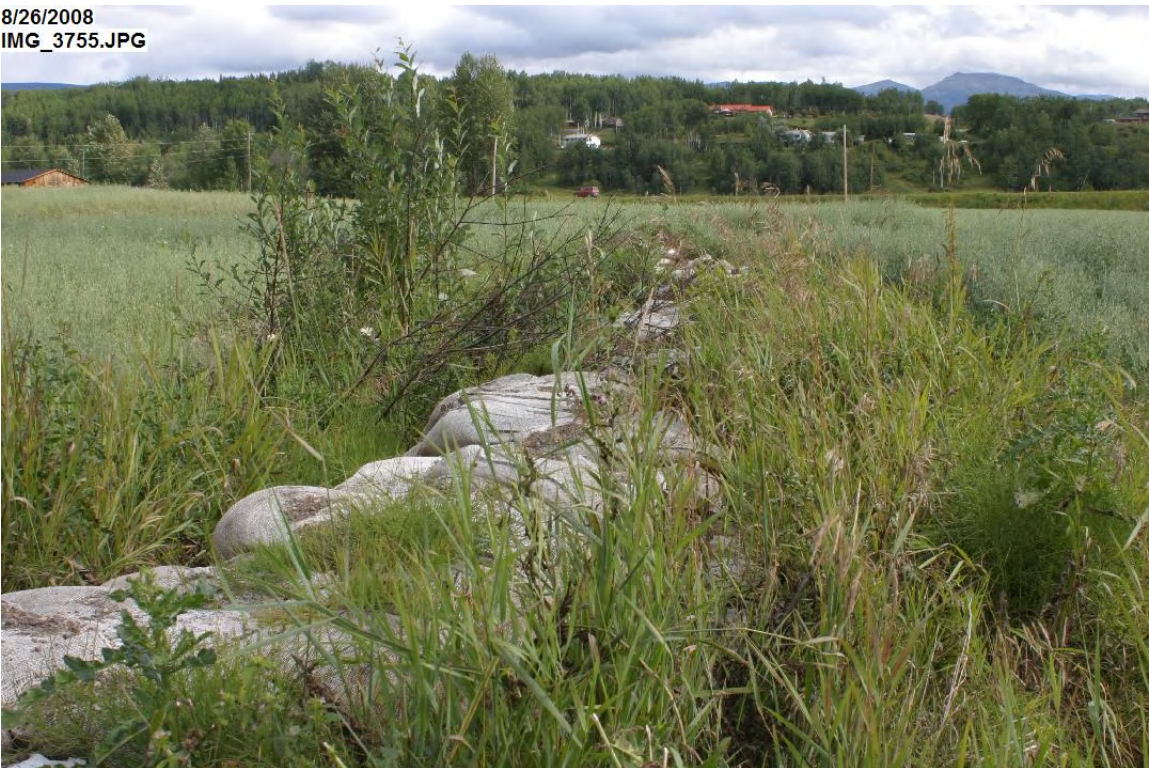
8/26/2008
IMG_3755.JPG

Sandbag dike looking east

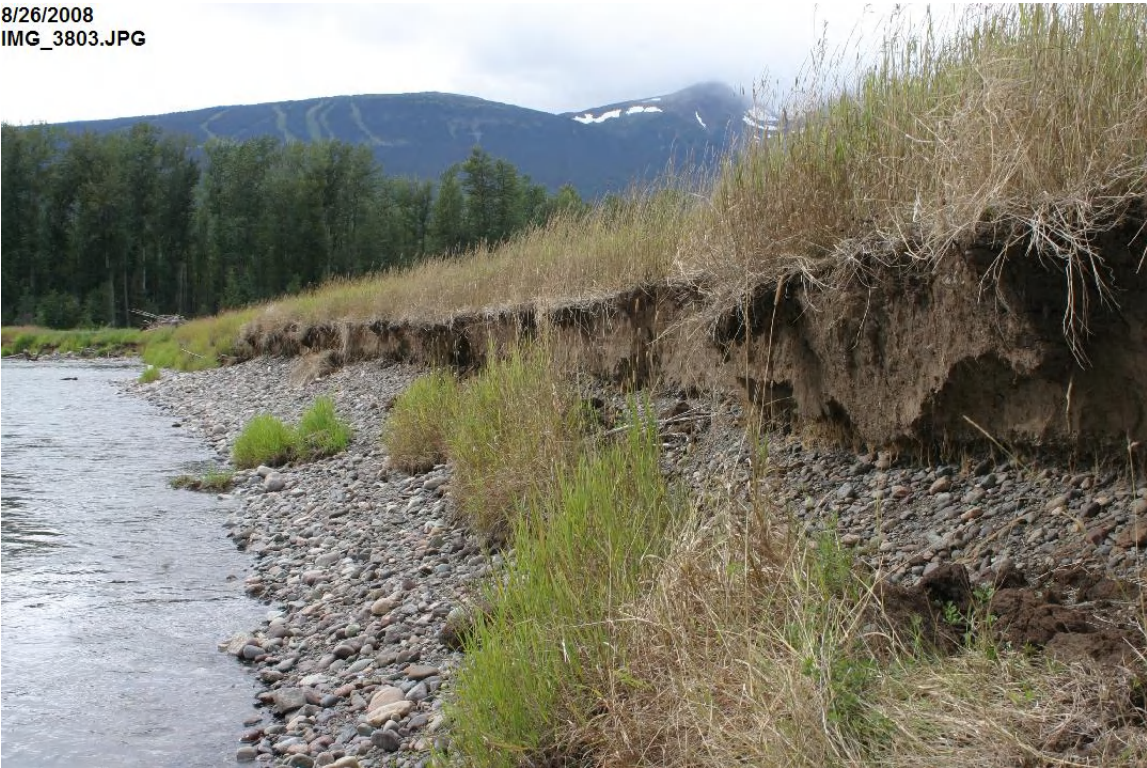
8/26/2008
IMG_3803.JPG

Bank undercutting at end of Kidd Road

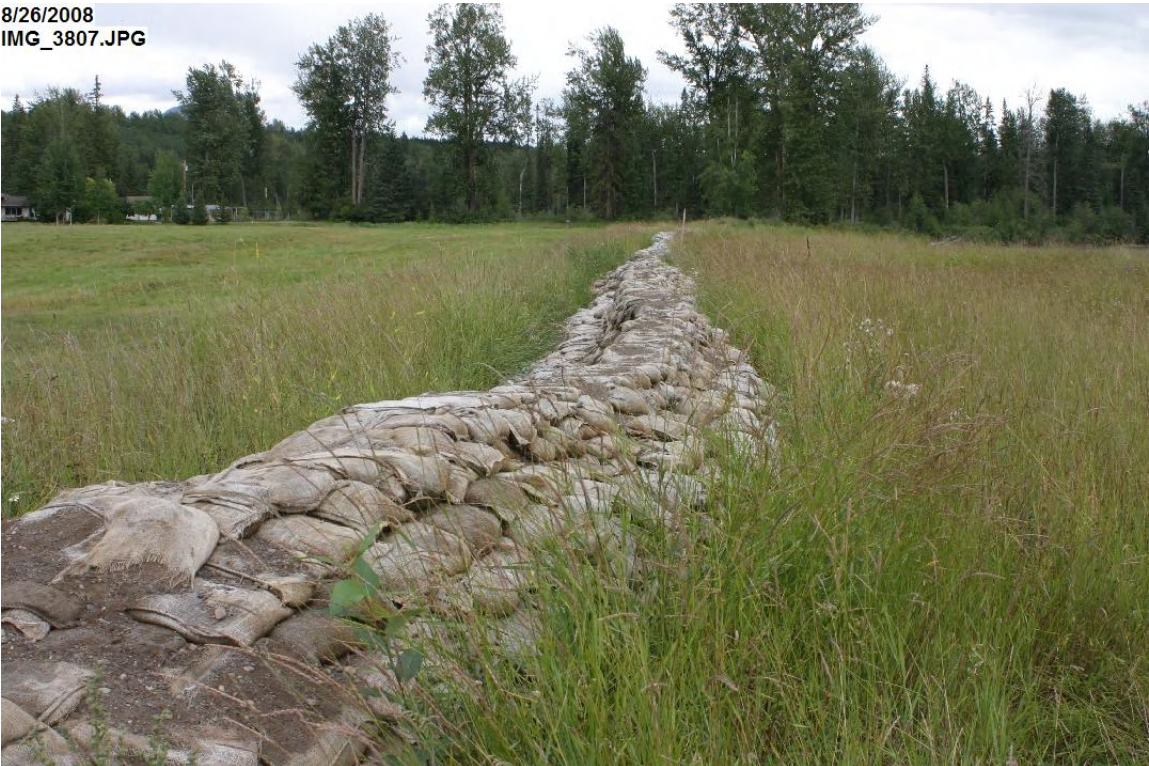
8/26/2008
IMG_3807.JPG

Sandbag dike at the end of Kidd Road

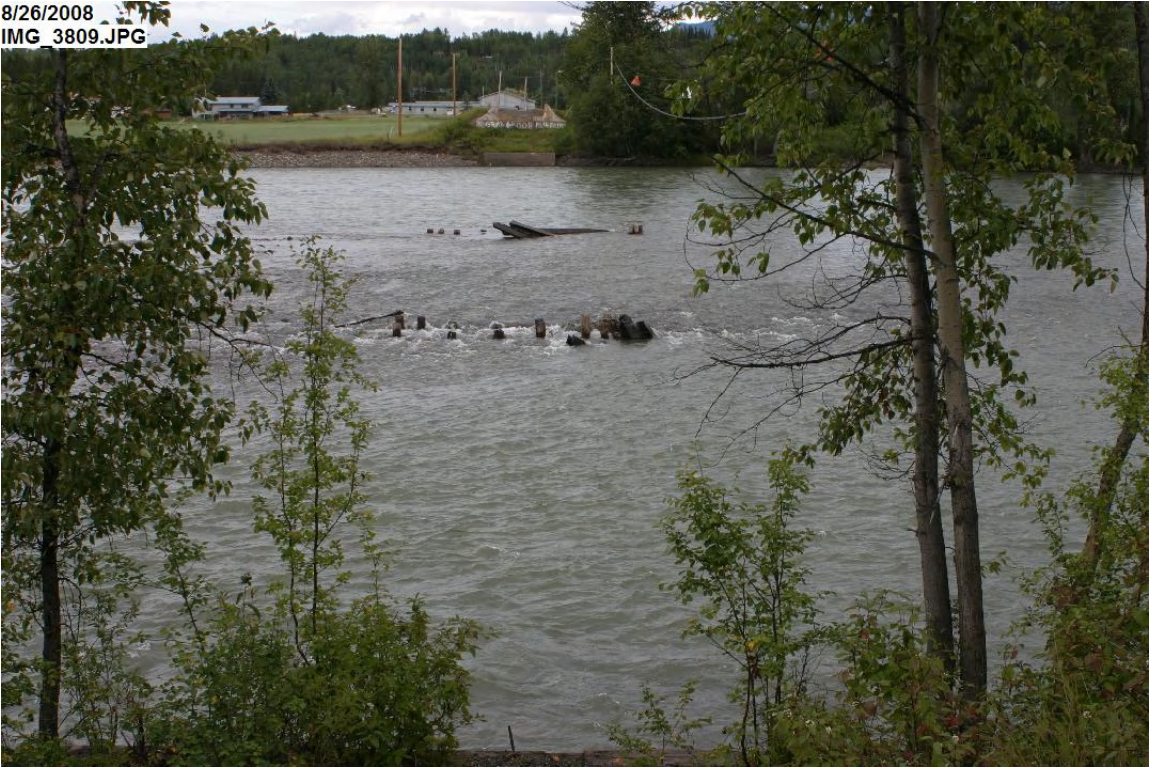
8/26/2008
IMG_3809.JPG

Bulkley crossing from south side – note old bridge piers

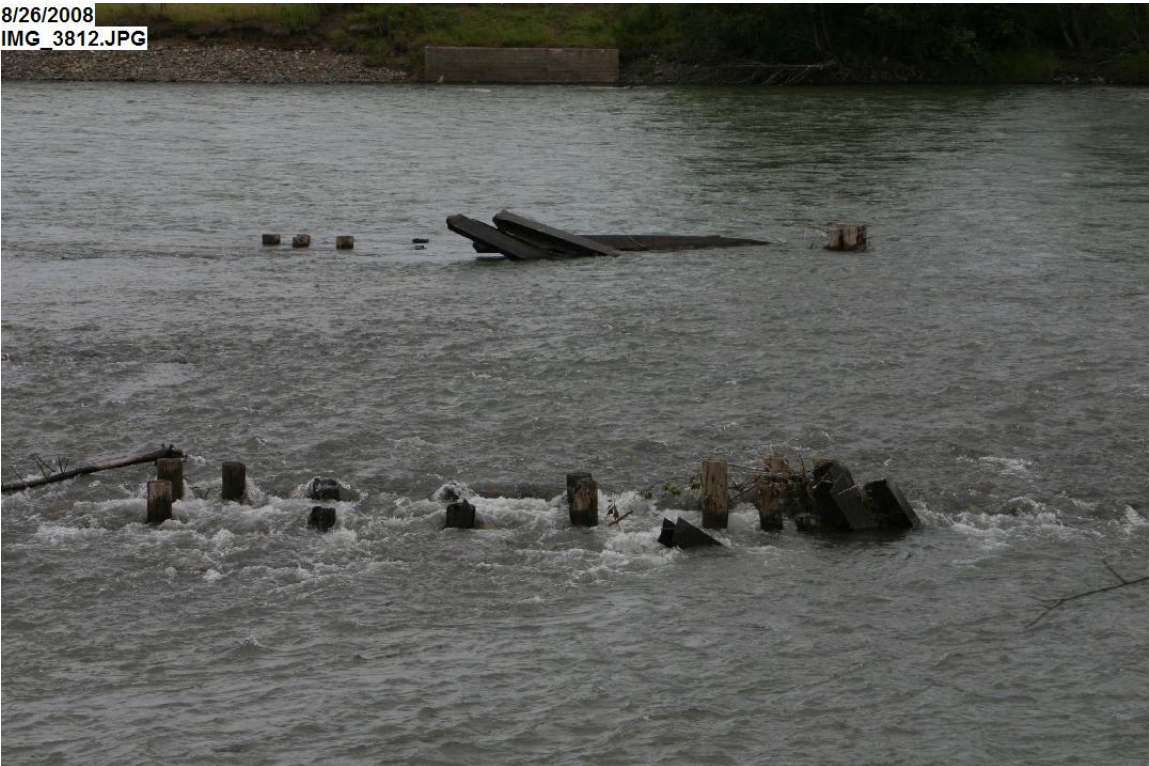
8/26/2008
IMG_3812.JPG

Lateral flow was noticed coming over the bridge piers and shallow gravel bar

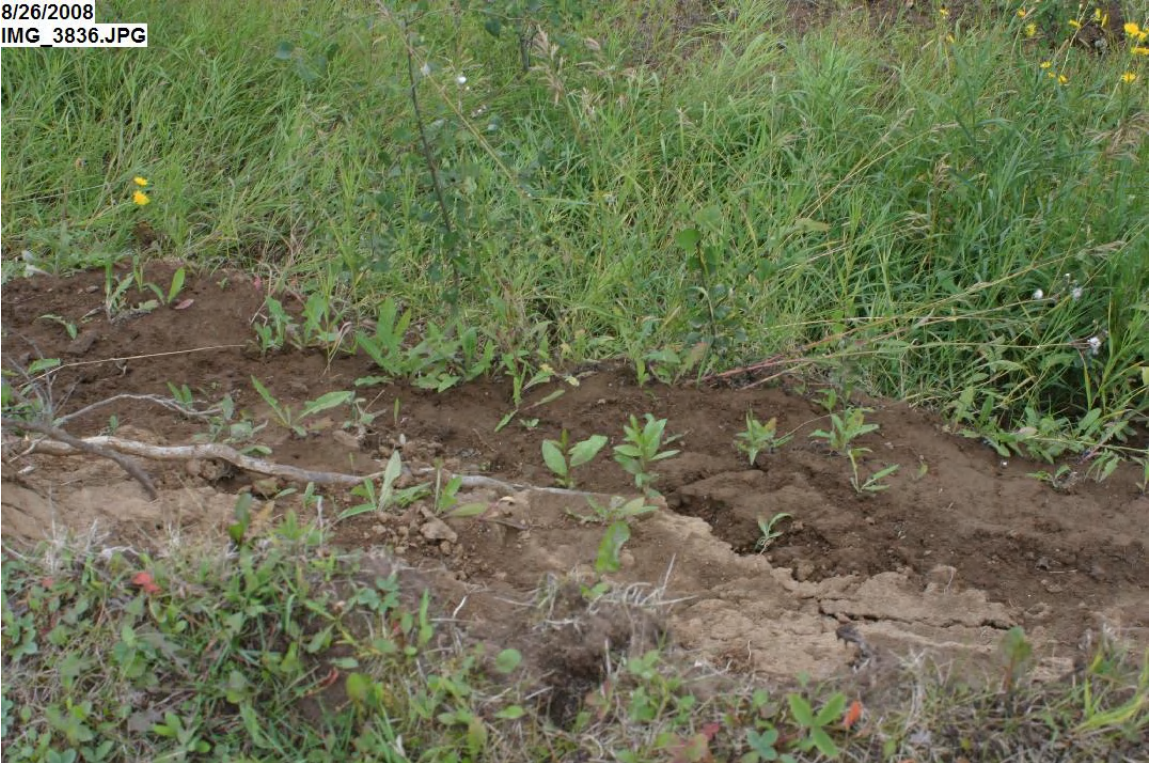
8/26/2008
IMG_3836.JPG

Riverside park entrance – steep and unstable bank

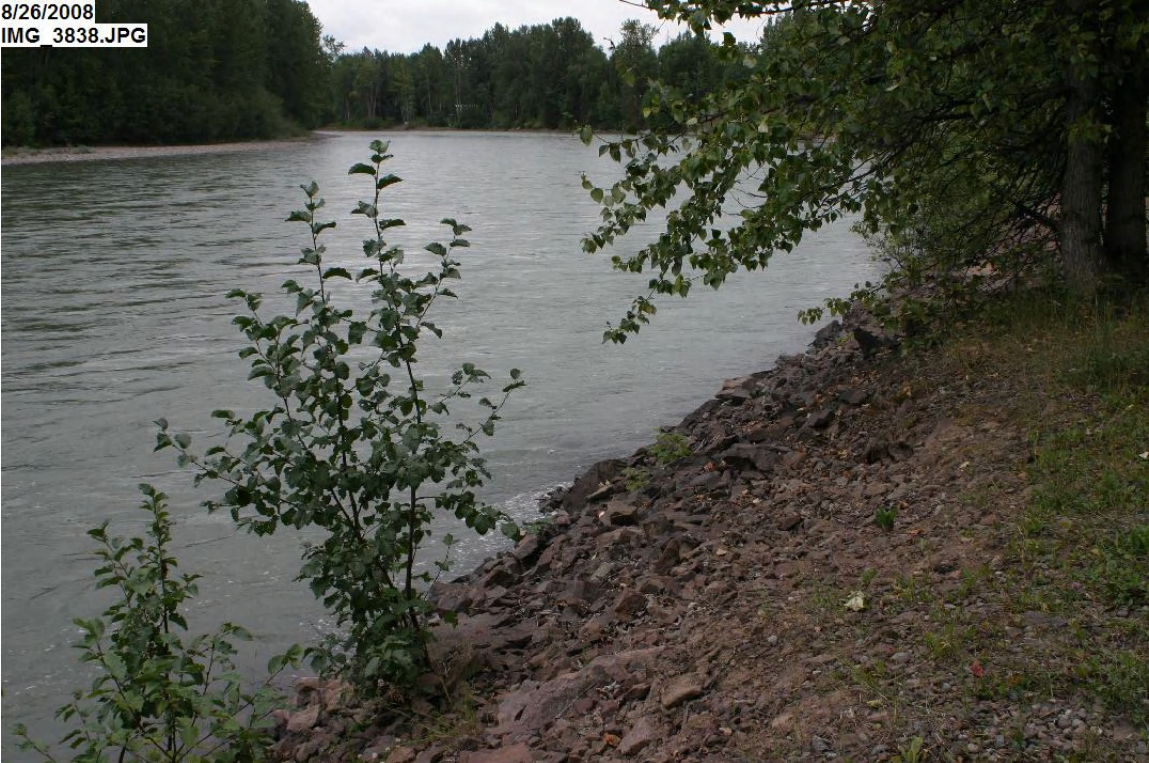
8/26/2008
IMG_3838.JPG

Riprap at Riverside Park
