August 26, 2014

Reference No. 051413495-2014-064-L-Rev0-2114

## **DENAK EAST PIT: DENAK FAULT STABILITY ASSESSMENT**

PROJECT  
DENAK EAST PIT  
DENAK FAULT STABILITY ASSESSMENT

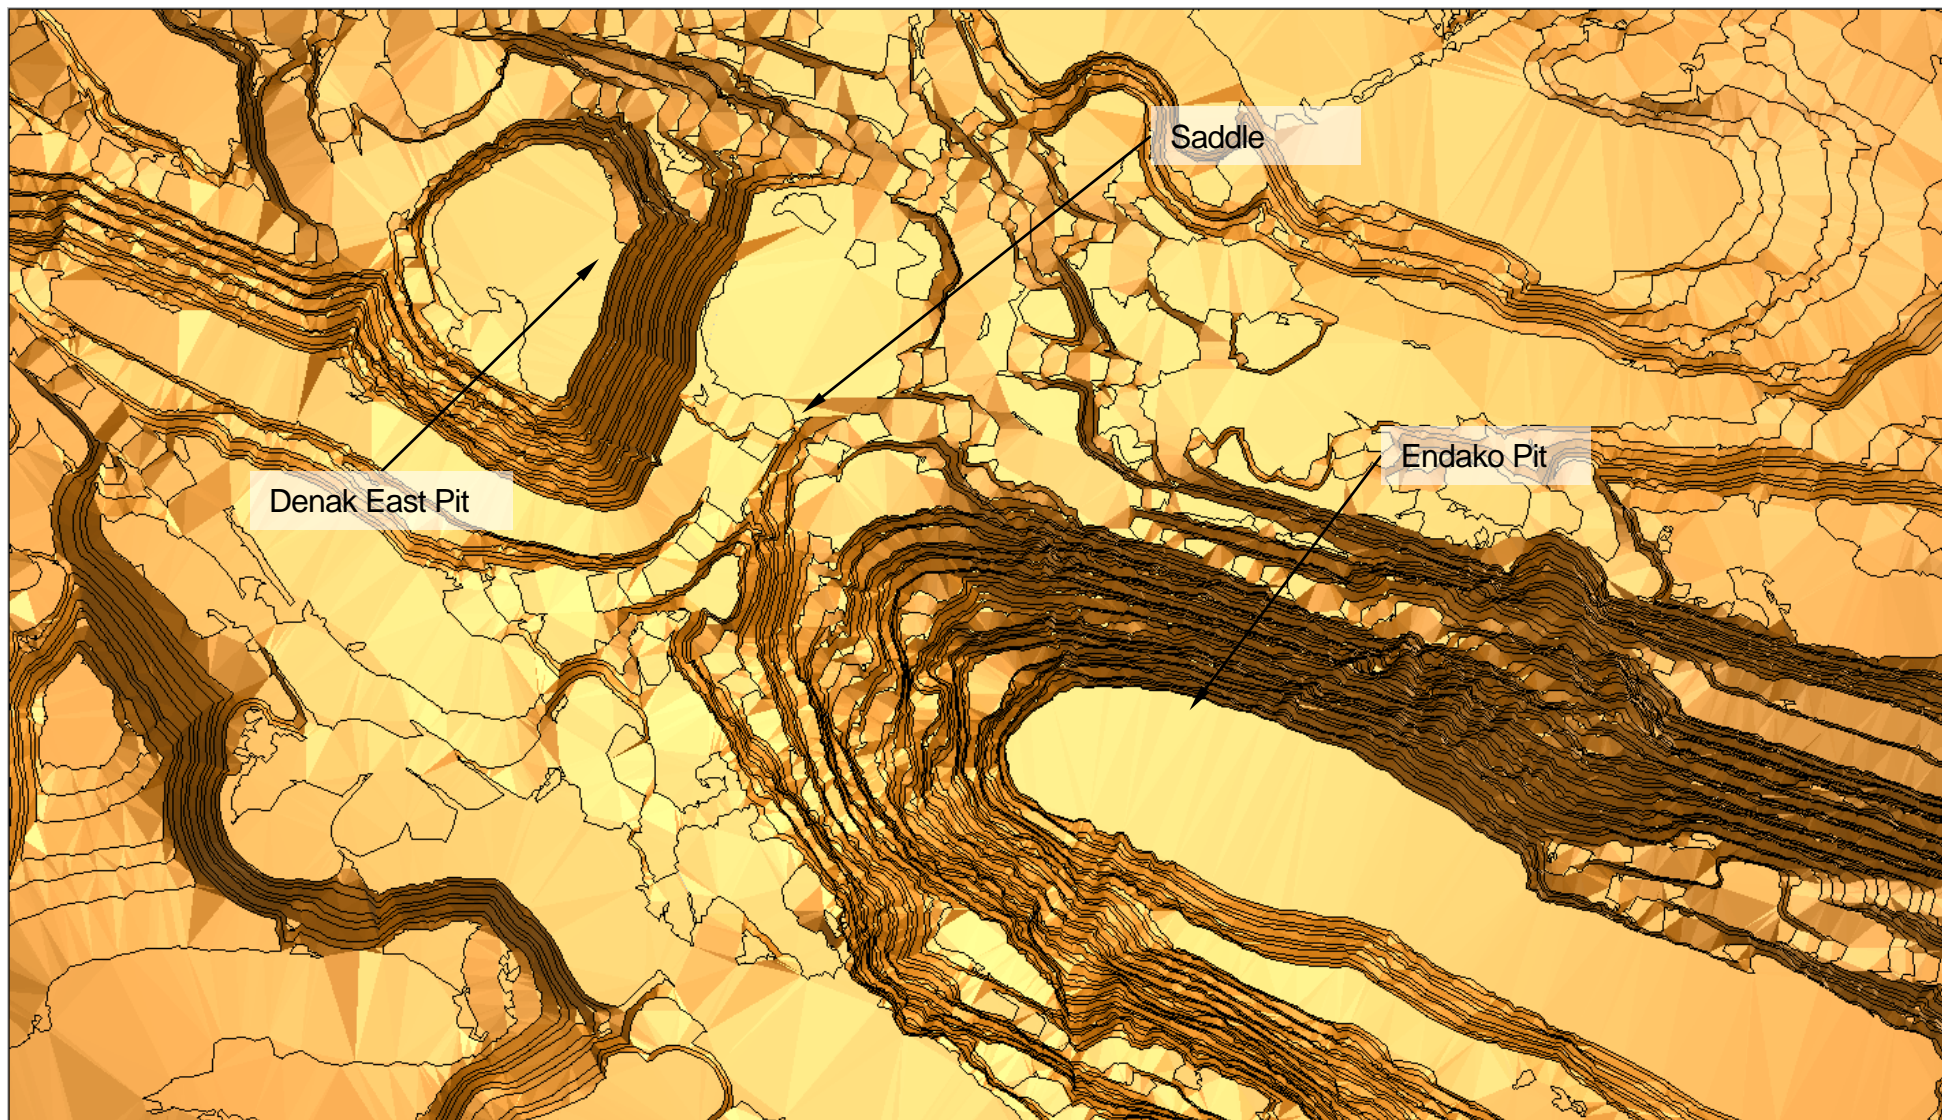
Figure  
**1**

Mining has previously been carried out in the existing Denak East and Endako Pits. The locations of the existing pits are shown in Figure 1. An in-pit dump has been advanced over the east wall of the Denak East Pit from the saddle, and the wall is covered in waste rock. The floor of the Denak East Pit is located at the 2,926-ft. elevation and the floor of the Endako Pit is located at the 2,530-ft. elevation. A saddle is located between the Denak East Pit and the Endako Pit. The crest of the saddle is located between the 3,179-ft. and the 3,355-ft. elevation. The west wall of the saddle (east wall of the Denak East Pit) is approximately 275 ft. high and the east wall of the saddle (west wall of the Endako Pit) is approximately 700 ft. high.

TITLE  
**Plan View of Denak East and Endako Pits**  
**August 2013 Asbuilt**

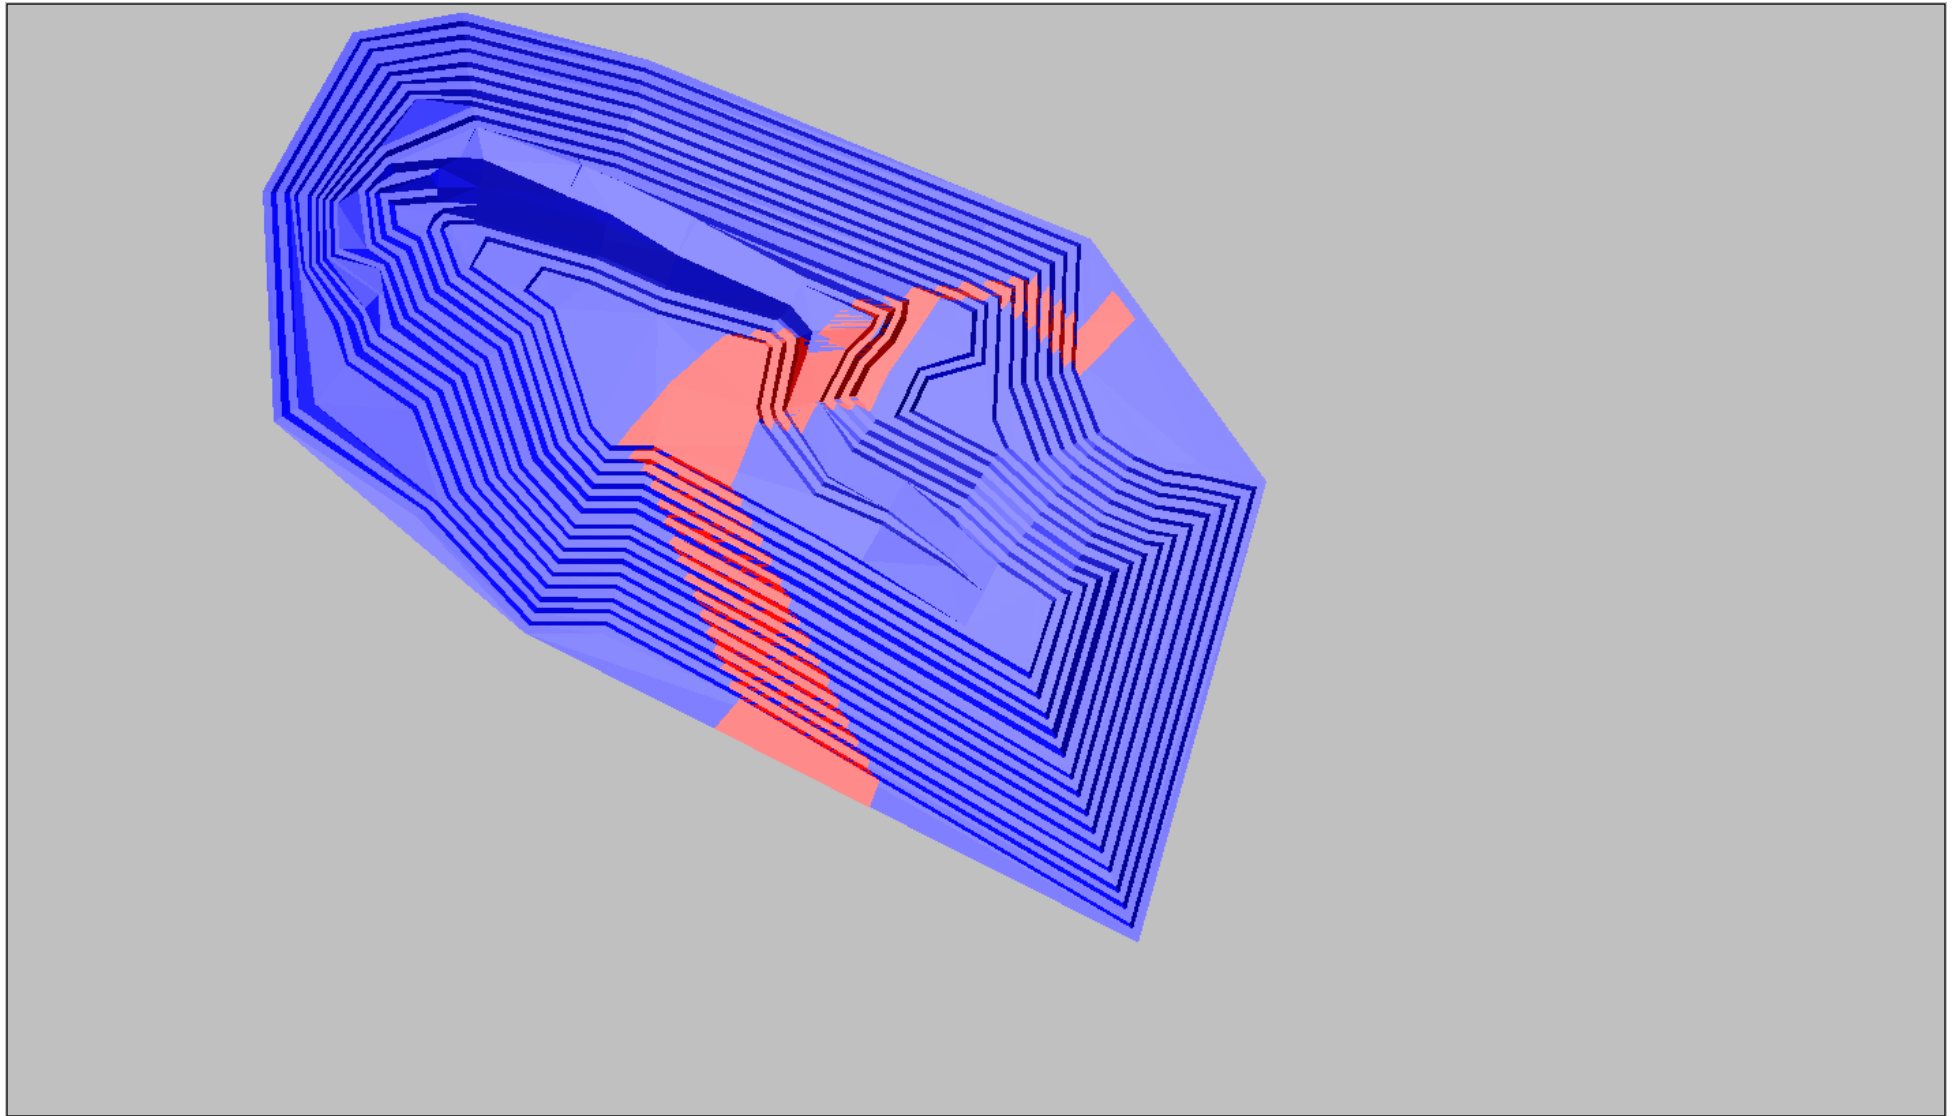
Figure  
**2**

TITLE  
**Plan View of Denak East Pit  
Proposed Revised Interim Pit with Fault Intersection**
