**EBENEZER FLATS/KIDD ROAD
EROSION PROTECTION STUDY
DRAFT**

**SUBMITTED TO
REGIONAL DISTRICT OF BULKLEY-NECHAKO**

McElhanney Consulting Services Ltd.
1633 First Avenue
Prince George BC V2L 2Y8

October 2008
Our File: 2331-00650-0

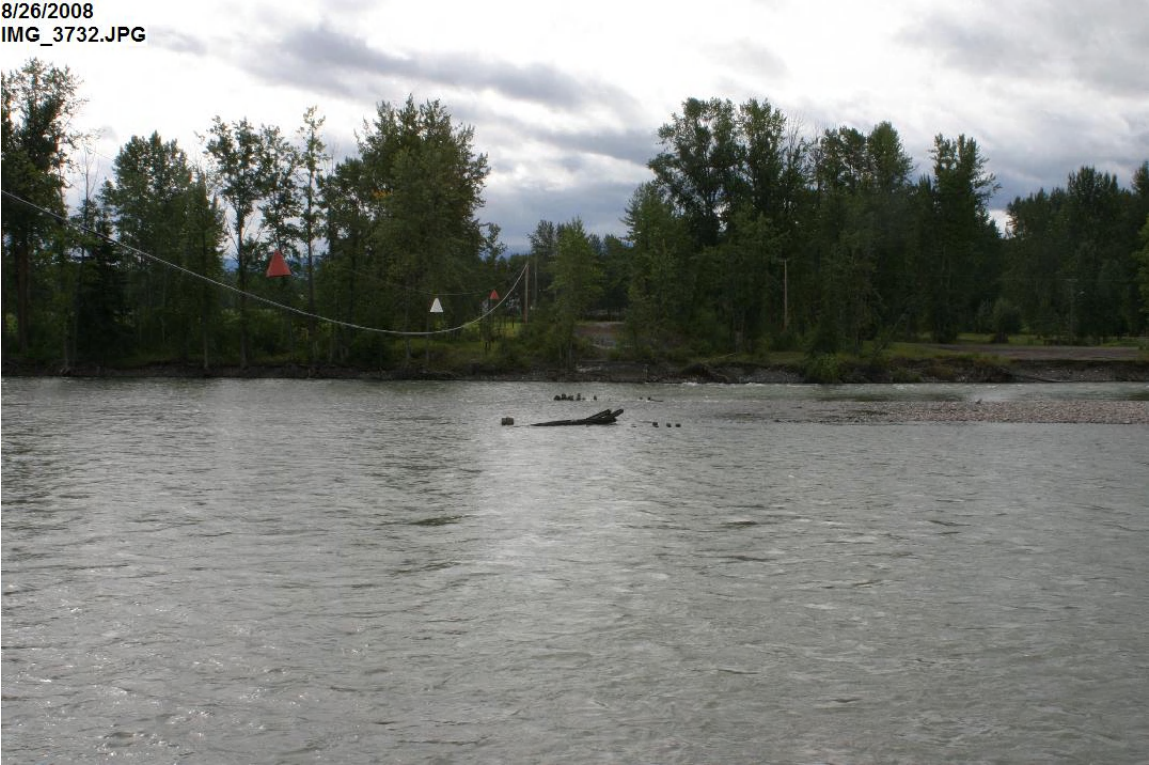
8/26/2008
IMG_3732.JPG

Old Bulkley River Crossing at foot of Lower Viewmount Road

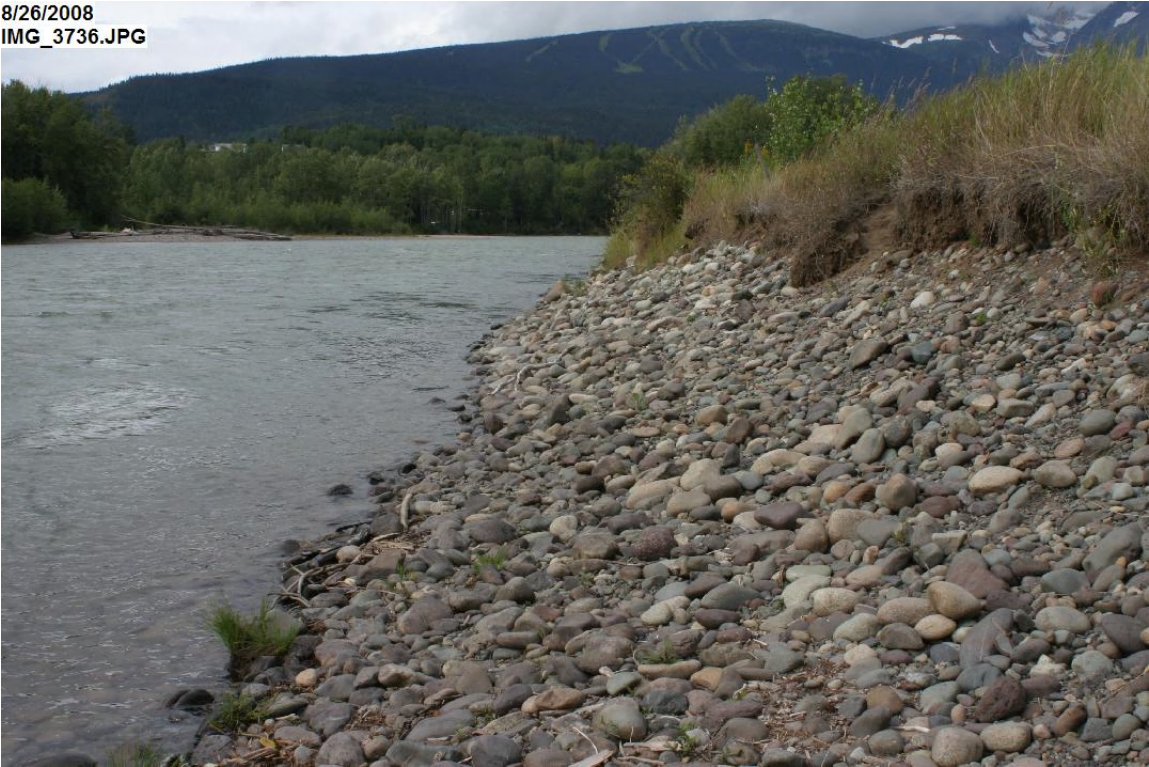
8/26/2008
IMG_3736.JPG

Typical bank material

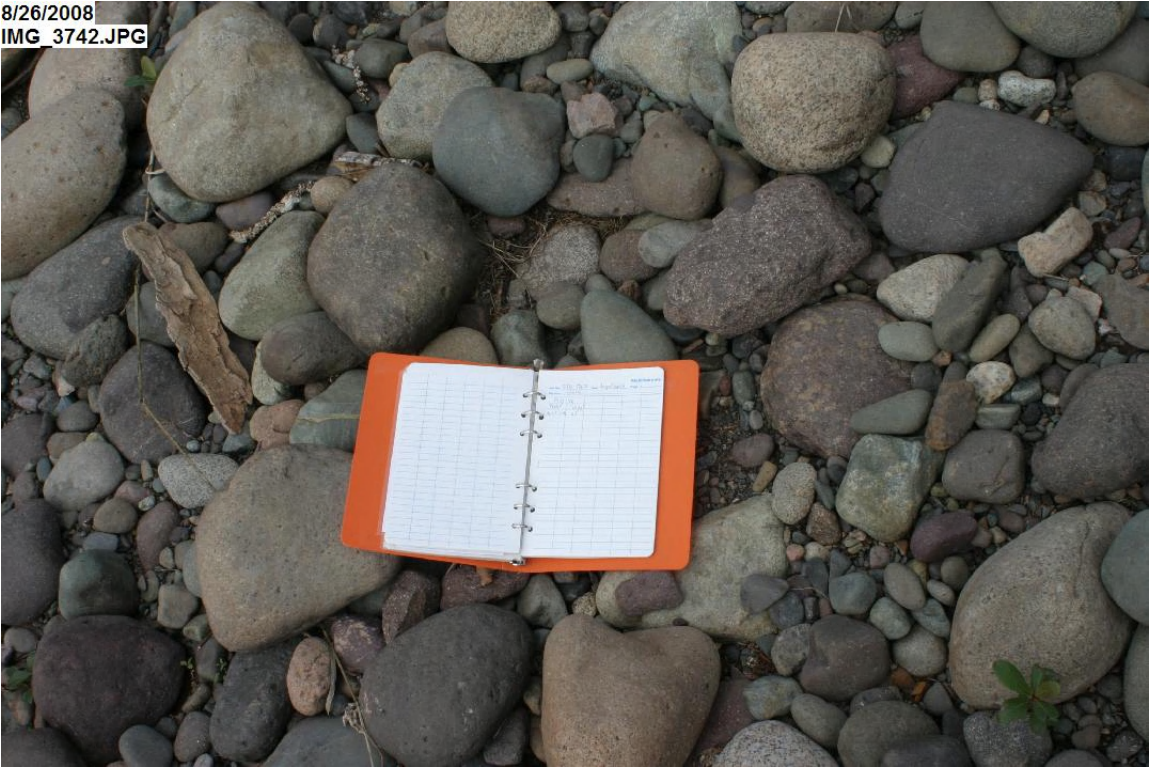
8/26/2008
IMG_3742.JPG

Closeup of typical bed material

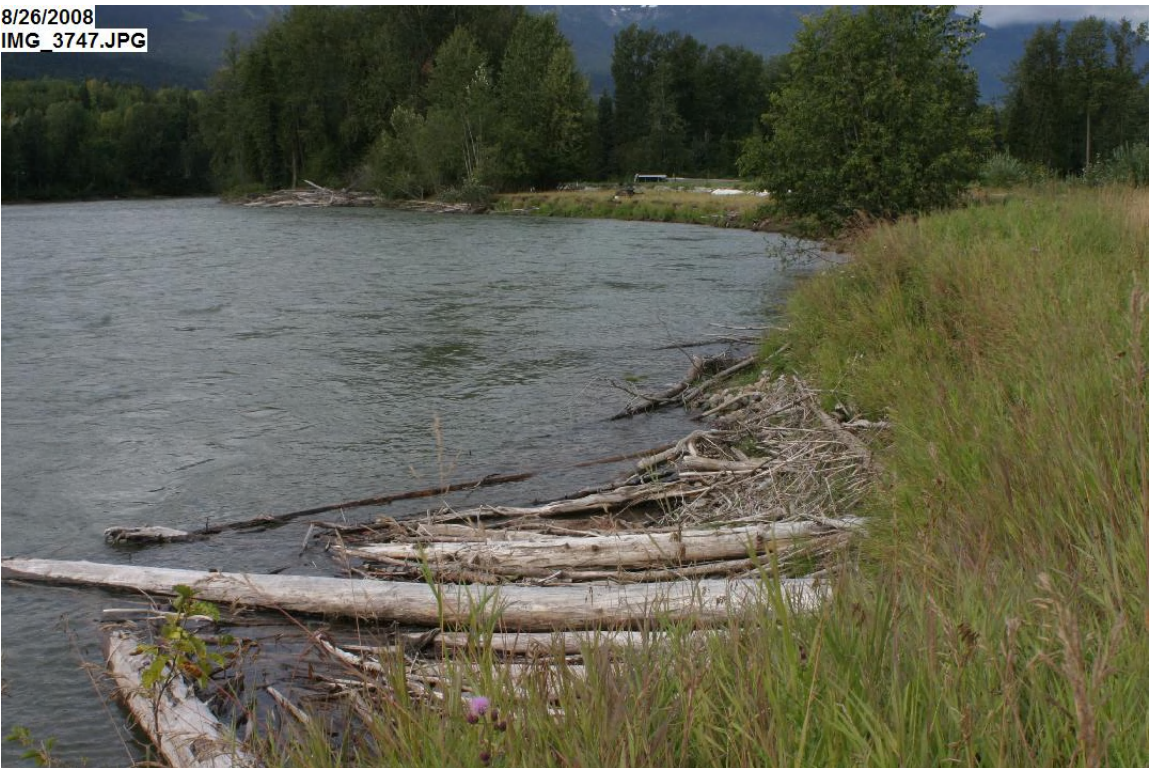
8/26/2008
IMG_3747.JPG

Deposition of woody debris

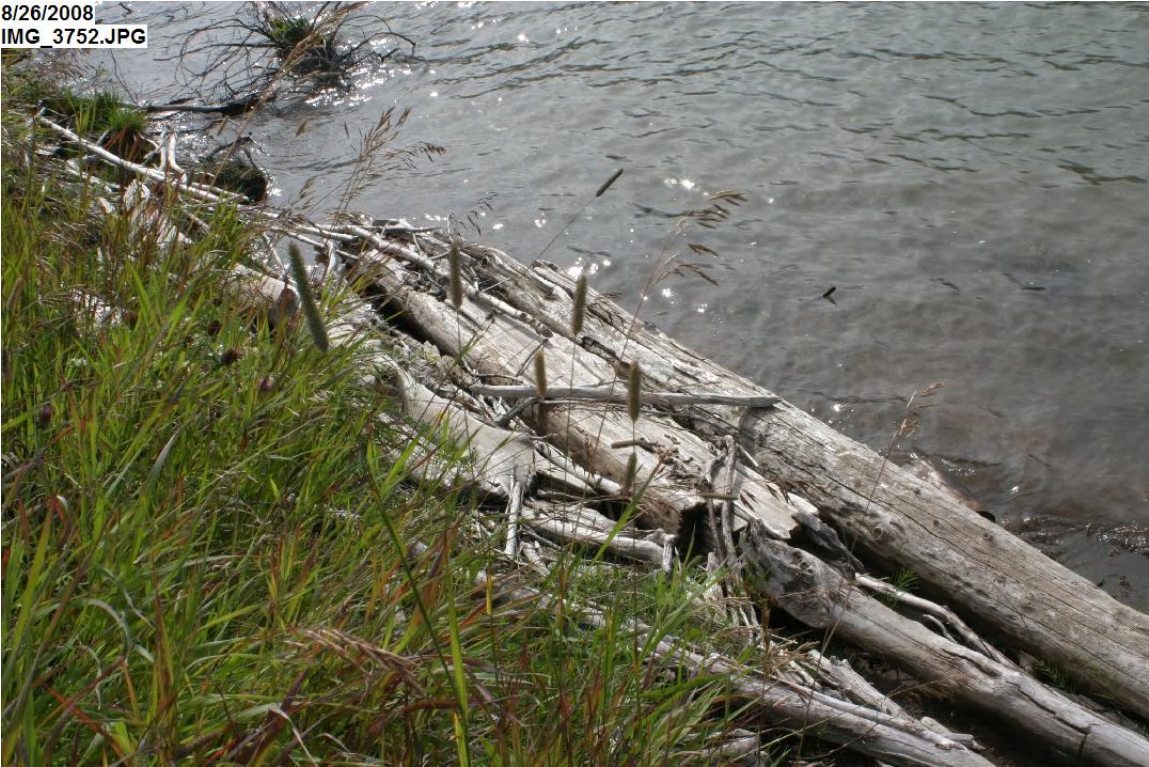
8/26/2008
IMG_3752.JPG

Deposition of woody debris

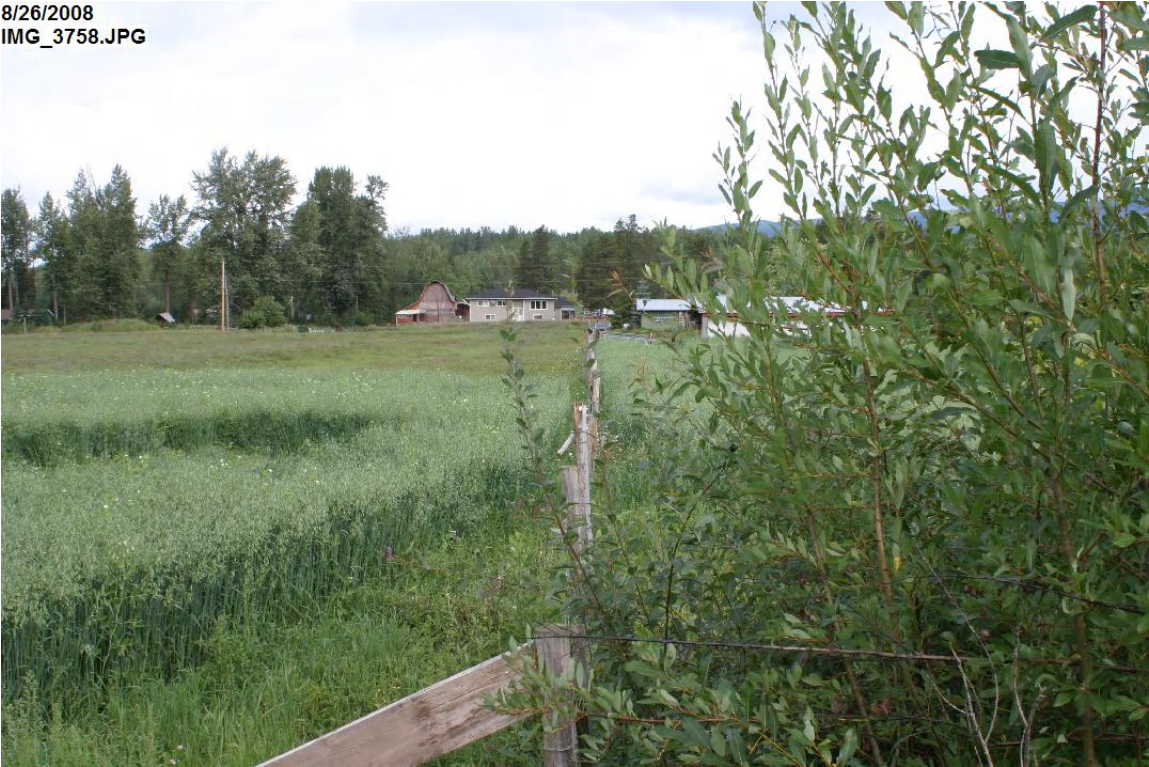
8/26/2008
IMG_3758.JPG

Fenceline

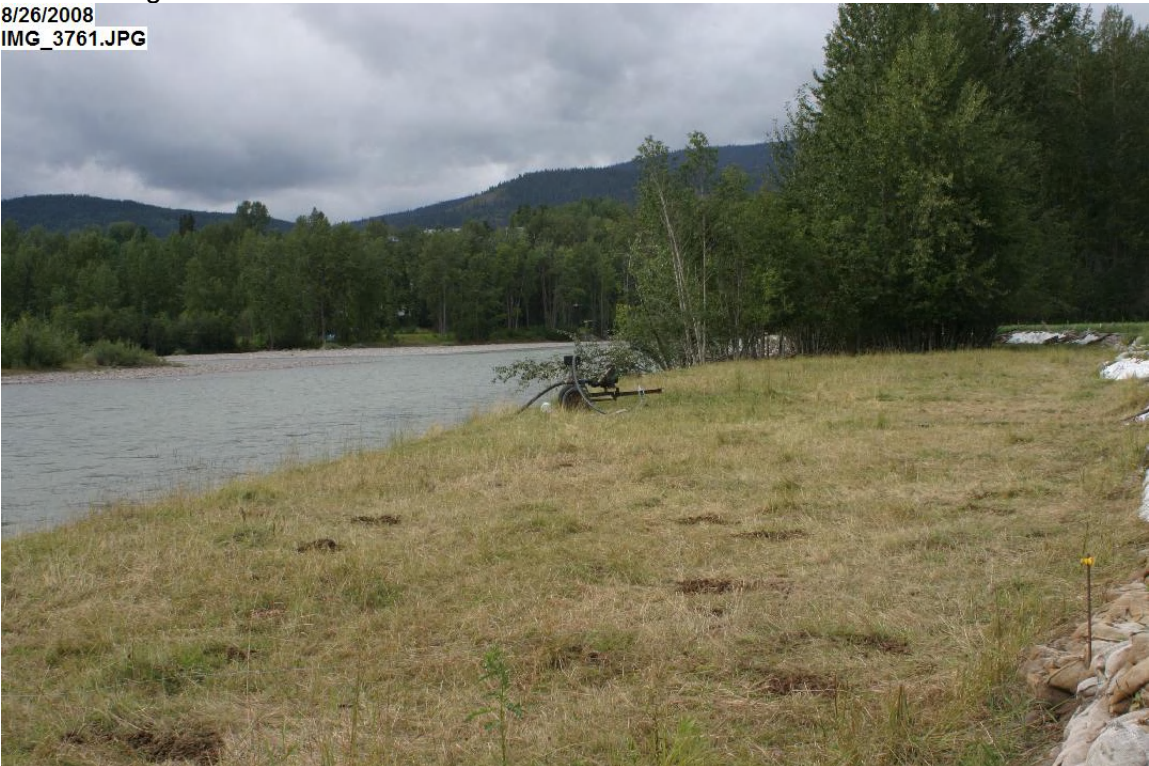
8/26/2008
IMG_3761.JPG

Dike looking west

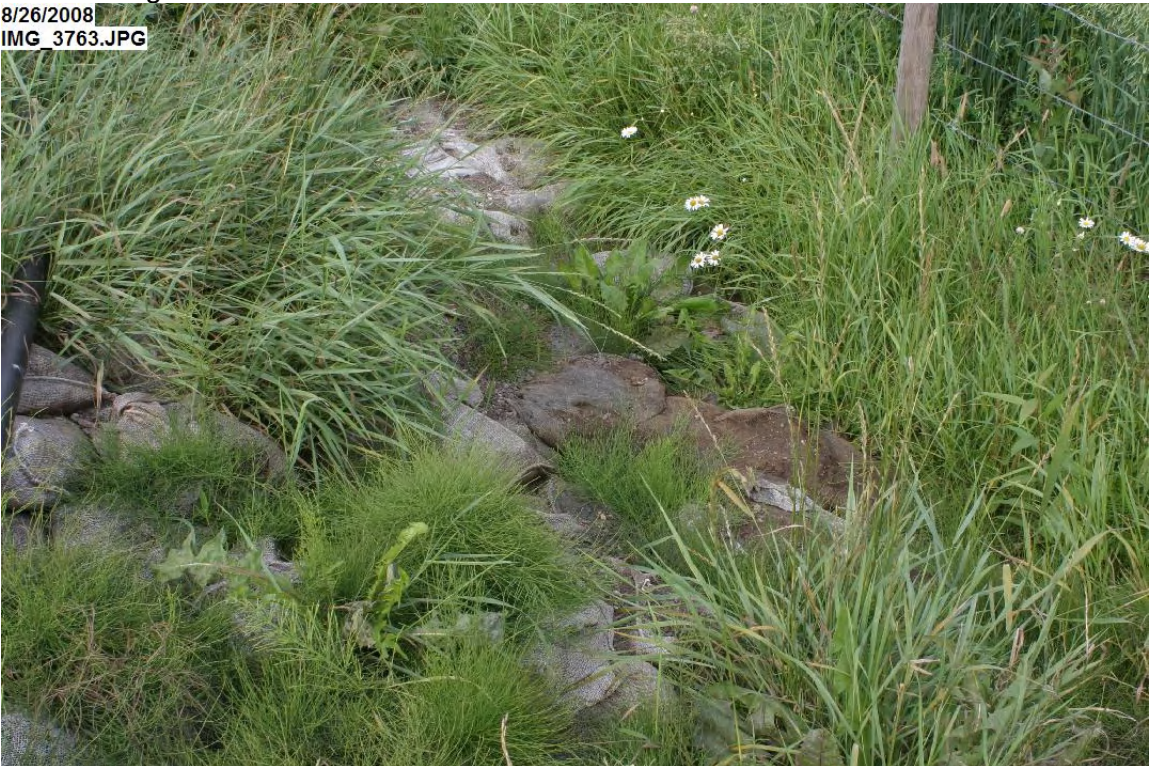
8/26/2008
IMG_3763.JPG

Dike looking east

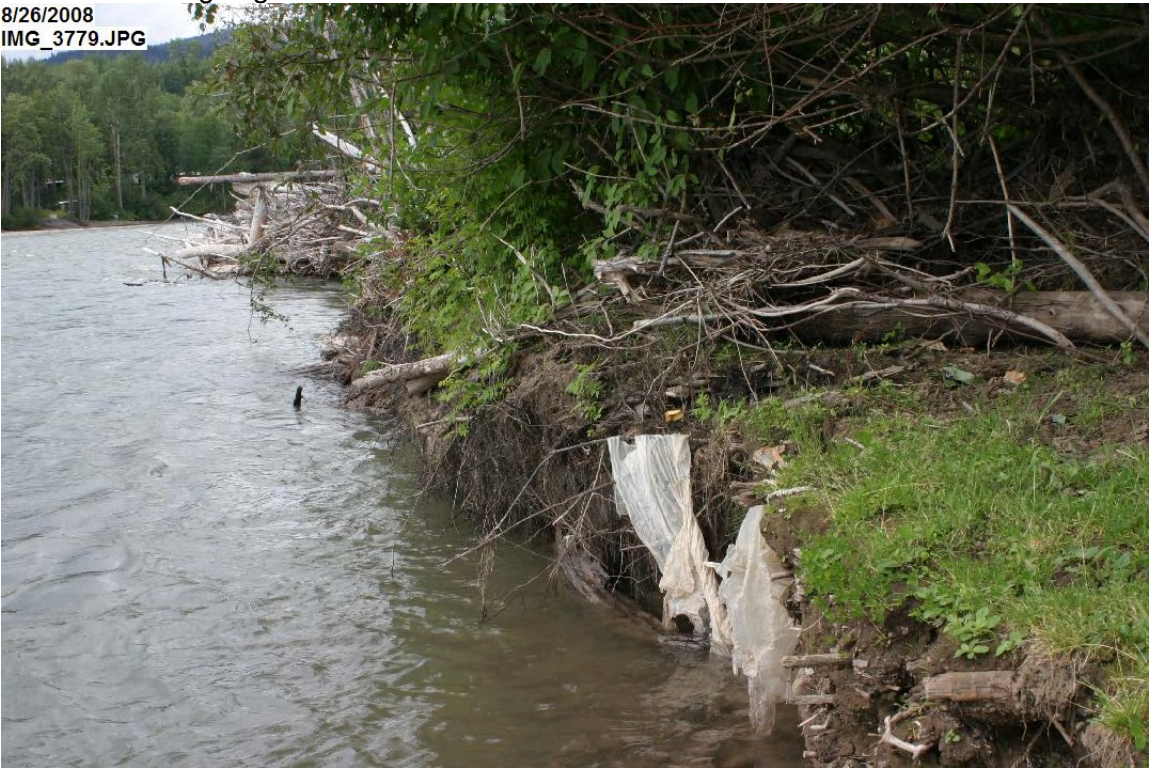
8/26/2008
IMG_3779.JPG

Note bank sloughing and soils with weak resistance to erosion

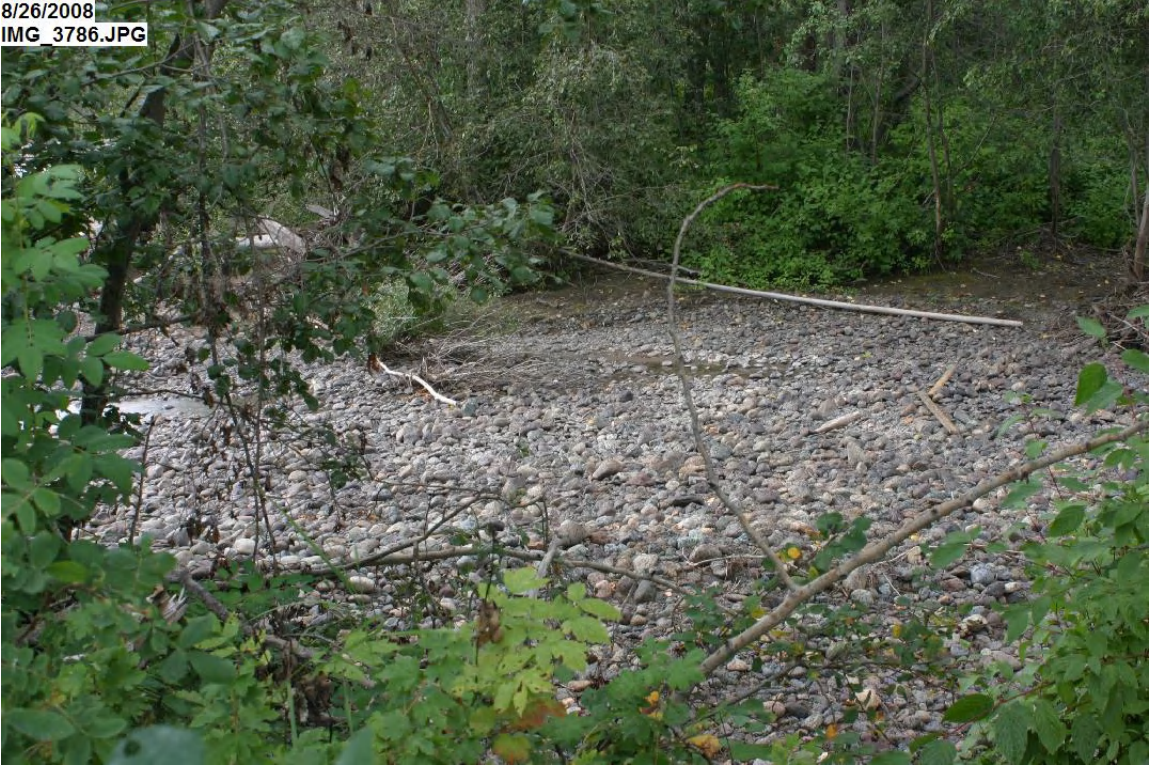
8/26/2008
IMG_3786.JPG

Dry channel of "Beaver Island"

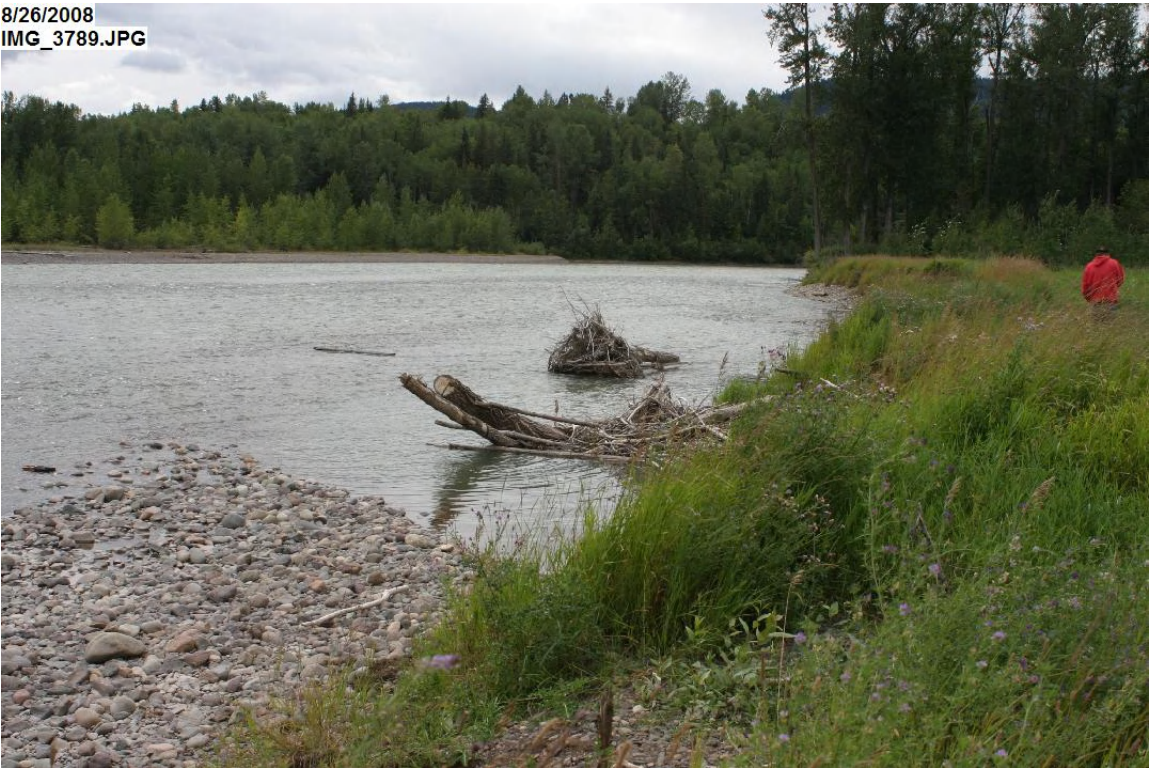
8/26/2008
IMG_3789.JPG

End of Kidd Road

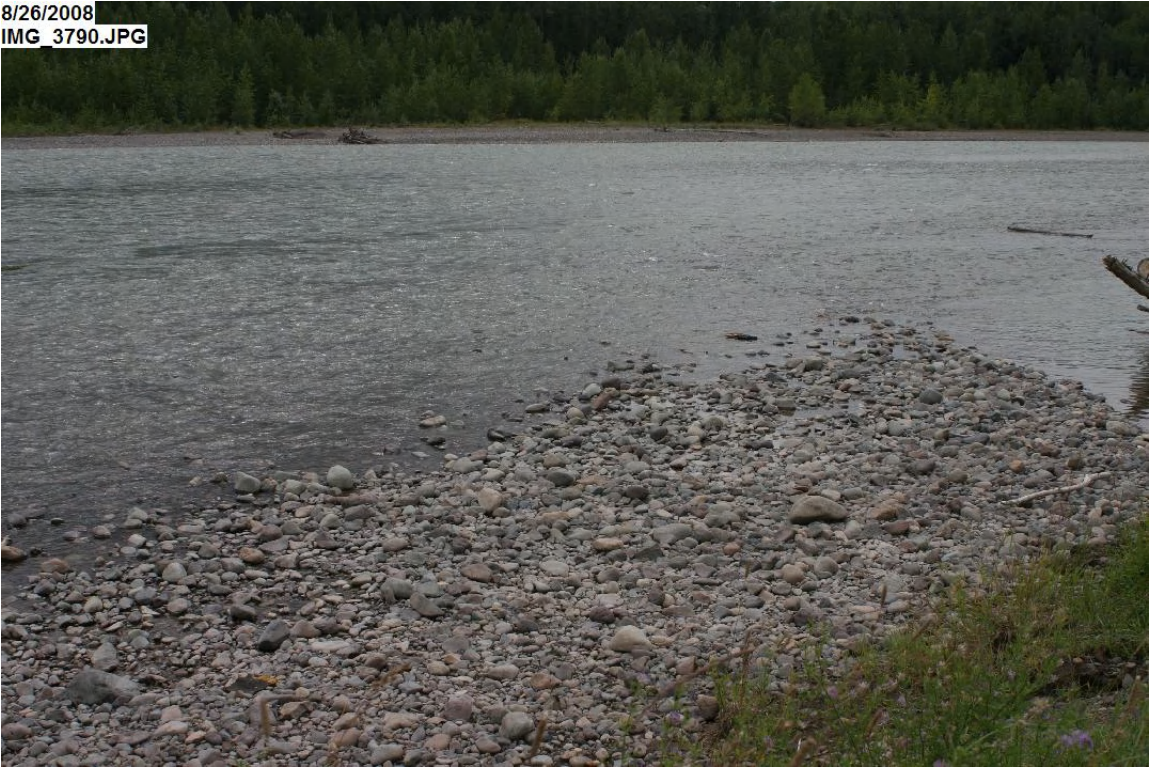
8/26/2008
IMG_3790.JPG

End of Kidd Road

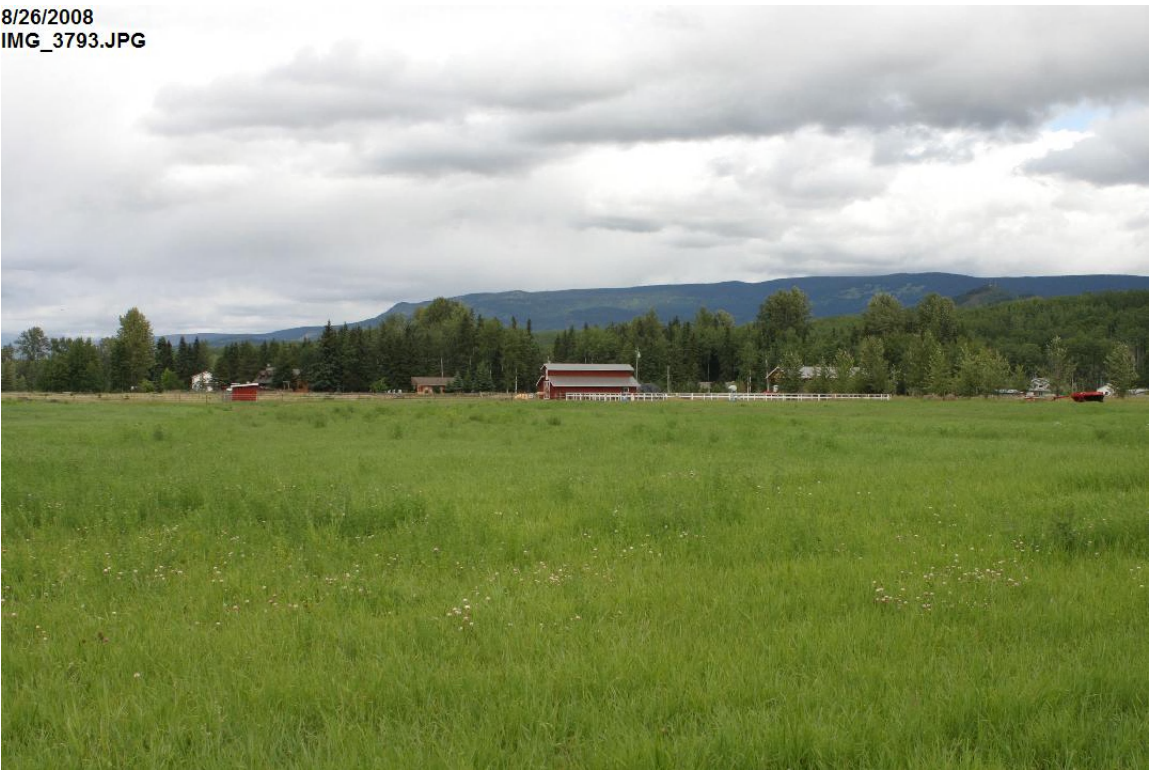
8/26/2008
IMG_3793.JPG

Bank erosion at end of Kidd Road

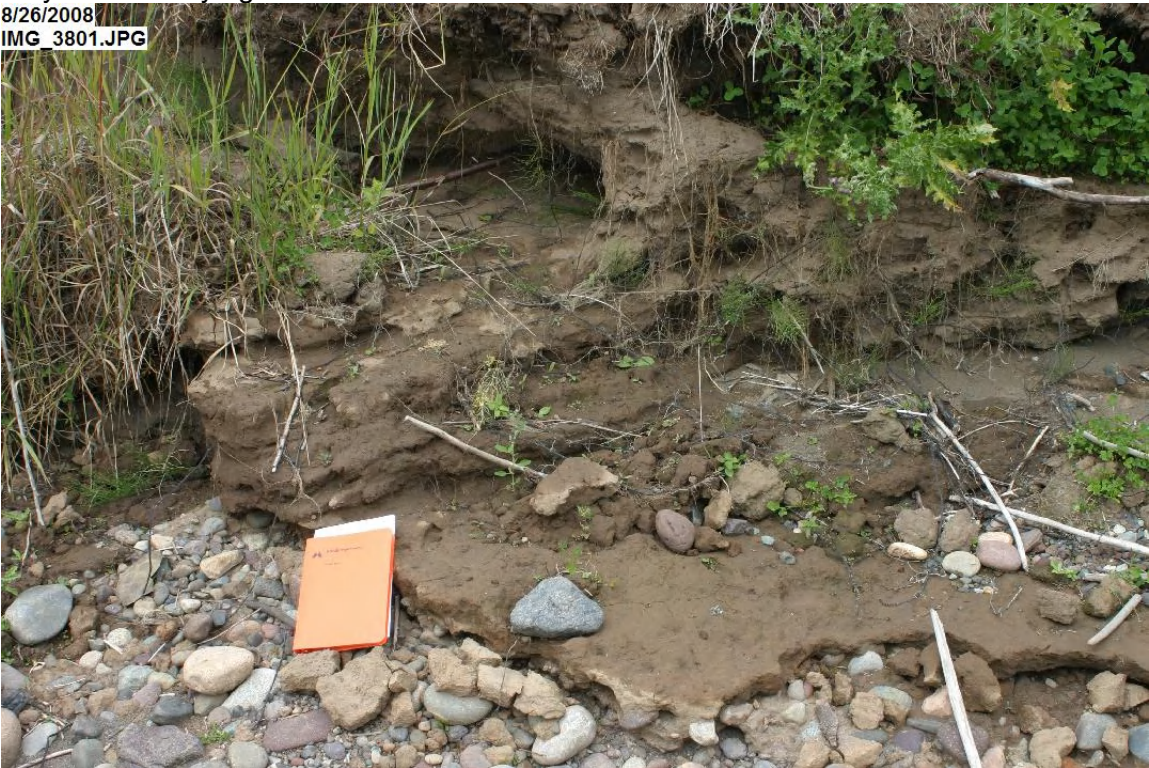
8/26/2008
IMG_3801.JPG

Silty sand overlying cobbles at end of Kidd Road

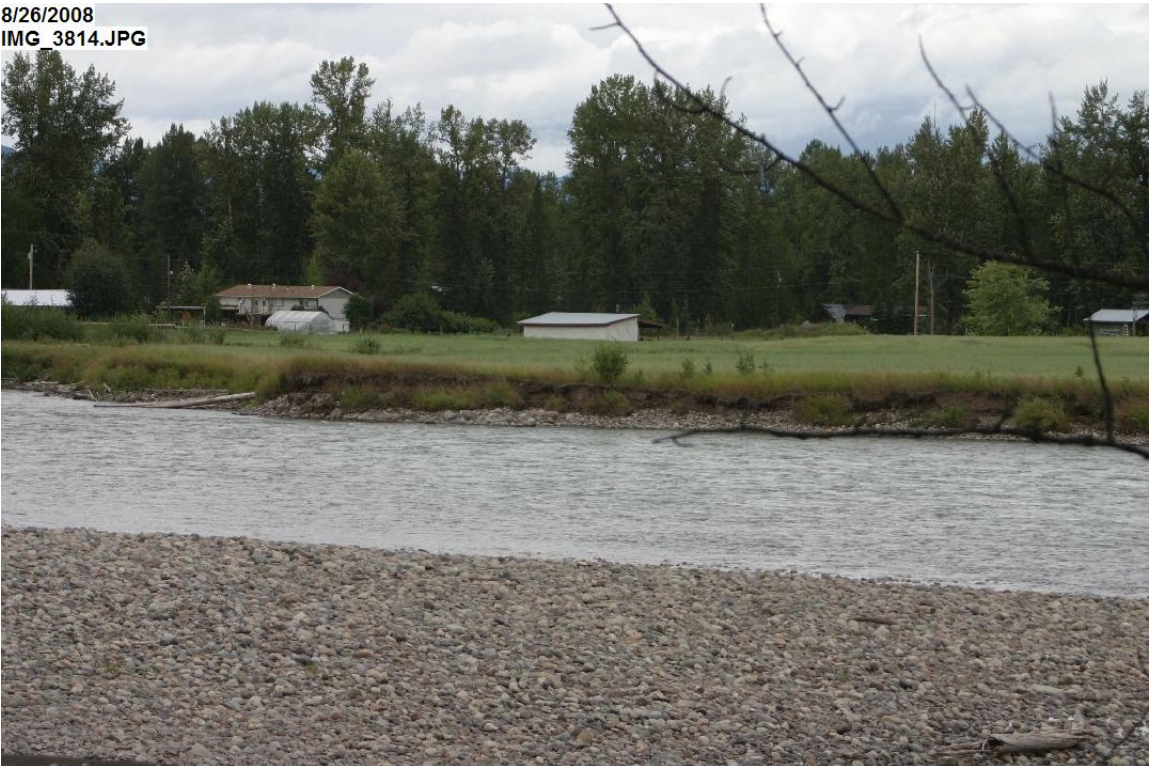
8/26/2008
IMG_3814.JPG

View of previously walked bank

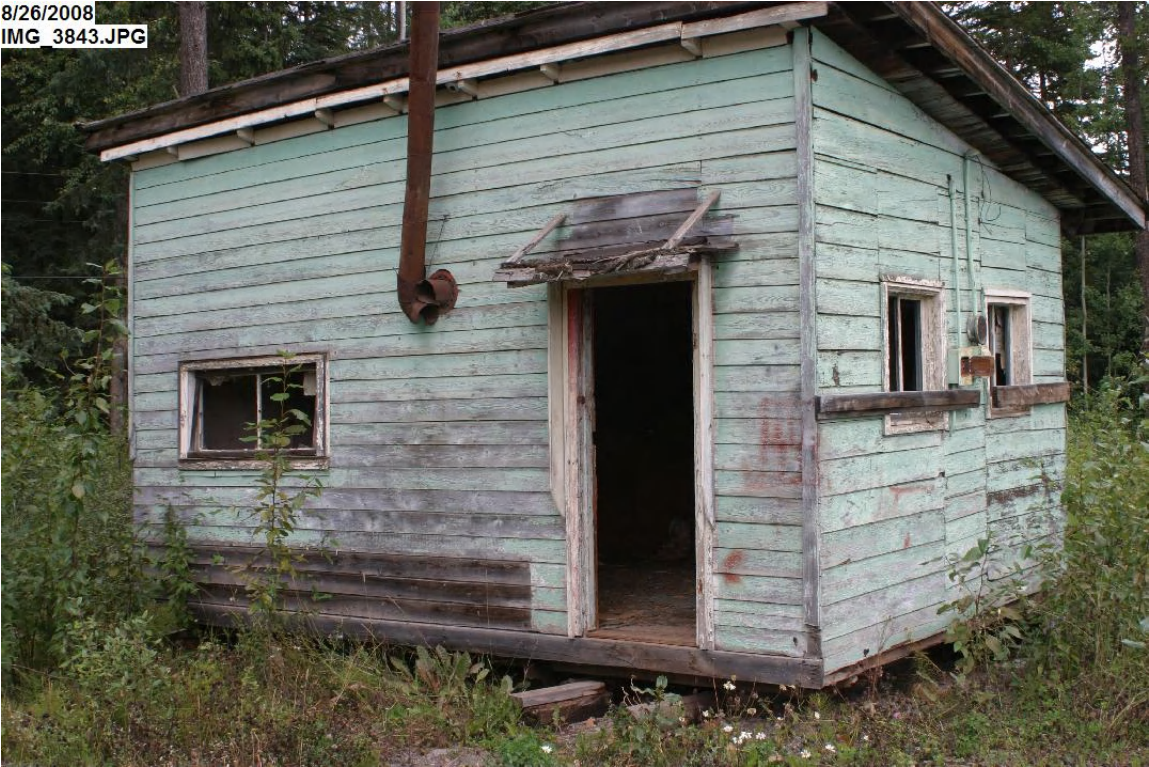
8/26/2008
IMG_3843.JPG

Rosenthal Road – steep eroded bank and abandoned buildings
